MODEL  
2012-2016MY  
Soul (AM, PS)  
w/Gamma 1.6L GDI

NUMBER  
PI2002A (Rev 1, 01/21/2021)

SUBJECT: **1.6L GDI KNOCK SENSOR DETECTION SYSTEM  
(KSDS) LOGIC IMPROVEMENT (PI2002A)**

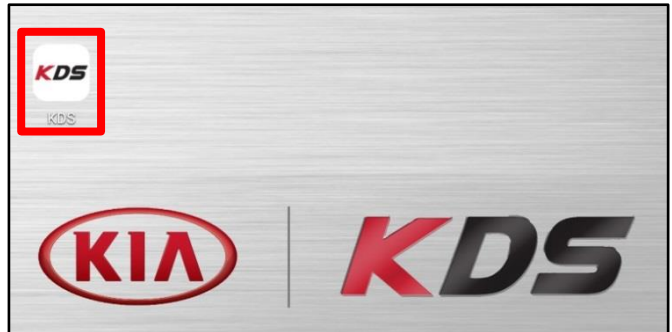
2. With the ignition ON, turn ON the KDS tablet. Select **KDS** from the home screen.

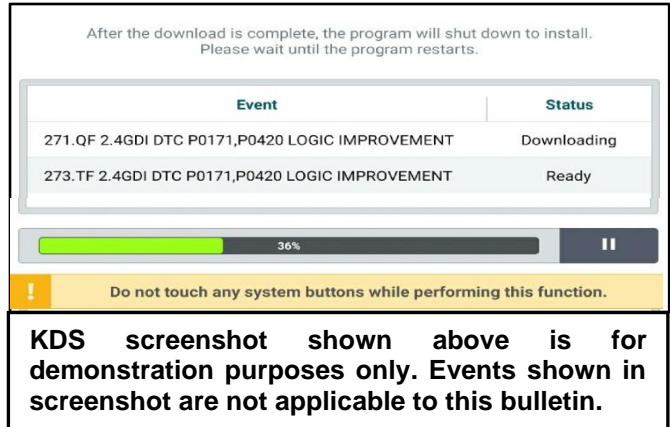
- The KDS will check the server for recently uploaded Events and then automatically download **Upgrade Event #521 (PS) or #522 (AM)**.

The vehicle must be identified in Vehicle Selection to download an Event for that vehicle.
