GROUP <b>Product Improvement</b>	MODEL <b>2011MY Sorento (XMa) w/2.4L MPI</b>
	NUMBER <b>PI2101</b>	DATE <b>January 2021</b>

**SUBJECT: THETA 2.4L MPI - KNOCK SENSOR DETECTION SYSTEM (KSDS) ECU LOGIC IMPROVEMENT (PI2101)**

## THETA 2.4MPI - KNOCK SENSOR DETECTION SYSTEM (KSDS) ECU UPGRADE (PI2101)

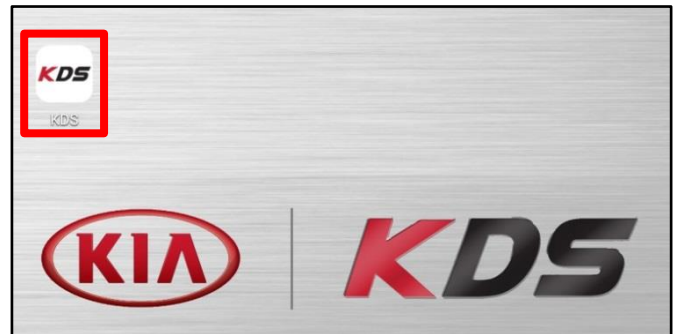
2. With the ignition ON, turn ON the KDS tablet. Select **KDS** from the home screen.

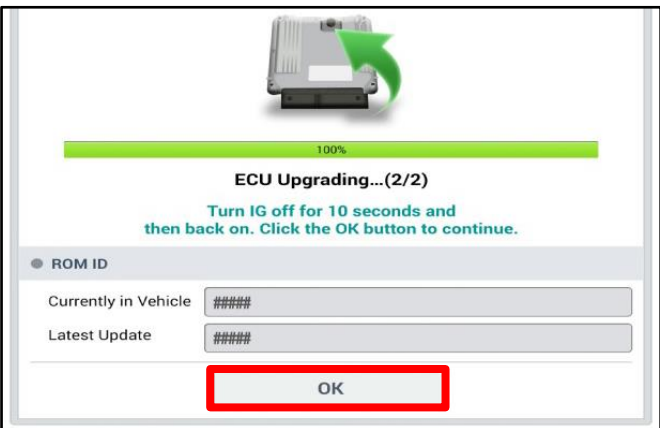
- When instructed on the KDS, turn the ignition **OFF** for ten (10) seconds then back on. Touch **OK** to continue.
