TECHNICAL SERVICE BULLETIN

SERVICE ACTION: MDPS LOGIC UPDATE FOR DTC C125901 & C111201 (SA456)

This bulletin provides the procedure to improve the logic of the Electronic Power Steering (EPS) software on some 2020MY Rio vehicles produced September 28, 2020 through November 21, 2020, which may exhibit reduced steering assist and MIL ON with DTC(s) C125901 and/or C111201. To correct this concern, apply the improved logic to the Electronic Power Steering (EPS) system using the KDS ECU Upgrade function as described in this bulletin. For confirmation that the latest reflash has been applied to a vehicle you are working on, verify the ROM ID using the table on page 3 of this bulletin. Before conducting the procedure, verify that the vehicle is included in the list of affected VINs.

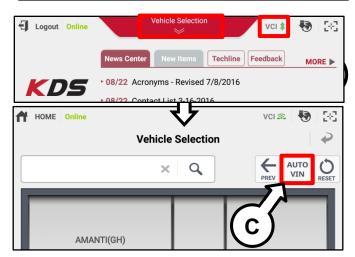
3. Confirm communication with VCI (A) and then configure the vehicle (B) using the **AUTO VIN** (C) feature.
