2020MY  
Niro (DE HEV/PHEV)

224

## TECHNICAL SERVICE BULLETIN

SERVICE ACTION: ACTIVE AIR FLAP (AAF)  
MIL ON JUDGMENT LOGIC IMPROVEMENT (SA459)

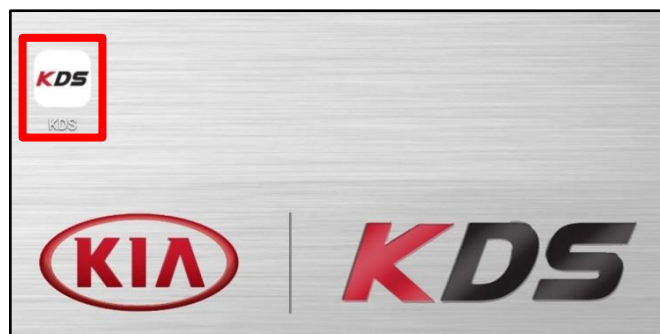
2. With the ignition ON, turn ON the KDS tablet. Select **KDS** from the home screen.

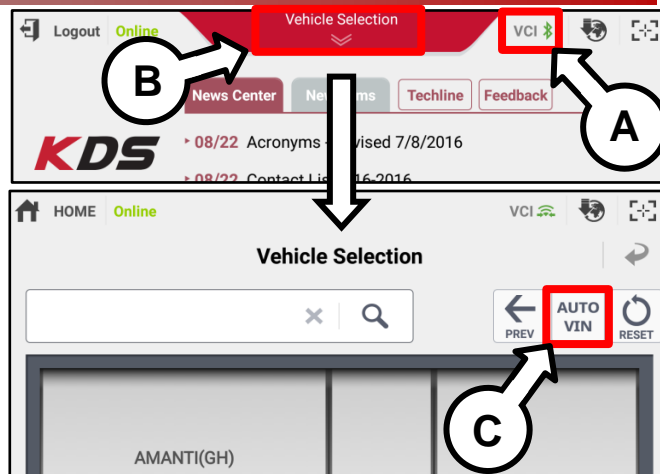
- Confirm communication with VCI (A) and then configure the vehicle (B) using the **AUTO VIN** (C) feature.

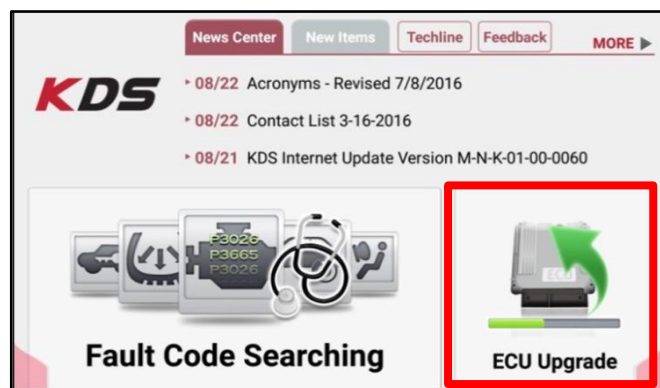
- Select **ECU Upgrade**.

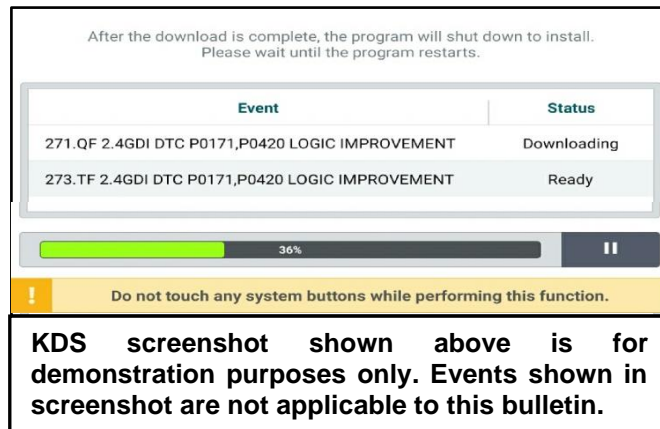
- The KDS will check the server for recently uploaded Events and then automatically download **Upgrade Event 517**.

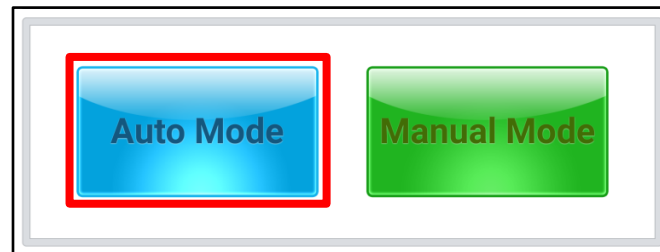
- Select **Auto Mode**.

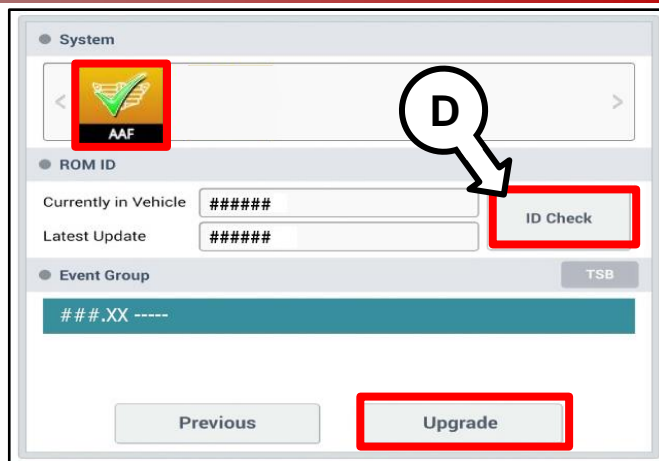
7. Select the **AAF** system under the System selection menu.

Touch **ID Check** (D) and confirm that the latest update is available.

Select **Upgrade Event 517** and select **Upgrade** to continue.

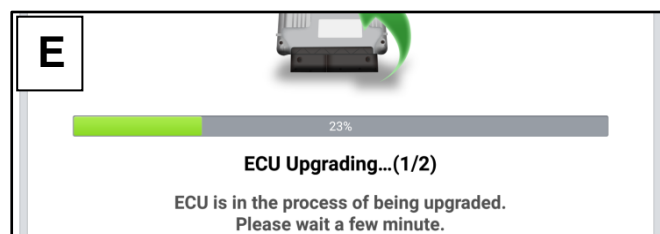
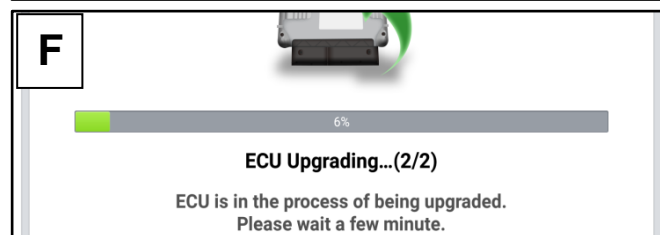
8. The ECU upgrade will begin and the progress of the upgrade will appear on the bar graph. Upgrade part (1/2) (E) will download the upgrade event to the VCI-II. Upgrade part (2/2) (F) will upgrade the ECU.

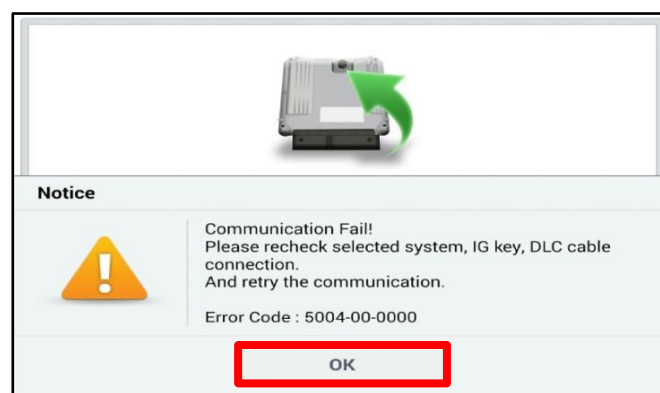
9. If a "Communication Fail" screen appears, verify that the VCI-II and KDS are communicating properly. Touch **OK** and restart the procedure from step 4.

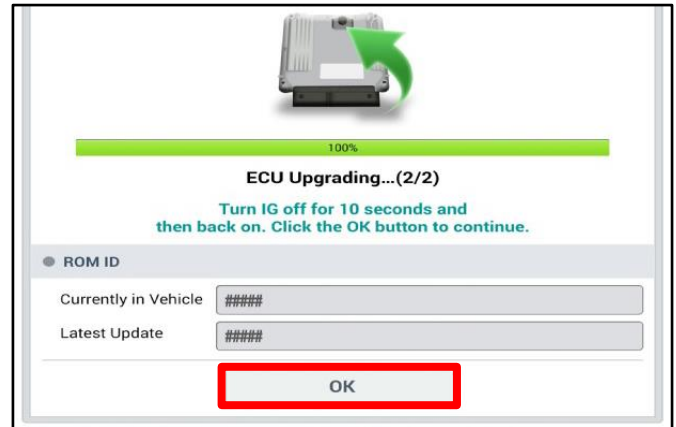
10. When instructed on the KDS, turn the ignition **OFF** for ten (10) seconds then back on. Touch **OK** to continue.

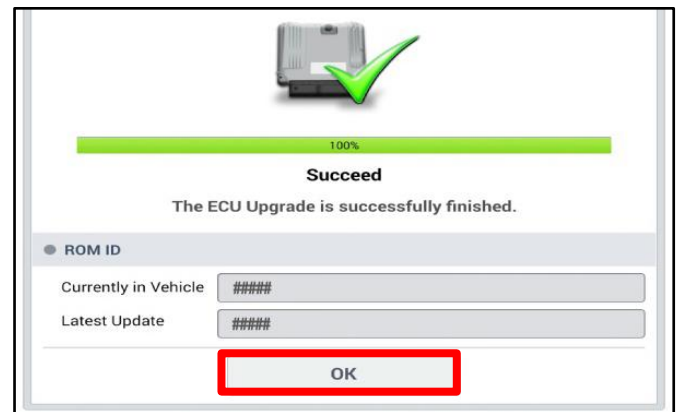
11. Once the upgrade is complete, touch **OK** to finalize the procedure.

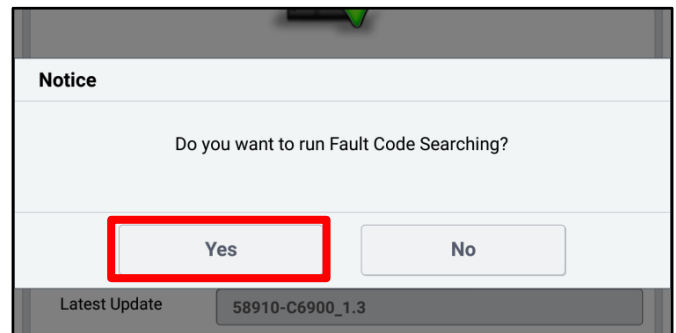
12. When prompted, select **YES** to check for Diagnostic Trouble Codes (DTC) and erase any DTCs stored such as EPS, ESC, and TPMS that may have been set during the upgrade.
