**Complaint - Driving Readiness Cannot be Established or 12-Volt Battery is Discharged (215/20)**

Model Line: **Taycan (Y1A)**

Model Year: **As of 2020 up to 2021**

Concerns: **High-voltage battery control unit (BMC)**

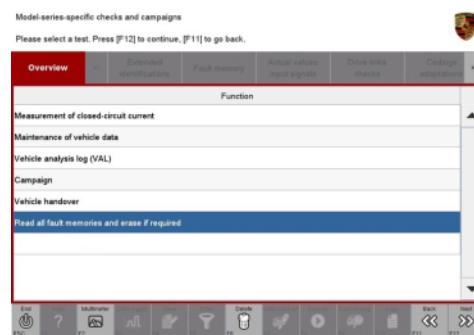
1.2 Select the function "Read all fault memories and erase if required" and press •F12" ('Next') to confirm your selection ⇒ *Erasing fault memories*.

*Erasing fault memories*

1.4 Press •F8" to delete fault memory entries.

1.5 Press •F12" ('Yes') in response to the question as to whether you really want to delete all fault memory entries.

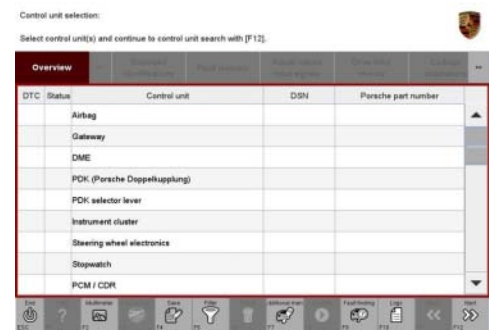
- 1.6 Once you have erased the fault memories, select the '**Overview**' menu to return to the control unit selection screen ⇒ *Control unit selection*.

*Control unit selection*

1.1 Press •F7" in the control unit selection screen ('Overview' menu) to call up the Additional menu.
