Articles Contained in this Issue

05 Abnormal Noise Diagnosis

06 VDC Control Module Replacement Followed by SRH Warning Light Information

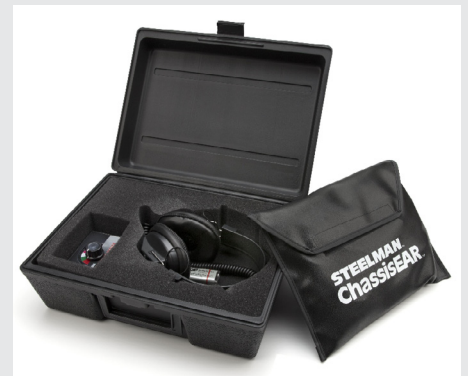
REMINDER: An Electronic Listening Device is required as per Subaru Minimum Required Equipment List found on SubaruNet.
