GROUP ENG	MODEL 2019MY Forte (BDM) w/Nu 2.0L MPI SULEV
	NUMBER 226	DATE January 2021

TECHNICAL SERVICE BULLETIN

**SUBJECT: SERVICE ACTION: NU 2.0L MPI SULEV
LOGIC IMPROVEMENT (SA462)**

This bulletin provides the procedure to improve the logic of the Engine Control Module (ECM) on some 2019MY Forte (BDm) vehicles equipped with NU 2.0L MPI Atkinson SULEV engines, produced from July 3, 2018 through July 16, 2019, for the fuel system readiness software logic in order to increase diagnosis ratios. Vehicles will not experience drivability concerns related to this improvement. To correct this concern, apply the improved logic to the ECU using the KDS ECU Upgrade function as described in this bulletin. For confirmation that the latest reflash has been applied to a vehicle you are working on, verify the ROM ID using the table on page 3 of this bulletin. Before conducting the procedure, verify that the vehicle is included in the list of affected VINs.

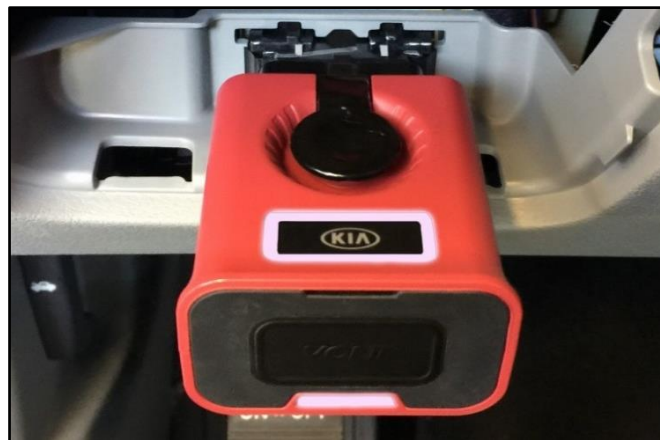
1. Connect the VCI-II to the OBD-II connector, located under the driver's side of the instrument panel.

The ECU upgrade function on KDS operates wirelessly. It is not necessary to perform the upgrade via USB cable.

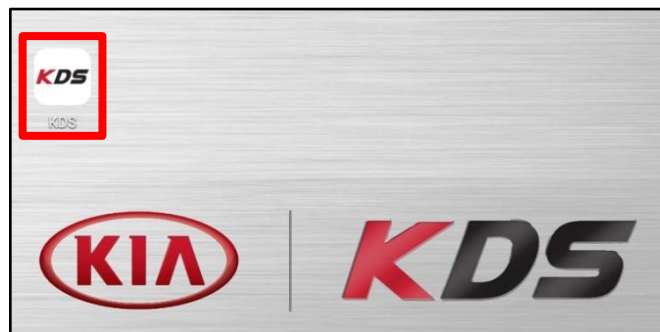
2. With the ignition ON, turn ON the KDS tablet. Select **KDS** from the home screen.

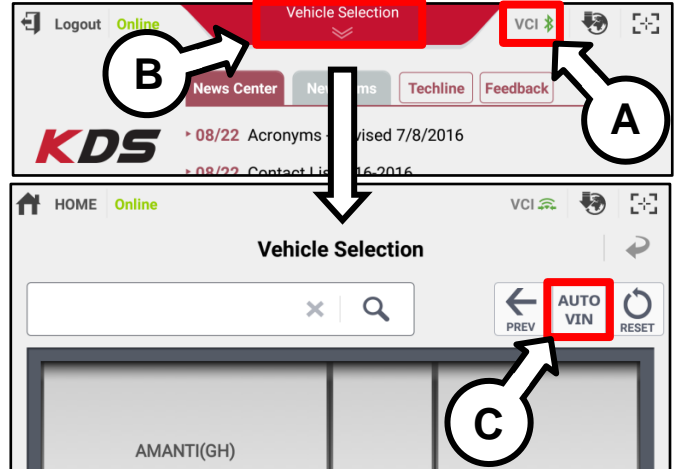
3. Confirm communication with VCI (A) and then configure the vehicle (B) using the **AUTO VIN (C)** feature.

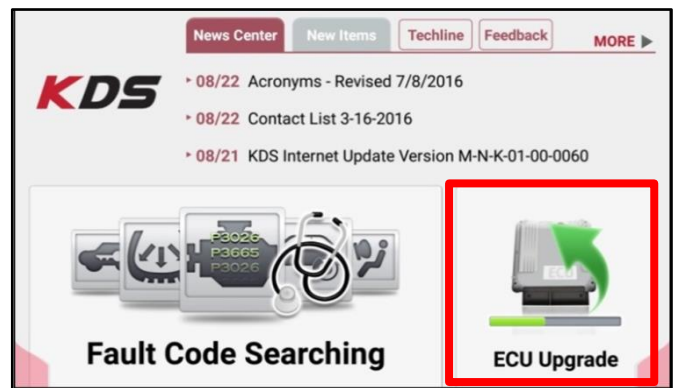
4. Select **ECU Upgrade**.

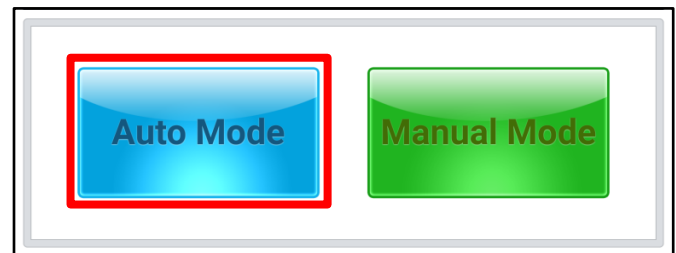
6. Select **Auto Mode**.

Do NOT attempt to perform a Manual Mode upgrade UNLESS Auto Mode fails. Always follow the instructions given on the KDS in either Auto or Manual mode.

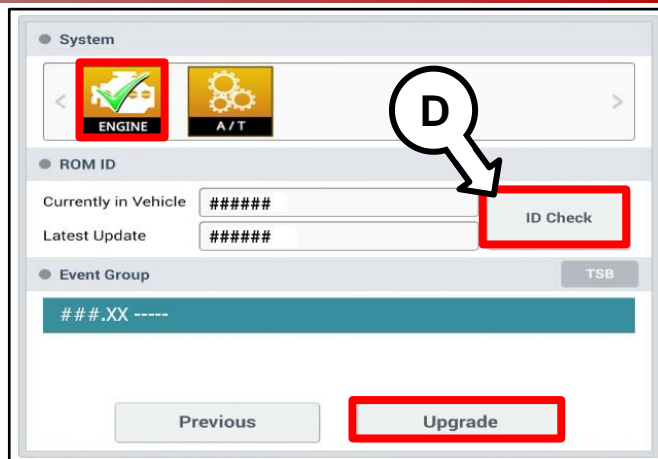
7. Select the **Engine** system under the System selection menu.

Touch **ID Check** (D) and confirm that the latest update is available.

Select **Upgrade Event #499** and select **Upgrade** to continue.

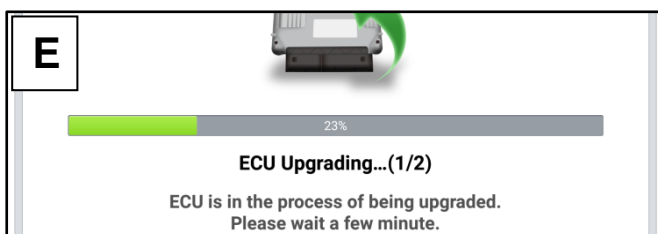
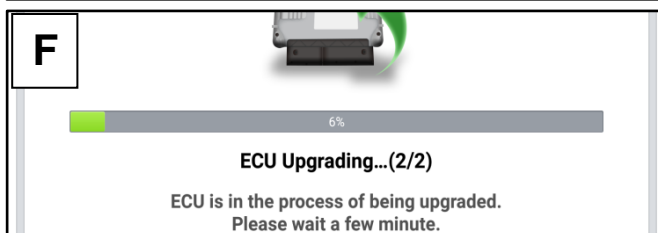
8. The ECU upgrade will begin and the progress of the upgrade will appear on the bar graph. Upgrade part (1/2) (E) will download the upgrade event to the VCI-II. Upgrade part (2/2) (F) will upgrade the ECU.

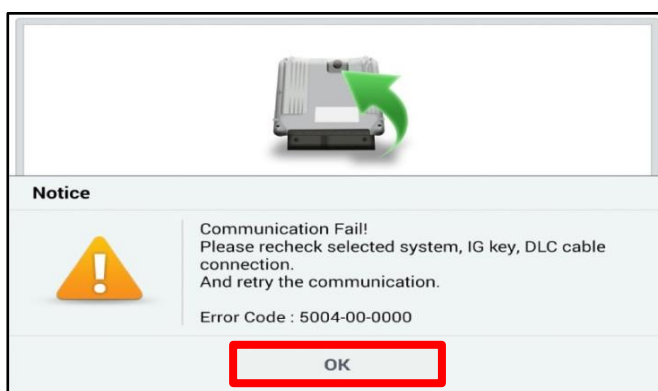
9. If a "Communication Fail" screen appears, verify that the VCI-II and KDS are communicating properly. Touch **OK** and restart the procedure from step 4.

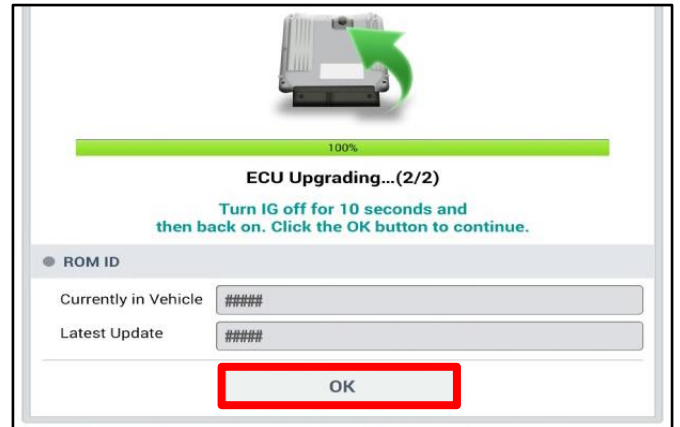
10. When instructed on the KDS, turn the ignition **OFF** for ten (10) seconds then back on. Touch **OK** to continue.

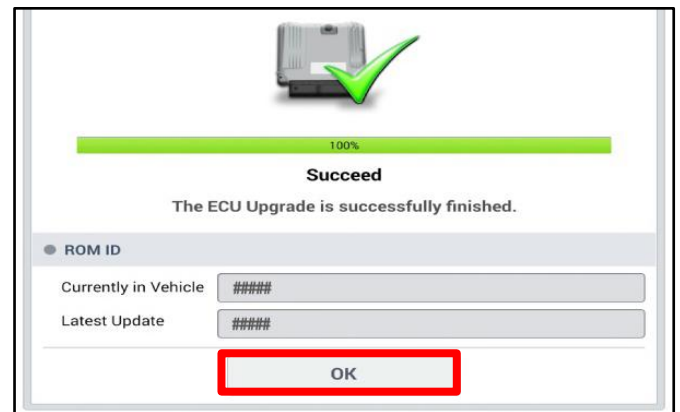
11. Once the upgrade is complete, touch **OK** to finalize the procedure.

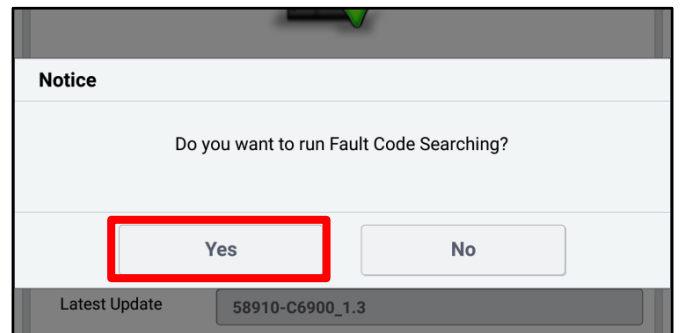
12. When prompted, select **YES** to check for Diagnostic Trouble Codes (DTC) and erase any DTCs stored such as EPS, ESC, and TPMS that may have been set during the upgrade.
