**Engine Symptom - Rough-Running engine in Near-Idle Range: Re-Programming DME Control Unit (SY 55/20)**

Model Line: **Macan (95B)**

Equipment: **2.0-litre 4-cylinder petrol engine (engine type: EA888)**

Subject: **DME control unit**

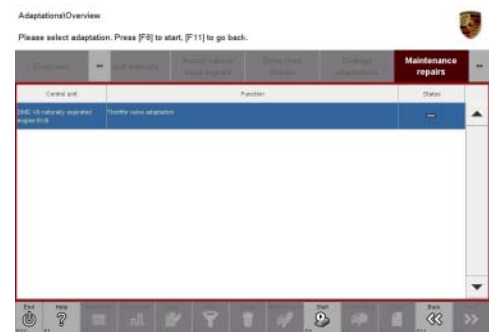
*Throttle valve adaptation*

5 Select the ⇒ **'Throttle valve adaptation'** function so that the corresponding text line turns blue and press **•F8**" ('Start') to start throttle valve adaptation ⇒ *Throttle valve adaptation*.

6 Follow the instructions on the PIWIS Tester while throttle valve adaptation is being performed.

Once throttle valve adaptation is complete, a tick will appear in the 'Value' field on the PIWIS Tester display.

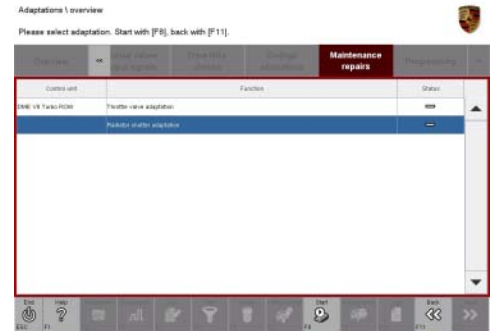
*Radiator shutter adaptation*

- Work Procedure: 1 Select the ⇒ **'Radiator shutter adaptation'** function so that the corresponding text line turns blue and then press **•F8** ("Start") to start radiator shutter adaptation ⇒ *Radiator shutter adaptation*.
- 2 Follow the instructions on the PIWIS Tester while radiator shutter adaptation is being performed ⇒ *PIWIS instructions*.
- Once adaptation is complete, a tick will appear in the 'Value' field on the PIWIS Tester display.
- If radiator shutter adaptation is **not** completed successfully, the adaptation must be repeated.
- 3 End radiator shutter adaptation by pressing **•F8** ("Stop").
- 4 Press **•F11** ("Back") to return to the start page of the ⇒ **'Maintenance/repairs'** menu.

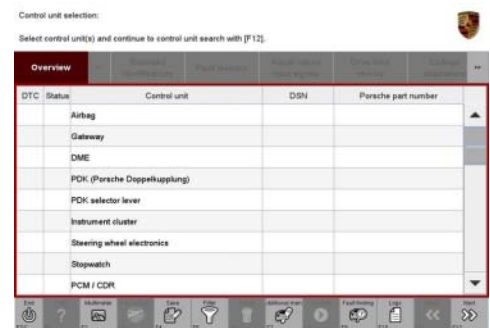
*Control unit selection*

- 5 Select the ⇒ **'Overview'** menu to return to the control unit selection screen ⇒ *Control unit selection*.
