Title: Programming Procedure for Center Panel Switch Packs

Applies To: LT, RH, HV, MV, 2018+ Lonestar, 2021+ HX

DESCRIPTION

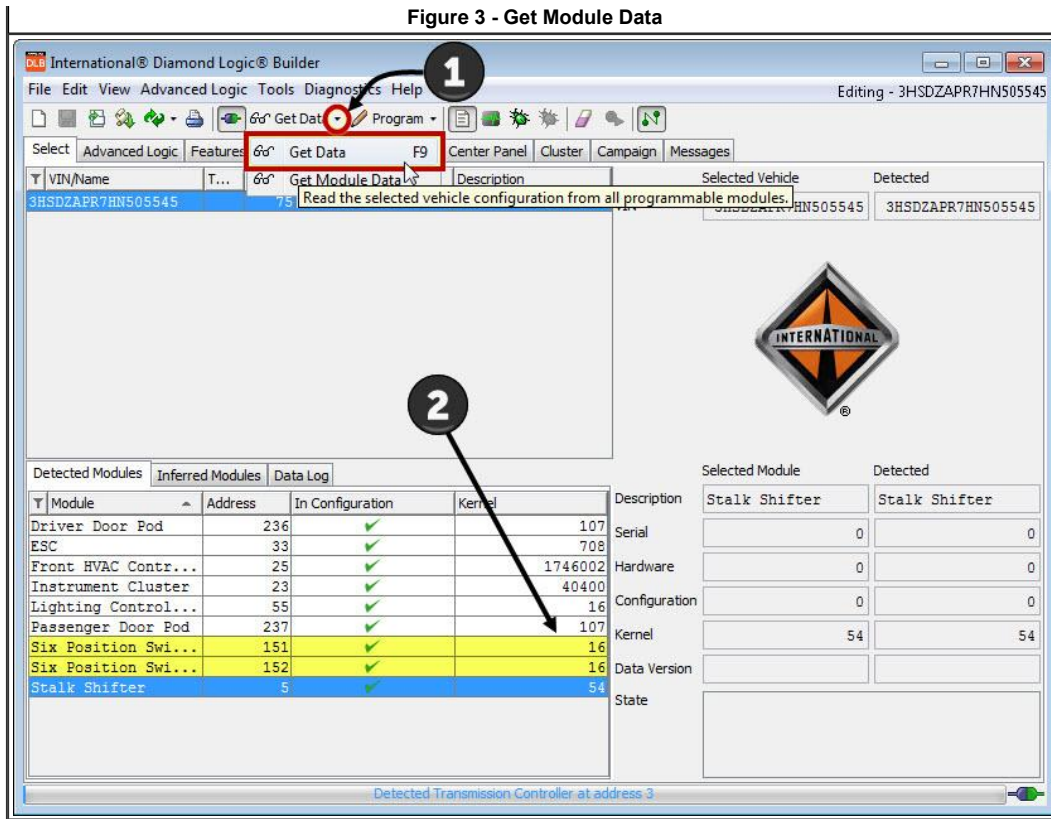
Figure 3 - Get Module Data

- Note which kernel is being displayed for the Six Position Switch-Packs
 - 23 or 17 or lower (Kernel 23 is identical to Kernel 17) - These Kernels are subject to the complaint of switch packs "flipping" or switches operating other features.
 - 24 or higher

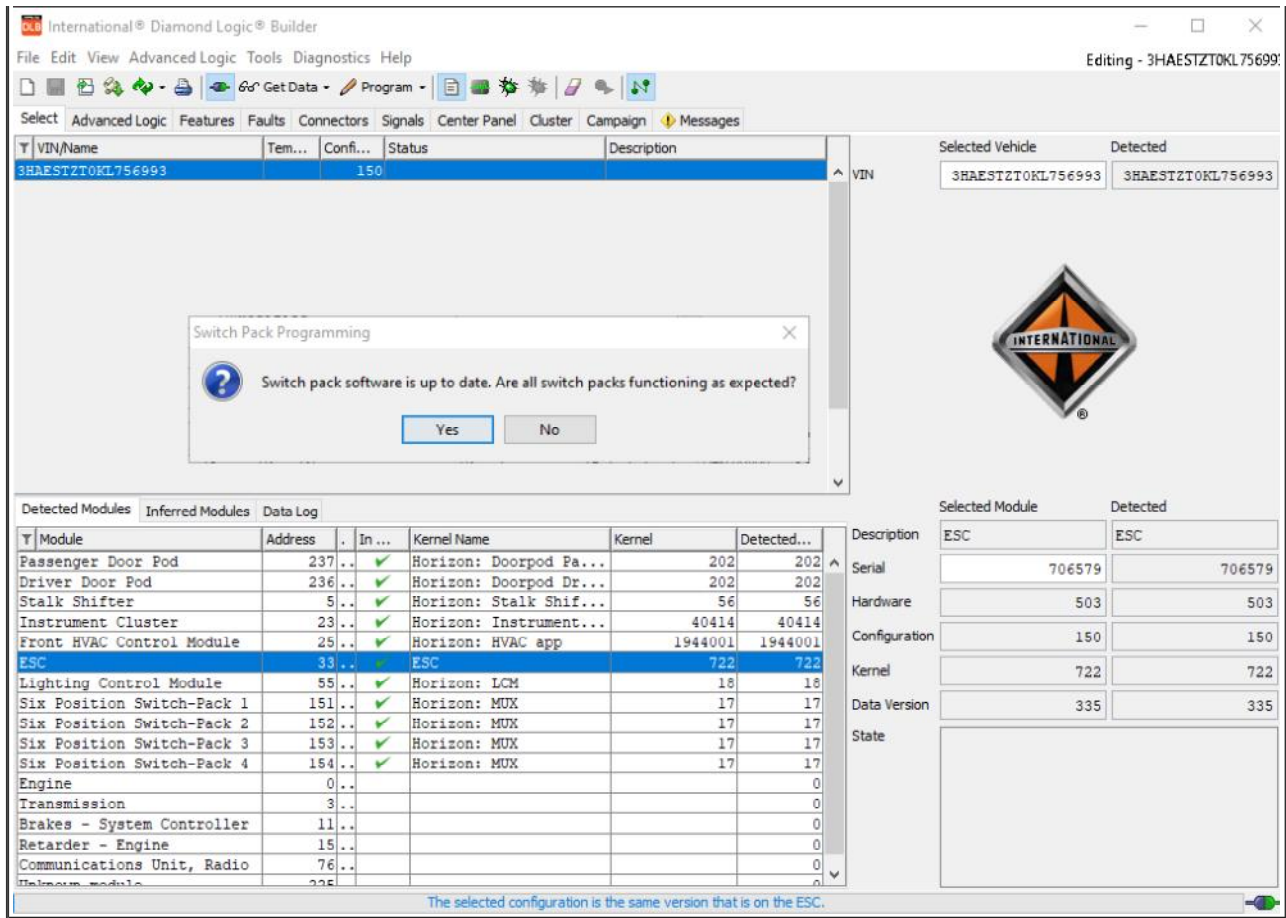
8. Figure 9 below is a prompt to check operation of each switch pack. This will help ensure the switch packs were at the proper source address before programming was performed
 - Clicking Yes - Programming is now complete, no further action is required.
 - Clicking No - You will be given a dialogue box to manually set the source addresses based on the module serial number.
