## DTC B2724-23 AND/OR C1B56-04 STORED, AND/OR RAB ERROR MESSAGE OR WARNING

**APPLIED VEHICLES:** 2020-2021 QX50 (J55)

**APPLIED SYSTEM:** Rear Automatic Braking

### Sonar Control Unit Reprogramming

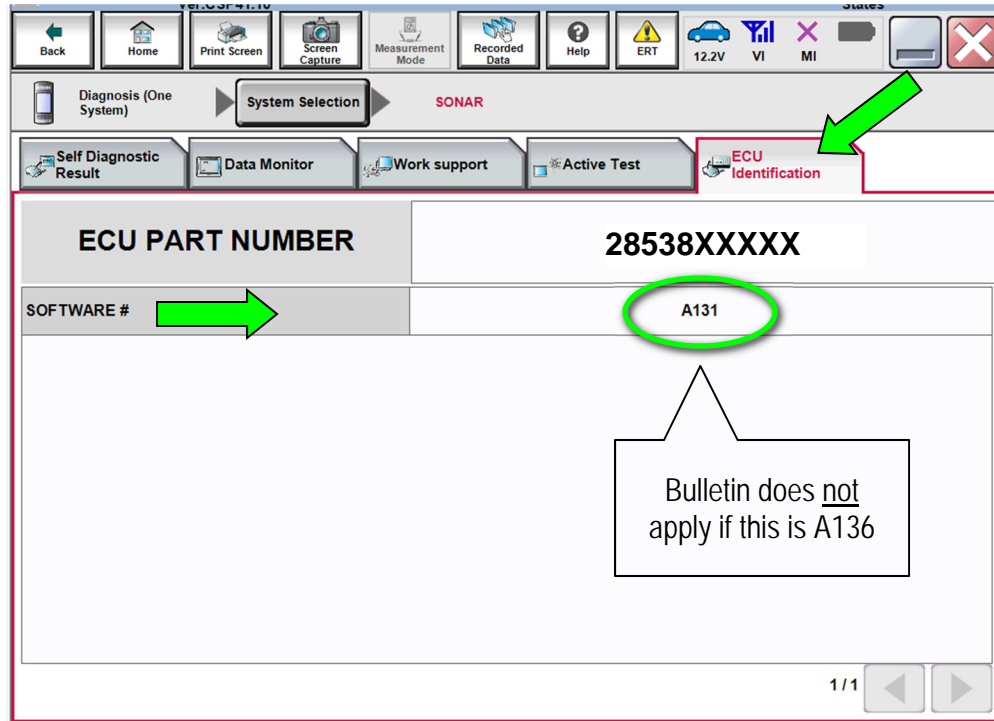
Figure 5

12. Select ECU Identification.
13. Confirm the SOFTWARE #. See Figure 5.
  - If the SOFTWARE # is A136, this bulletin does not apply. See the Electronic Service Manual (ESM) for further diagnostic information.
  - If the SOFTWARE # is not A136, proceed to step 14.

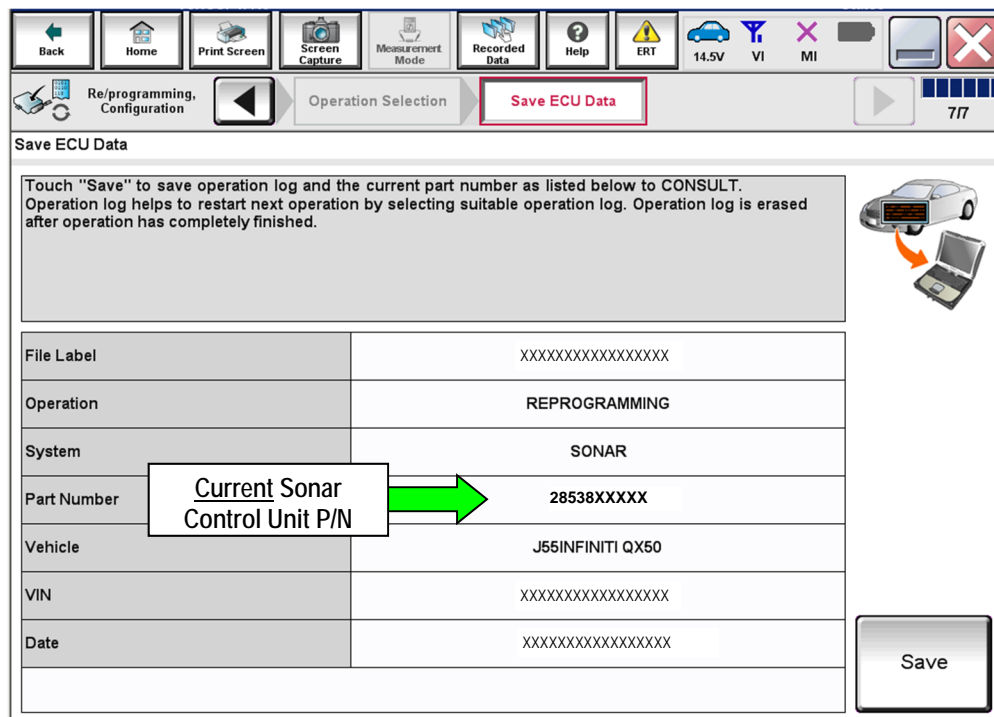
Figure 14

25. When you get to the screen shown in Figure 14, confirm that a reprogram is available as follows.

- A. Find the Sonar Control Unit Part Number and write it on the repair order.

**NOTE:** This is the current part number (P/N).

- B. Compare the part number you wrote down to the part numbers in **Table A**.
- If there is a match, continue with the reprogramming procedure.
  - If there is not a match in **Table A**, this bulletin does not apply. See the ESM for further diagnostic information.
