SERVICE BULLETIN

Classification: AN20-036a	Reference: NTB20-080a	Date: January 28, 2021
------------------------------	--------------------------	---------------------------

SOFTWARE UPDATE FOR INFOTAINMENT ISSUES

APPLIED VEHICLES: 2019-2020 Altima (L34)
 2018-2020 Kicks (P15) – SV and SR
 2019-2020 Murano (Z52)
 2020 NV200 (M20)
 2020 Versa (N18) – SV and SL

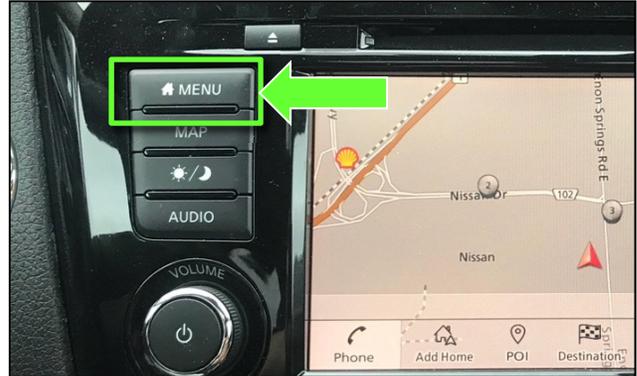
Figure 2

1. Push the **MENU** button.

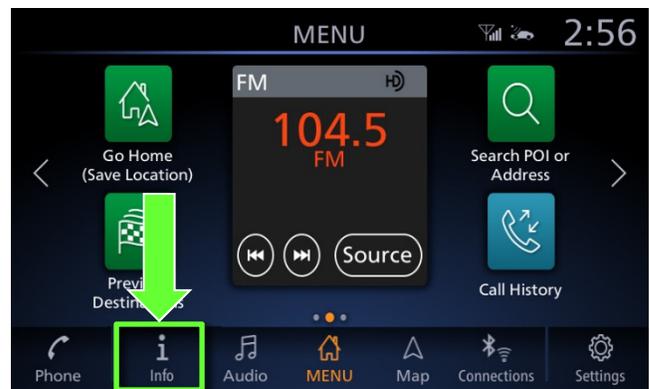
Figure 3

2. Select the **Info** icon.
 - If the **Info** icon does not appear as shown in Figure 3, this bulletin does not apply.

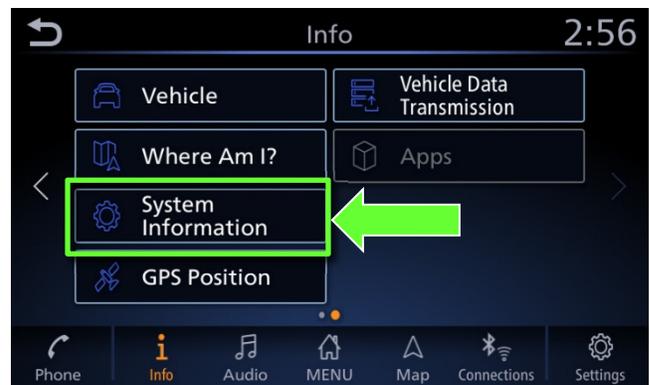
Figure 4

3. Select **System Information** to access the vehicle update menu.

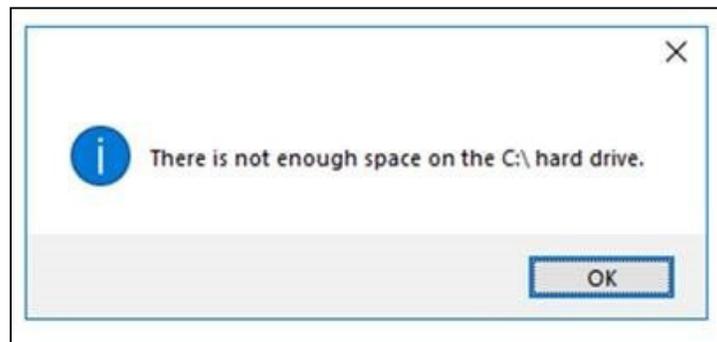
Figure 9

- The update-software is estimated to take **4 hours** to download to the USB drive.
- If, while attempting to download the software to the ASIST Station, you receive the message shown in Figure 9:
 - a. First, attempt to clear space on the ASIST Station hard drive.
 - b. If space on the hard drive cannot be cleared, email Bosch at **nissan.dealers@us.bosch.com** for additional options.

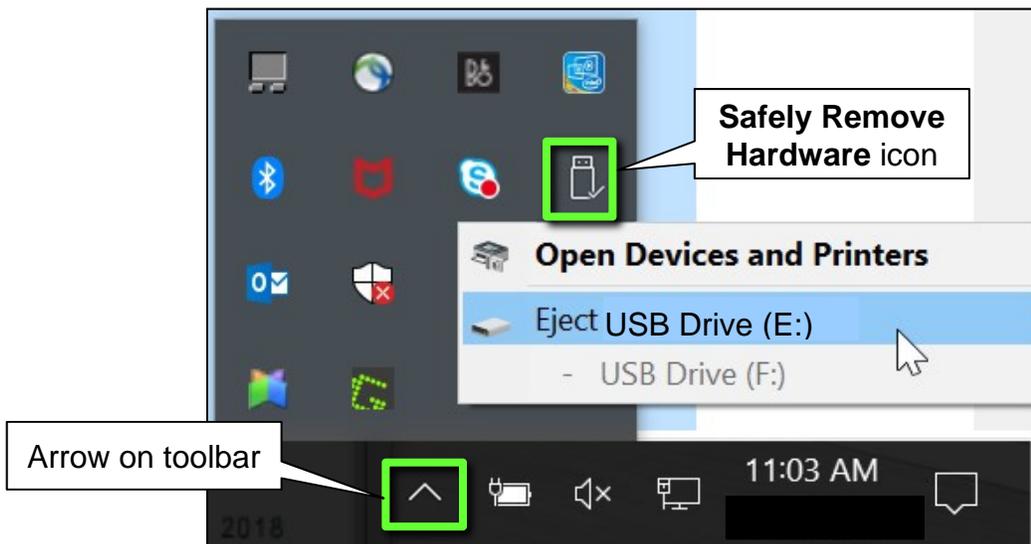
Figure 11

12. Once the transfer is complete, safely remove the USB drive from the ASIST Station.
 - a. From the PC toolbar, select the **Safely Remove Hardware** icon.
 - The icon is on the toolbar, or can be found after selecting the arrow.
 - b. Select the USB drive to be removed, and then remove the USB drive from the ASIST Station.

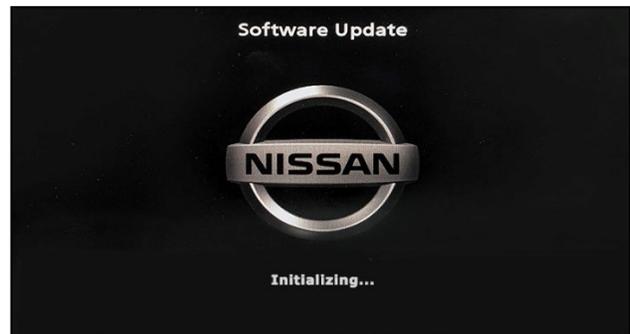
17. Wait approximately 10-30 seconds for the screen in Figure 14 to appear.

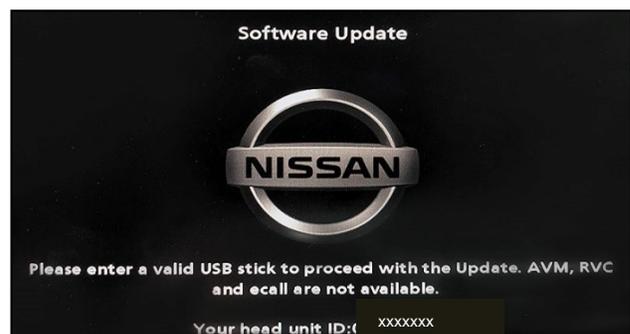
- The screen in Figure 15 may briefly appear. **Do not remove the USB drive**. The audio system will detect the USB and continue the update.

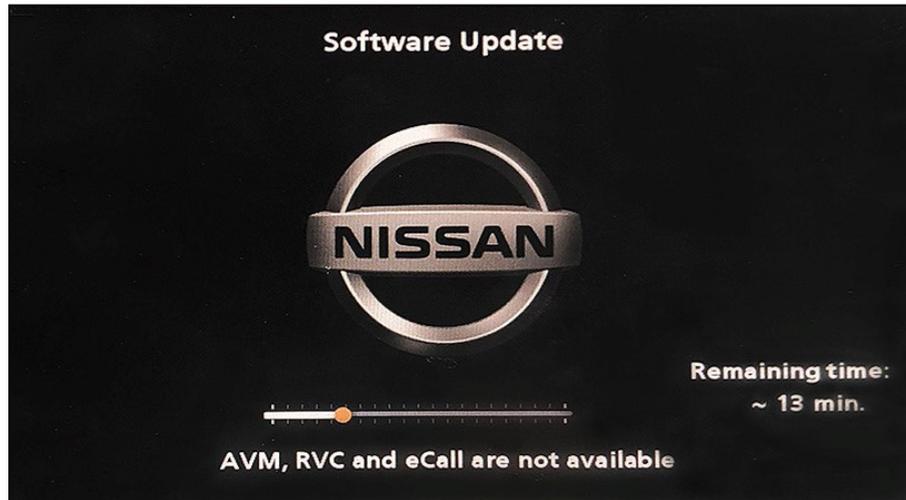
Figure 16

18. Wait for the update to complete.
- Follow the on-screen instructions while waiting.

HINT: The update may take 15-25 minutes.

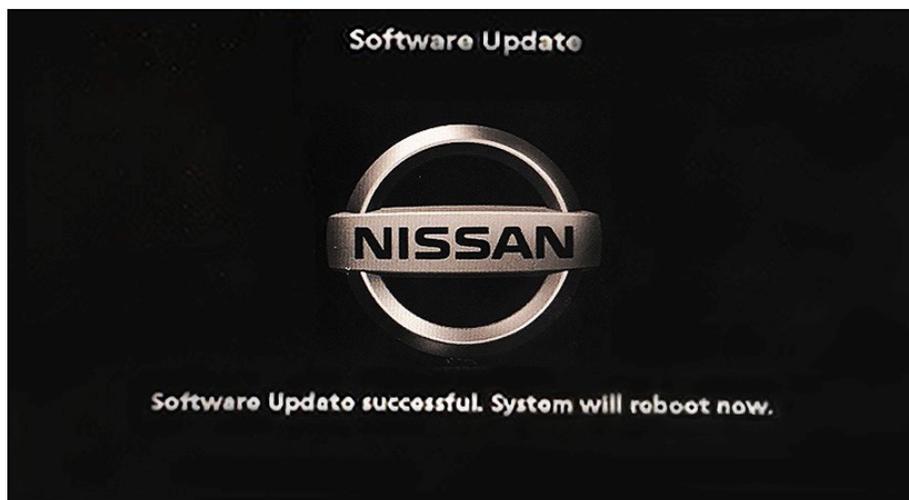
Figure 17

19. Once the update is complete (Figure 17), remove the USB drive; the system will reboot (restart).

HINT: The system will not reboot until the USB drive is removed.

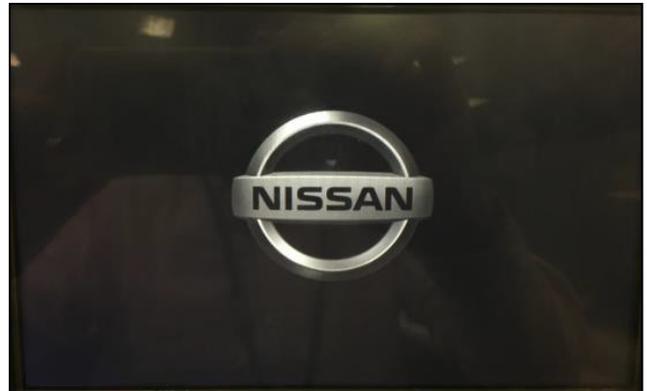
Figure 18

20. Allow the reboot to complete (approximately 30 seconds).
 - The Nissan logo will be displayed during the reboot.

24. Turn the ignition ON (engine OFF) and wait for the Nissan logo to appear (Figure 18).
 - If the Nissan logo does not appear (this might take up to 30 seconds), start over from step 21.

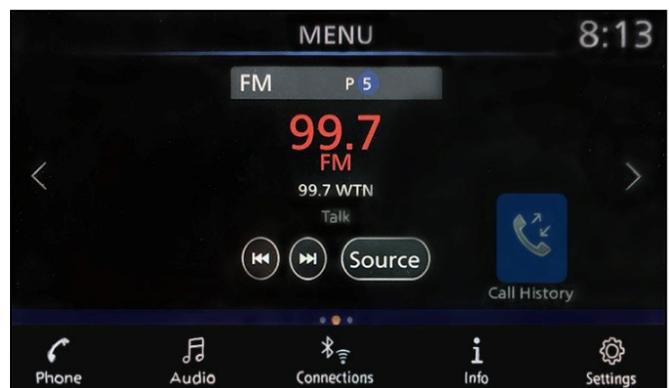
25. After the Nissan logo appears, wait about one (1) minute.
 - The MENU (Home) screen in Figure 19 will be displayed.
