# SERVICE BULLETIN

Classification: AN21-002	Reference: NTB21-008	Date: January 28, 2021
-----------------------------	-------------------------	---------------------------

## SOFTWARE UPDATE FOR INFOTAINMENT ISSUES

**APPLIED VEHICLES:** 2019 Titan/Titan XD (A61)

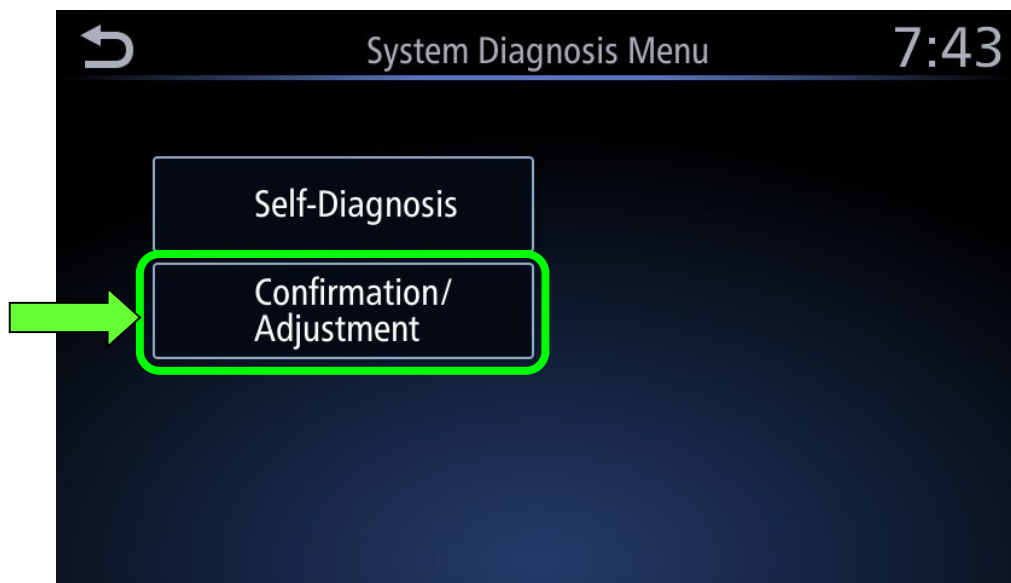
Figure 3

2. Select **Confirmation/Adjustment** (Figure 3).

- Select and hold the **MENU** button (not shown), and at the same time rotate the tuning knob more than three clicks in each direction (back and forth) until the **System Diagnosis Menu**, shown in Figure 3, displays.

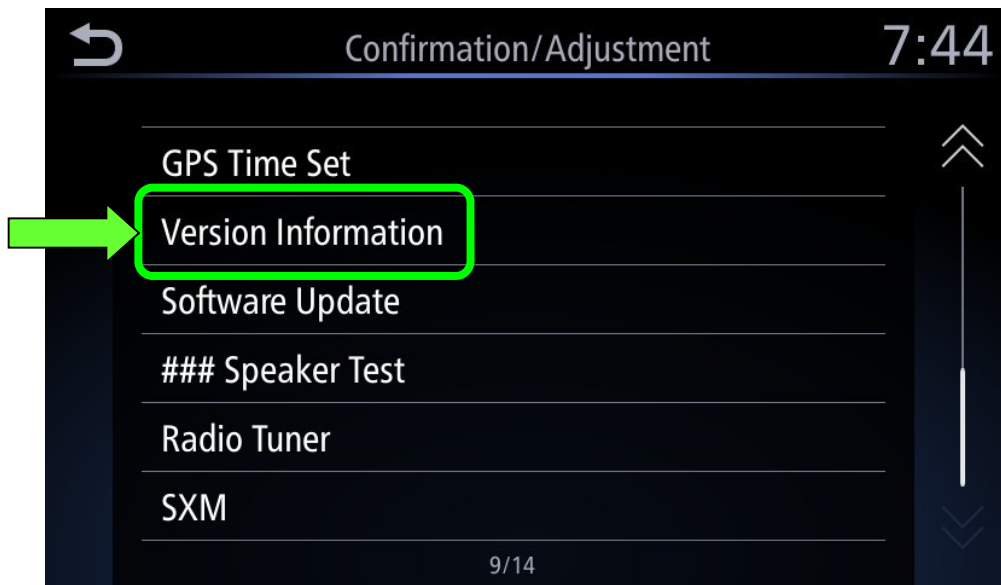
Figure 4

3. Select **Version Information**.

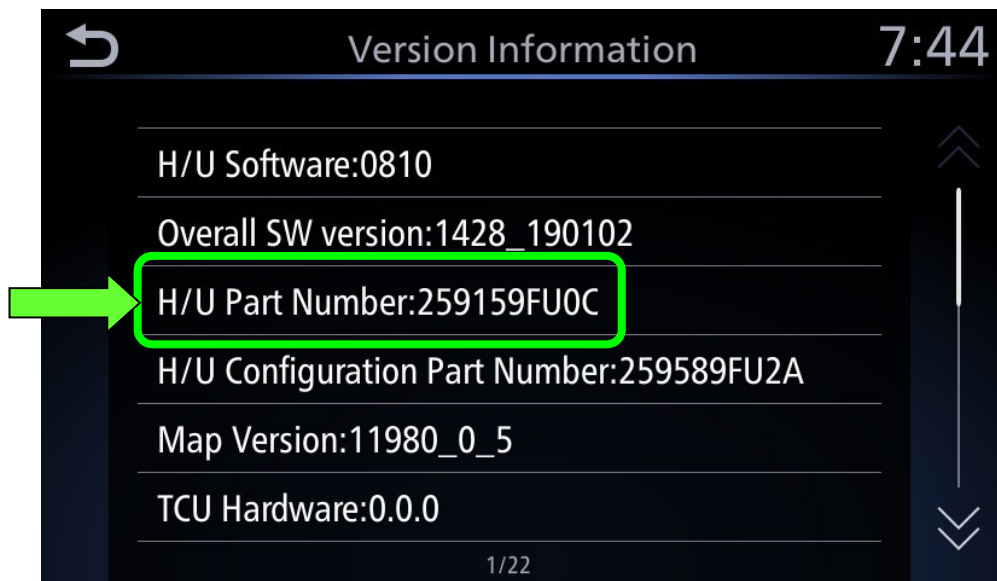
Figure 5

4. Scroll to, and then confirm the **H/U Part Number** (Figure 5).

- If the **H/U Part Number** is in the list below, proceed to step 5 on page 5 to update the AV control unit.
  - 25915-9FU2C
  - 25915-9FU0C
  - 2591A-9FU0C

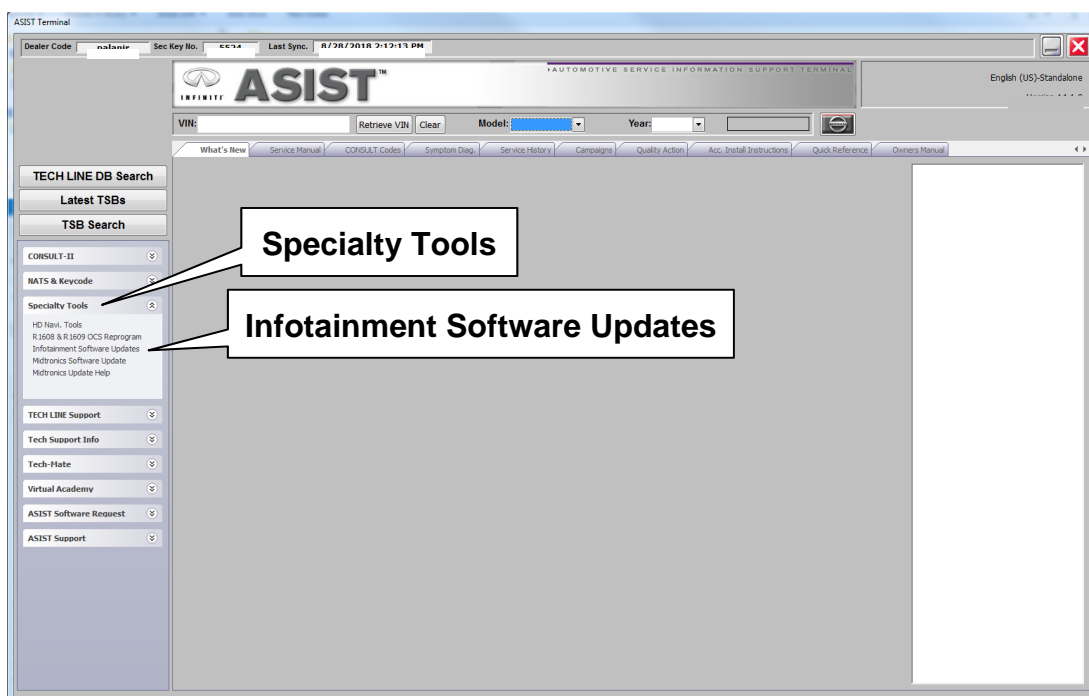
Figure 6

7. Select **Specialty Tools**, and then select **Infotainment Software Updates**.

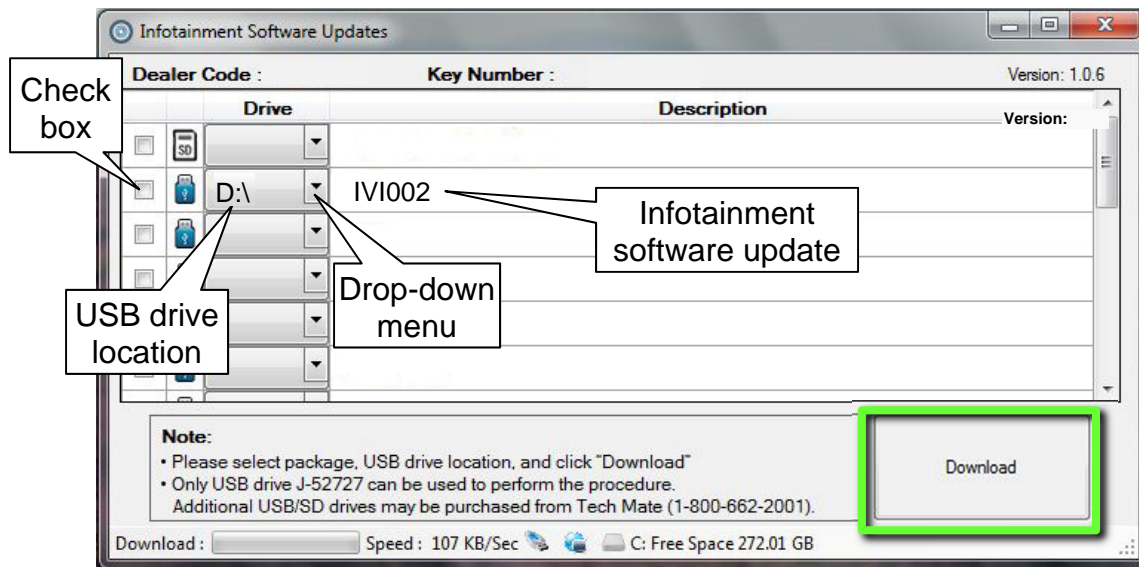
Figure 7

8. Select the check box next to the **IVI002** infotainment update-software (Figure 7).
9. Use the drop-down menu and select the location of the USB drive that was inserted into the ASIST station in step 5.

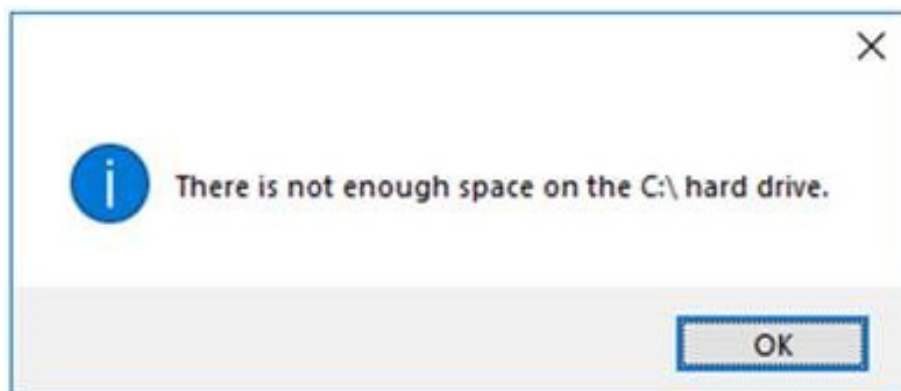
Figure 8

- The update-software is estimated to take **4 hours** to download to the USB drive.
  - If, while attempting to download the software to the ASIST station, you receive the message shown in Figure 8:
    - a. First, attempt to clear space on the ASIST station hard drive.
    - b. If space on the hard drive cannot be cleared, email Bosch at **nissan.dealers@us.bosch.com** for additional options.

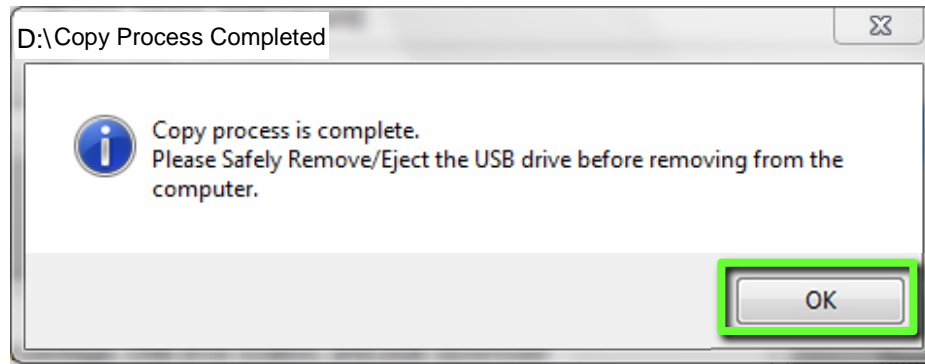
Figure 9

11. Select **OK**.

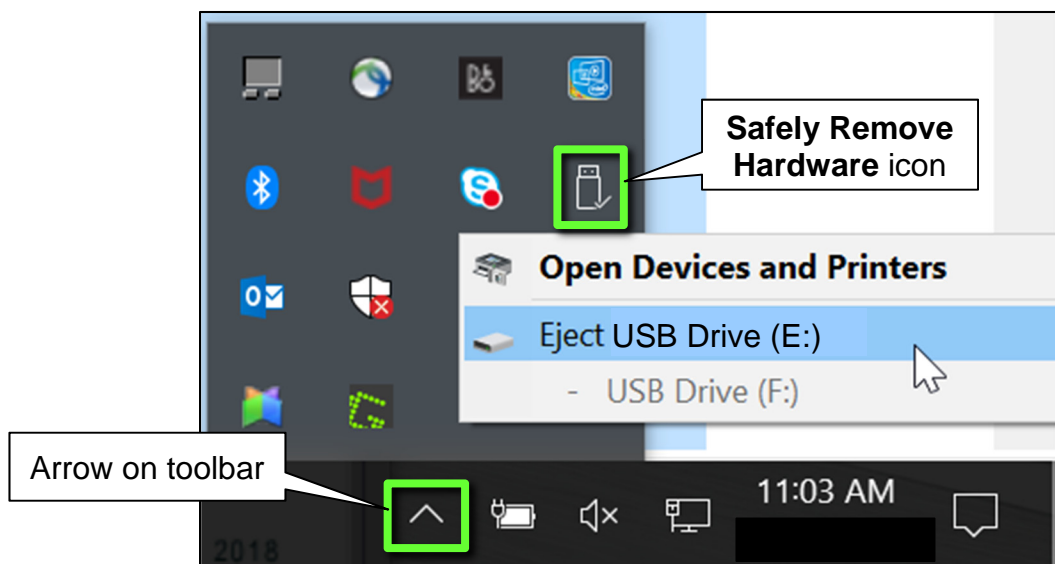
Figure 10

12. Once the transfer is complete, safely remove the USB drive from the ASIST station.

- a. From the PC toolbar, select the **Safely Remove Hardware** icon.
  - The icon is on the toolbar, or can be found after selecting the arrow.
- b. Select the USB drive to be removed, and then remove the USB drive from the ASIST station.

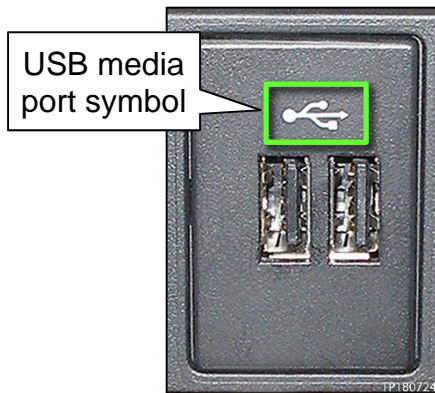
Figure 11

16. Insert the USB drive with infotainment update-software into the vehicle's USB media port (see Figure 11).

**HINT:** Charging ports are marked in the vehicle with a “lightning bolt” symbol.

**NOTICE** Do not insert the USB drive into a charging port. If used, the update-software and/or USB drive may become damaged. Only insert the USB drive in a USB media port.

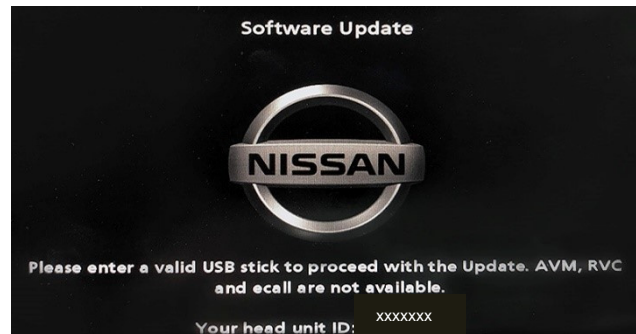
- The screen in Figure 14 may briefly appear. **Do not remove the USB drive.** The audio system will detect the USB drive and continue the update.

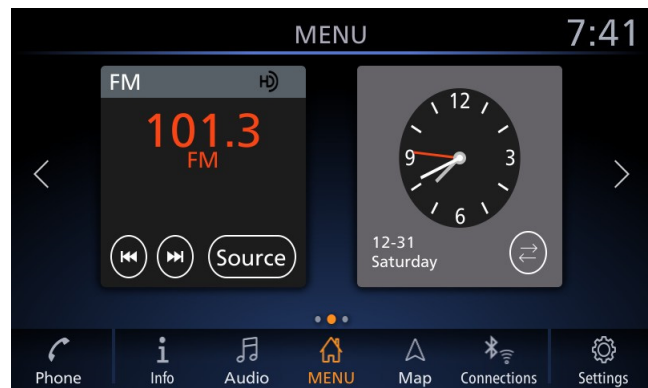
25. After the Nissan logo appears, wait about one (1) minute.
  - The MENU (Home) screen in Figure 18 will be displayed.
