Subject: N202316130 - Service Update  
OnStar Emergency Low Volume Calibration

Models: 2021 Cadillac Escalade  
2021 Cadillac Escalade ESV  
Equipped with Cadillac User Experience (RPO IOV)

# Service Update

## N202316130 OnStar Emergency Low Volume Calibration

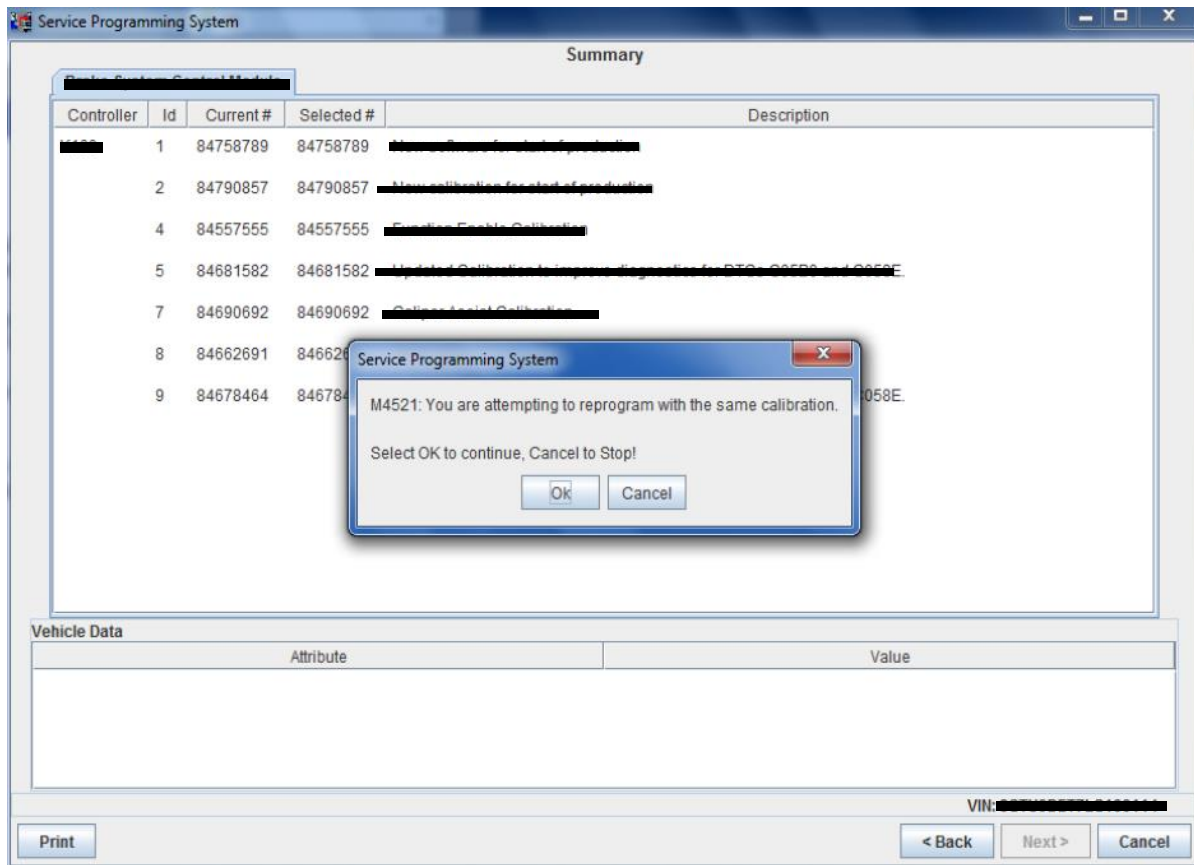
5431207

**Important:** Techline Connect and TIS2WEB screens shown above.

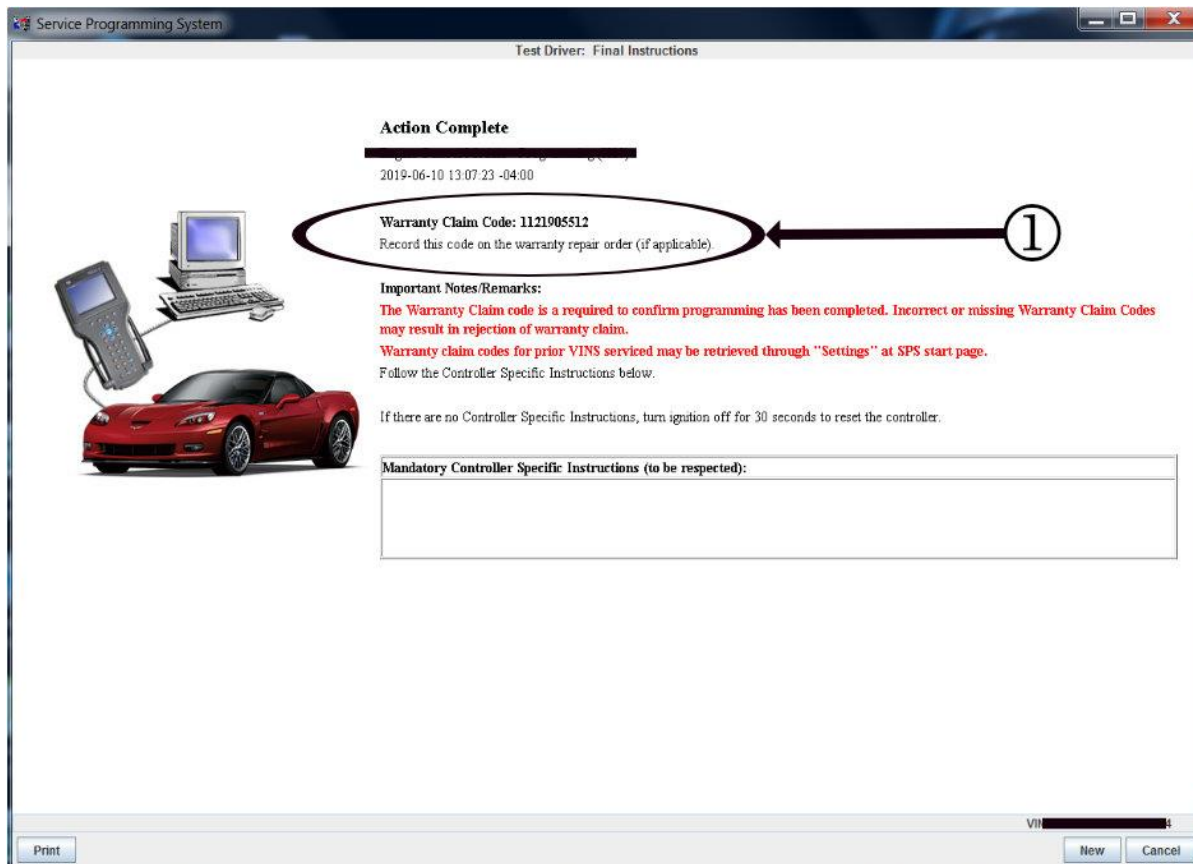
5431209

**Note:** The screenshots above are an example of module programming and may not be indicative of the specific module that is being programmed. Module selection and VIN information have been blacked out.
