Lack of A/C Performance at Idle in High Ambient Temperature

Service Category Vehicle Interior

Section Heating/Air Conditioning

YEAR(S)	MODEL(S)	ADDITIONAL INFORMATION
2016 - 2021	Tacoma	VDS(s): AZ5CN, BZ5DN, CZ5AN, DZ5BN, EZ5CN, FZ5DN, GZ5AN, HZ5BN, RZ5CN, SZ5AN Engine(s): 2GR Transmission(s): 6AT

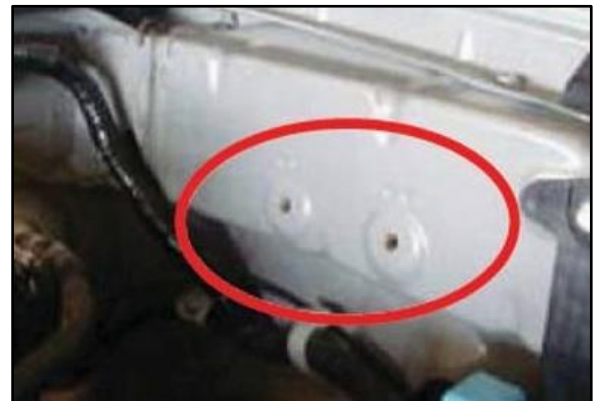
Figure 5.

7. Locate the bolt holes on the driver side inner fender. Attach the NEW bracket to the inner fender with the bolts provided in the kit.

Torque: 9.8 – 18.1 N*m
(100 – 185 kgf*cm, 7.5 – 13 ft*lbf)

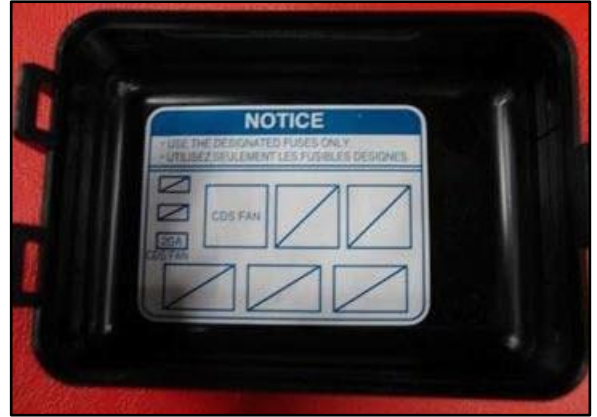
Figure 7.

8. Install the NEW notice label on the inside of the NEW relay block relay cover.

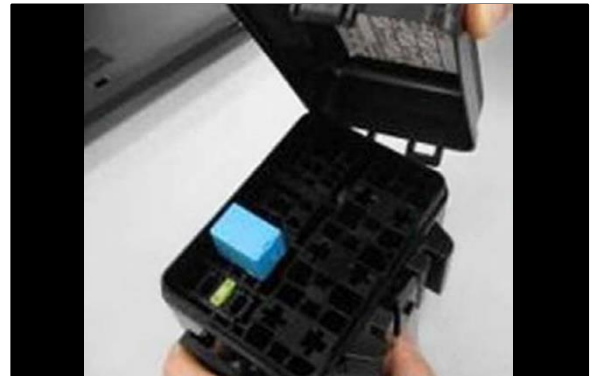
Figure 8.

9. Install the NEW relay into the “CDS FAN” location as indicated on the notice label.

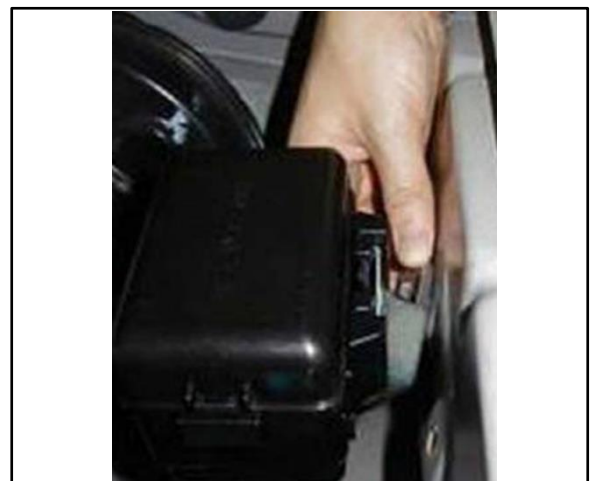
Figure 9.

10. Attach the relay block to the bracket installed in step 7.

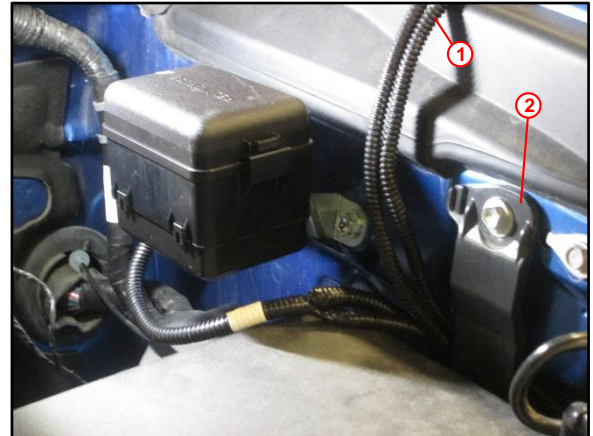
Figure 22.

- A. Remove the bolt from the engine room relay block bracket and route the NEW sub-wire harness behind the bracket.
- B. Loop and bring the NEW A/C ECU pigtail and driver J/B sub-wire harnesses back behind the bracket, which will later be routed into the passenger compartment.
- C. Apply a tie band at the marked location on the sub-wire harness, attach it to the engine room relay block bracket, and cut off the excess.

- D. Reinstall the engine room relay block bracket bolt.

1	A/C ECU Pigtail and Driver J/B Sub-wire Harnesses
2	Engine Room Relay Block Bracket Bolt

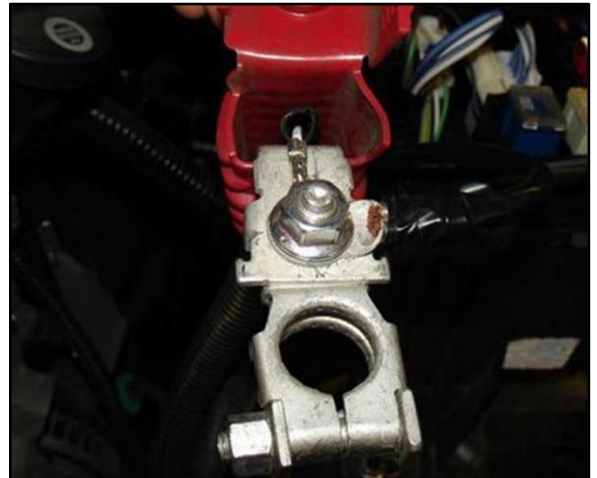
Figure 25.

- F. Unscrew the nut from the stud bolt on the positive battery cable.
- G. Put the ring terminal from the NEW sub-wire harness (white) onto the stud bolt flange side up.
- H. Tighten the nut.
Torque: 9.8 – 15.7 N*m
(103 – 159 kgf*cm, 7.5 – 11.5 ft*lbf)

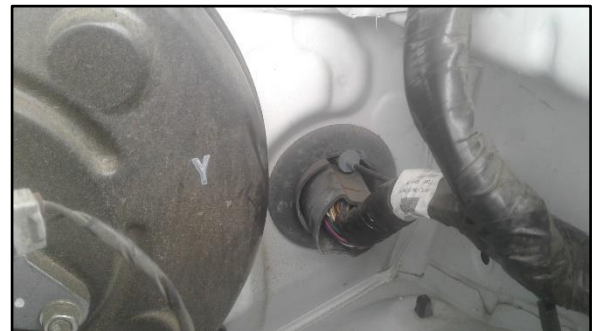
Figure 33.

- 21. The A/C ECU pigtail and driver J/B sub-wire harnesses from the engine compartment will be routed into the passenger compartment through the engine compartment bulk head grommet located next to the power brake booster.

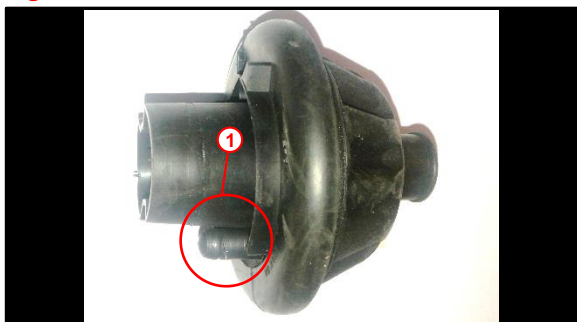
Figure 35.

- 23. Modify the bulk head grommet by using scissors or equivalent and cut off the rubber end of the passage at the indent mark to expose the passage through to the passenger compartment.

1	Grommet Indent Mark
----------	----------------------------

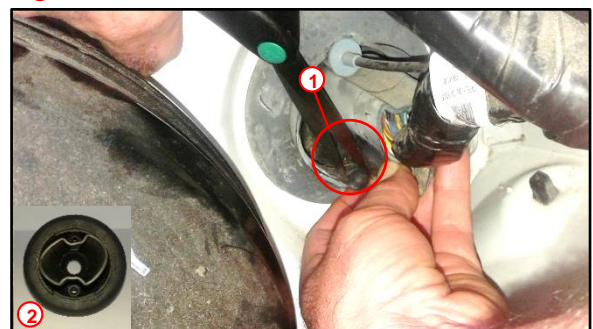
Figure 36.

1	Cut at Grommet Indent Mark
2	Modified Grommet

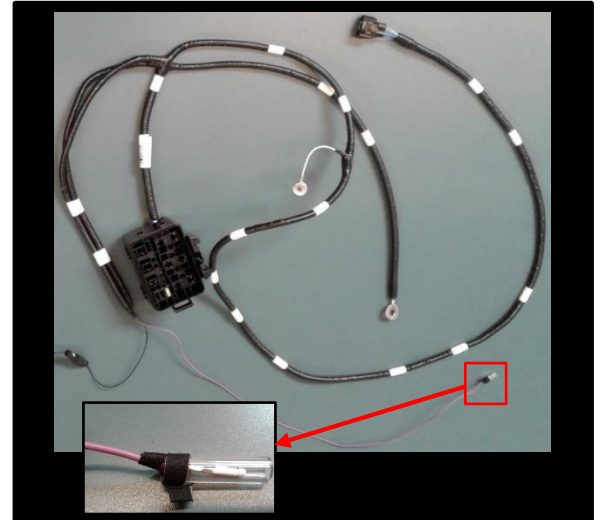
Figure 39.

26. Remove the vinyl tube protecting the pin on the end of the driver J/B sub-wire harness by removing the black tape and vinyl tube exposing the pin.

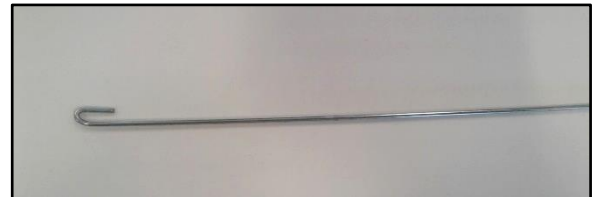
Figure 40.

27. Cut the bottom straight portion of a wire coat hanger approximately 30 cm in length and bend one end of it backward onto itself.

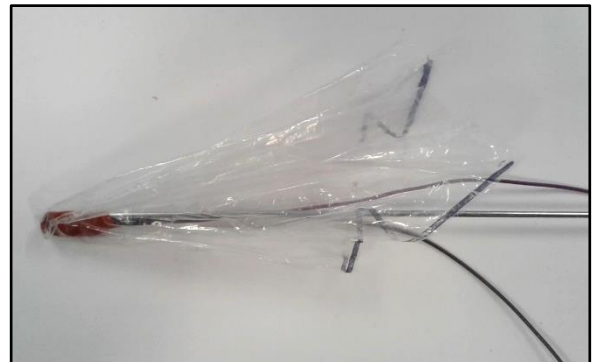
Figure 44.

31. Wrap the bent end of the wire coat hanger with the cut corner of the plastic parts bag and dip the end in isopropyl rubbing alcohol.

This step aides in passing the wire coat hanger and the attached wires through the rubber grommet passage.

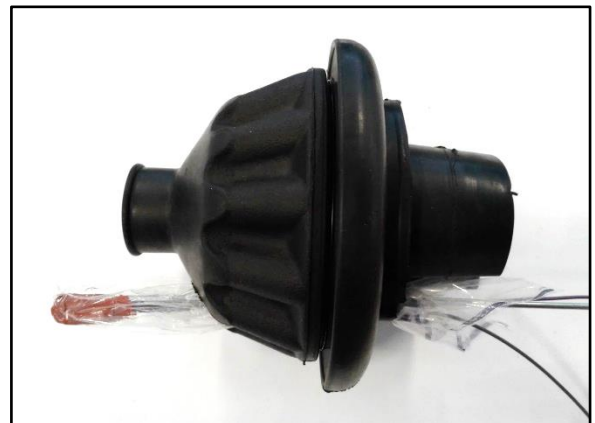
Figure 45.

32. From the engine compartment side, gently insert the bent end of the wire coat hanger through the bulk head grommet passage previously made in step 23.

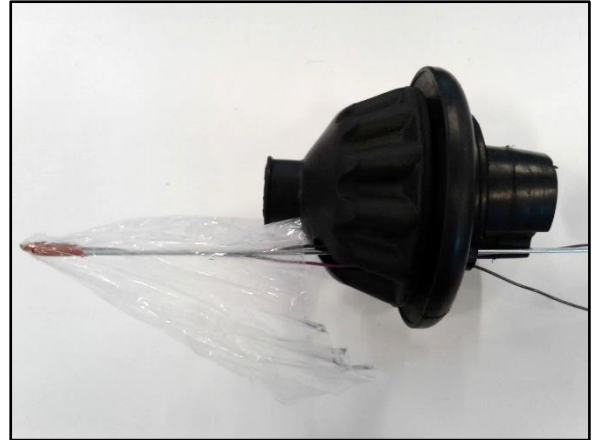
Figure 46.

33. Insert the bent wire coat hanger all the way through into the passenger side so the plastic is free of the grommet.

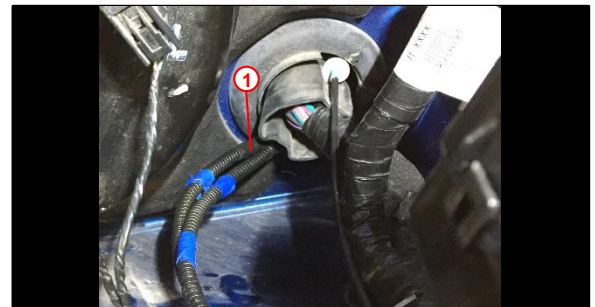
Figure 48.

1	Engine Compartment – Corrugated Sub-wire Harness Covers
----------	--

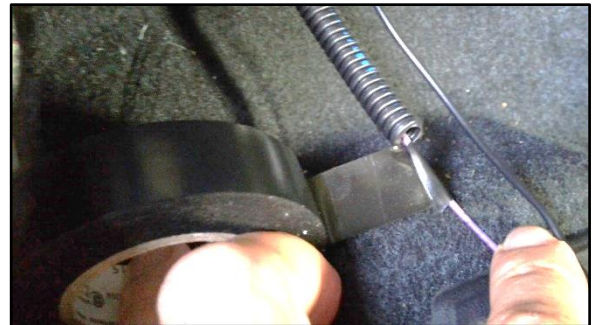
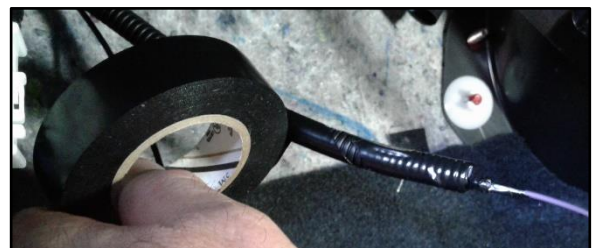
- B. Wrap the entire length of the corrugated tube with electrical tape. Begin at the section of wire protruding closest to the end of the corrugated tube as shown.

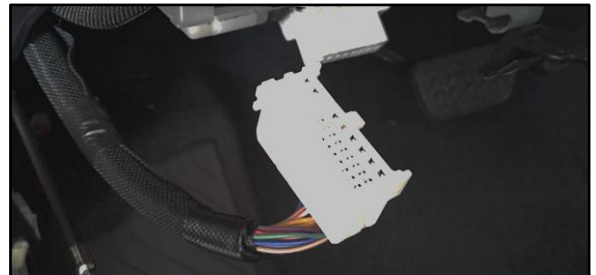
39. Remove the black plastic lock lever from the connector.

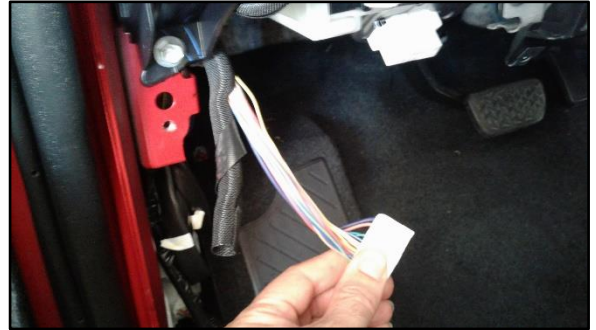
Figure 62.

40. Remove the electrical tape from the connector harness and pull back the wire harness cover to expose the wires.

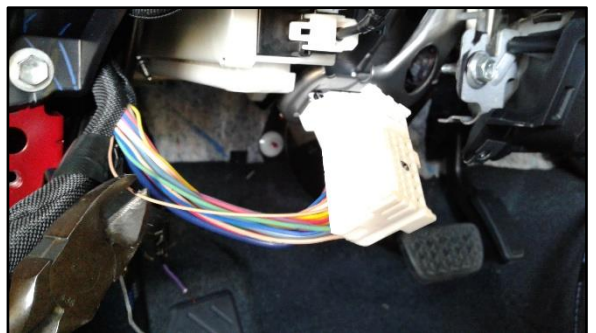
Figure 65.

41. Confirm there is a pin and wire in pin location 16 in connector 1F. The connection will be made with a wire splice procedure.
 - A. From the back side of connector 1F, locate and isolate the pin 16 wire.
 - B. Measure 60 mm along the pin 16 wire from the base of connector 1F and mark the wire.
 - C. Using the diagonal cutters, cut the pin 16 wire at the 60 mm mark.

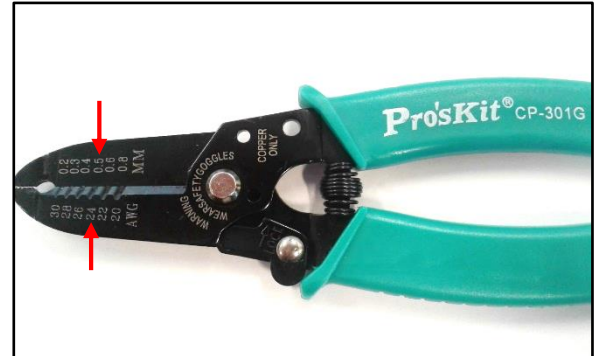
- D. Using the wire stripper (P/N CP-301G; use 24 AWG/0.5 mm to strip insulation from wire), strip 11 mm of the wire insulation from the end of pin 16 wire.

- Due to the small gauge of the pin 16 wire, be very careful NOT to cut off ANY strands of the wire while stripping the wire insulation, or the integrity of the wire will be compromised.
- If strands of wire are cut off during the wire stripping process, cut off the stripped wire and repeat the process. Be careful not to cut the wire too short, or the splice process will be difficult.

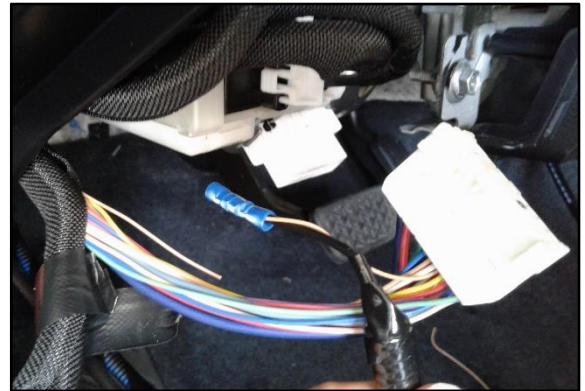
Figure 76.

- M. Crimp both ends of the joint terminal with the crimp tool at the INS position.

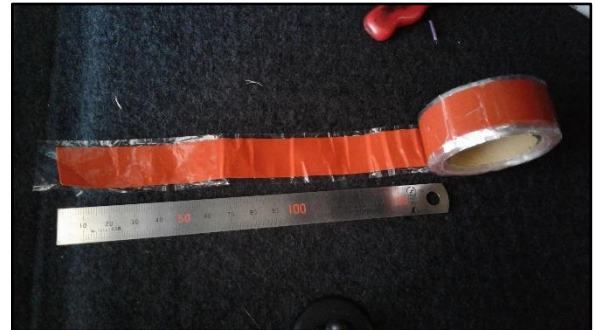
Figure 77.

- N. Using silicone tape, measure a 150-mm length piece of tape and cut it with scissors.

Do NOT let the silicone tape fold or touch itself as it is very difficult to unstick once this has occurred.

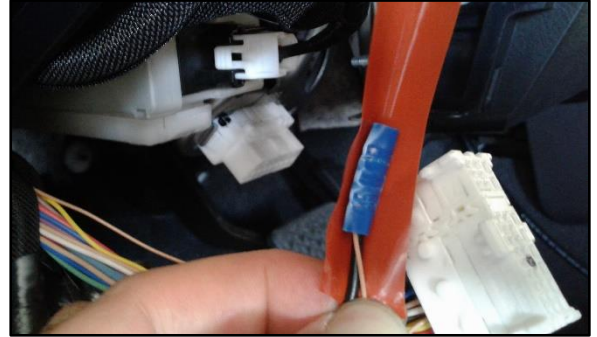
Figure 78.

- O. Wrap the joint terminal with the silicone tape by placing the tape lengthwise along the terminal so the end of the tape hangs below the terminal, approximately the width of the tape.

During the wrapping process of the joint terminal with the silicone tape, keep the silicone tape in tension (stretched) at ALL times.

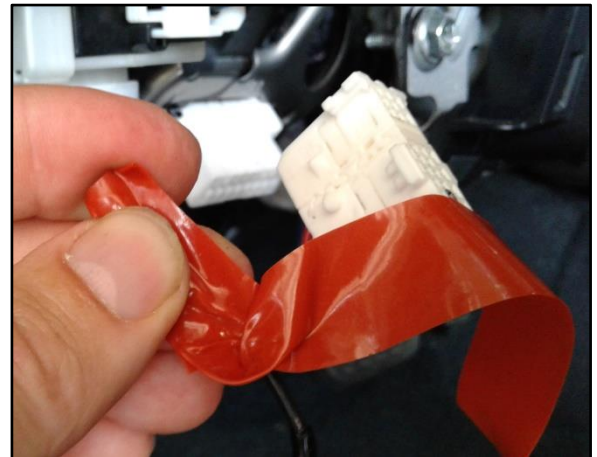
Figure 79.

- P. Fold the silicone tape over the top of the joint terminal and down the opposite side of the terminal, adhering the tape to itself over the terminal area.

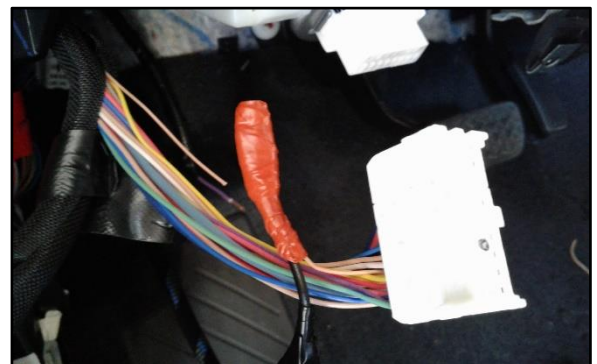
Figure 80.

- Q. Continue to wrap the terminal from the bottom up to the top of the terminal, and ensure the tape is adhered to itself.

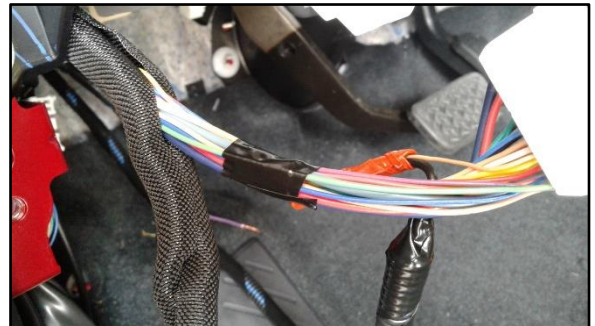
- R. Fold the wire back onto itself from the opposite end of the pin 16 wire, which remains, and using electrical tape, tape the wire back into the harness.

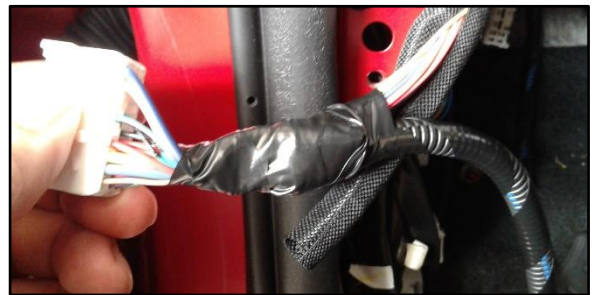
- S. Place the splice connection along the wire harness, fold back the driver J/B sub-wire harness along the connector harness, and completely wrap with electrical tape.

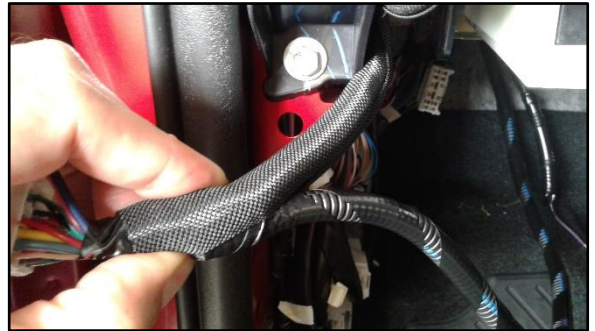
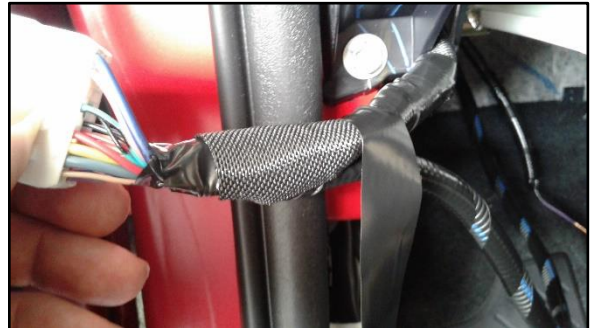
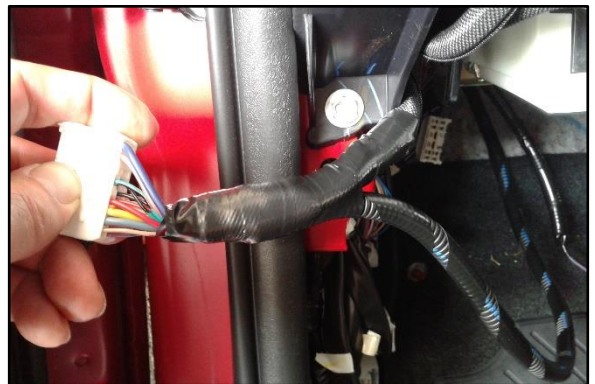
- C. Close the pin lock retainer at the top of connector 1F.
 - D. Hold the driver J/B sub-wire harness along the driver side J/B harness and completely wrap the wire harnesses together with electrical tape (similar to the procedure in step 41, substep S).
43. Reapply the driver side J/B wire harness cover previously pulled back in step 40 and completely wrap with electrical tape.

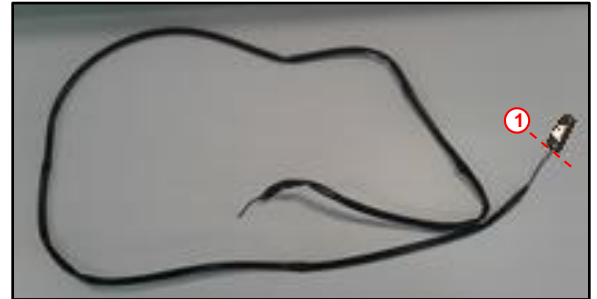
Figure 95.

48. Locate the NEW A/C ECU sub-wire harness, and using the diagonal cutters, cut the plastic connector off and discard the connector.

1	Cut Connector End Off From the A/C ECU Sub-harness
----------	---

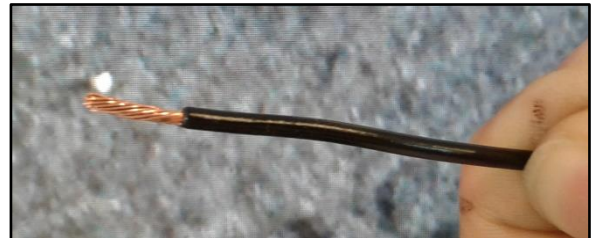
Figure 96.

49. Using the wire stripper, strip 11 mm of wire insulation from the end of the A/C ECU sub-wire harness where the plastic connector was previously cut off in step 48.

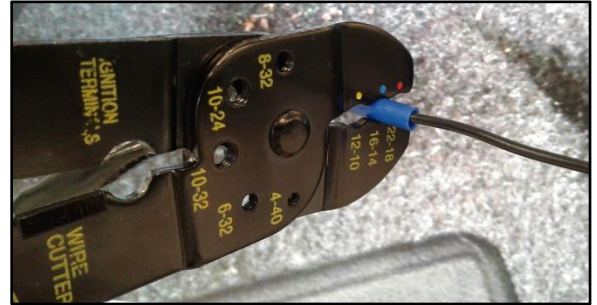
Figure 101.

52. Using a crimp tool, place the joint terminal into the blue dot position of the crimp jaws and center the terminal.

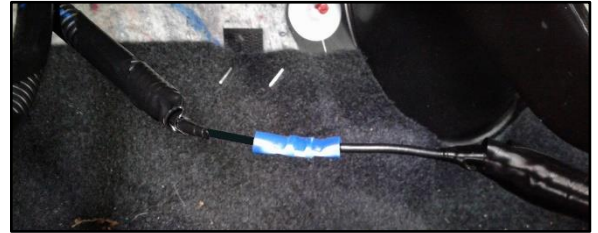
Figure 104.

55. Crimp both ends of the joint terminal with the crimp tool at the INS position.

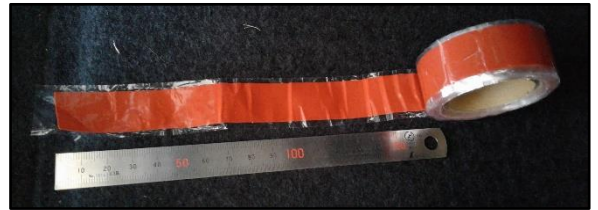
Figure 105.

56. Using silicone tape, measure a 150-mm length piece of tape and cut it with scissors.

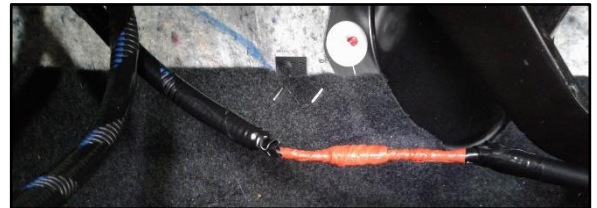
58. Continue to wrap the tape around the joint terminal, ensuring good adhesion until the terminal is completely wrapped.

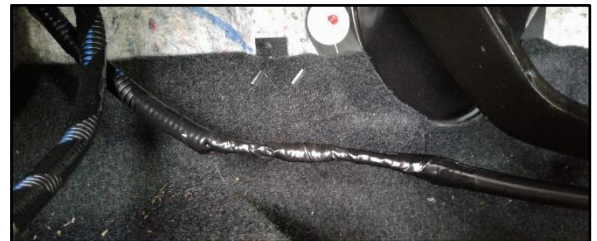
Figure 109.

59. Repeat the same joint terminal wrapping process as used in steps 56 – 58, using electrical tape.

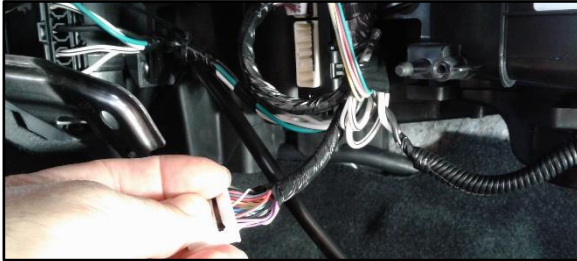
69. Remove the electrical tape from the connector harness to expose the wires.

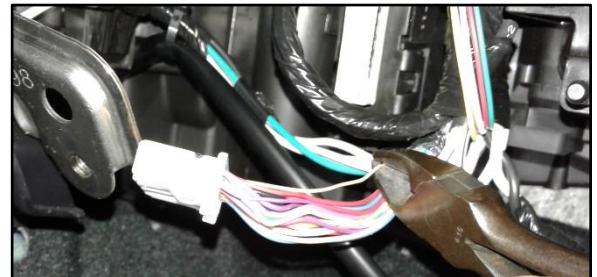
Figure 121.

- A. From the back side of connector A35, locate and isolate pin 8 wire (pin 16 in connector A14 for manual A/C).
- B. Measure 60 mm along the pin 8 wire from the base of connector A35 and mark the wire.

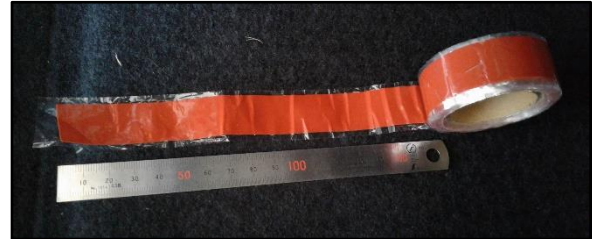
Figure 131.

- L. Using silicone tape, measure a 150 mm length piece of tape and cut it with scissors.

Do NOT let the silicone tape fold or touch itself as it is very difficult to unstick once this has occurred.

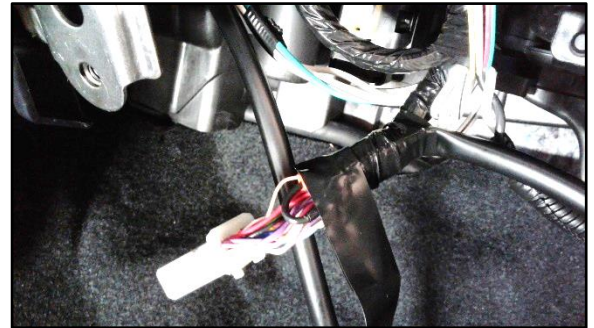
- Q. Place the splice connection along the wire harness and fold back the A/C ECU sub-wire harness along the connector harness and begin wrapping with electrical tape until it is completely wrapped.

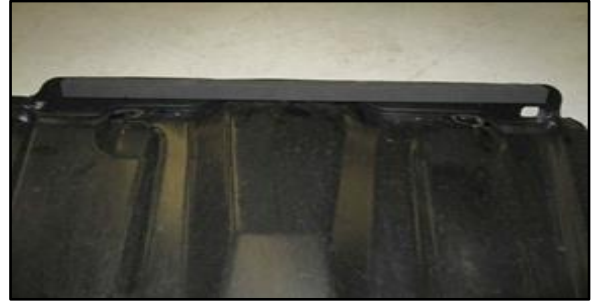
Figure 151.

- D. Install the NEW skid plate seal in the position as shown.

- E. Reinstall the No. 1 engine under cover sub-assembly with the four bolts.

Torque: 30 N*m (306 kgf*cm, 22 ft*lbf)
