Audio Head Unit Software Update (Denso-Ten)

Service Category Audio/Visual/Telematics

Section Navigation/Multi Info Display

YEAR(S)	MODEL(S)	ADDITIONAL INFORMATION
2020 - 2021	Highlander, Highlander HV, RAV4, RAV4 HV, Tundra

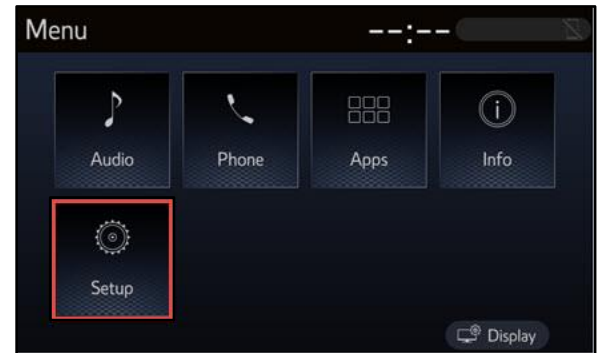
Figure 1.

1. Turn ON the ignition.
2. Press the Menu button on the radio faceplate, then select Setup.
3. Select General on the Setup screen.

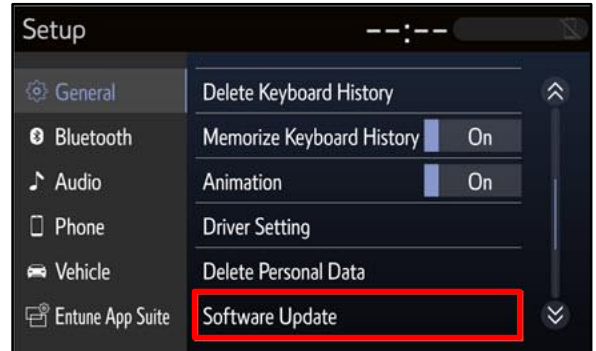
Figure 3.

4. Scroll down and select Software Update.

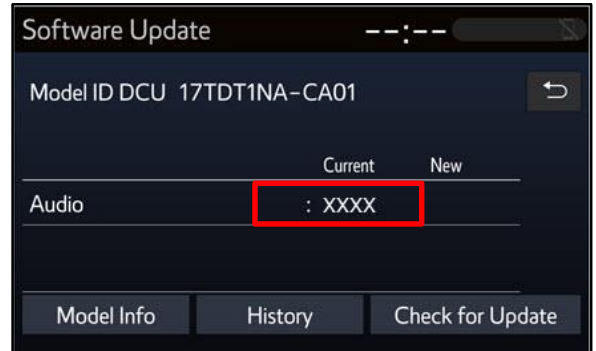
Figure 4.

5. Verify that the software version is the same or earlier than indicated in the Introduction.

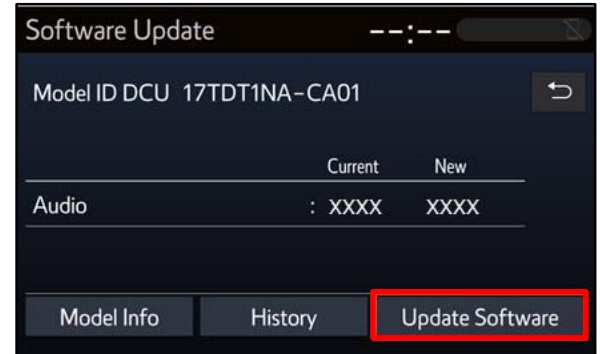
Figure 5.

9. Select the Update Software button in the lower right-hand corner.

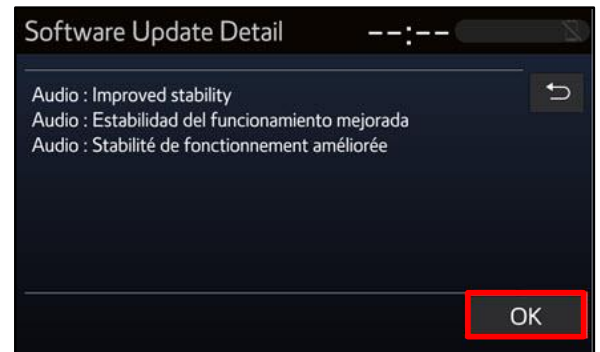
Figure 6.

10. Select OK on the Software Update Detail screen.

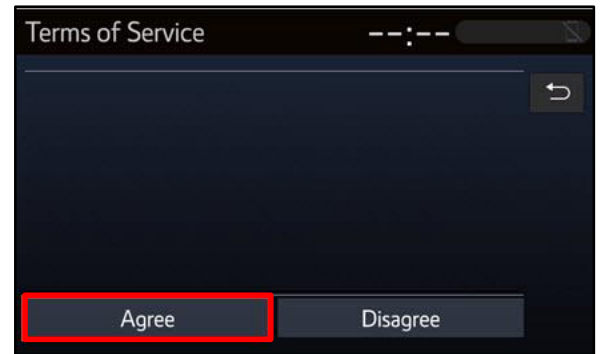
Figure 7.

11. Select Agree on the Terms of Service screen.

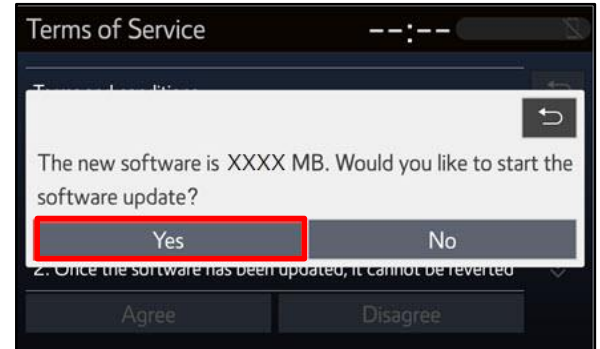
Figure 8.

12. Select Yes on the “Would you like to start the software update?” pop-up.

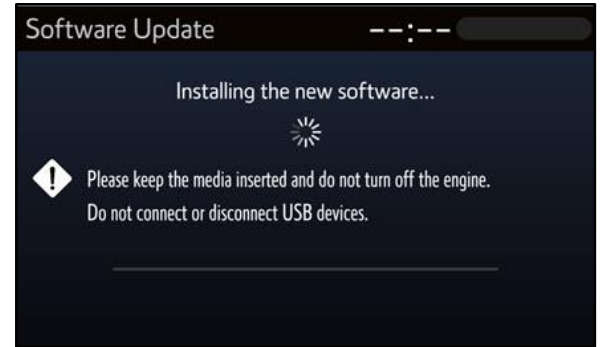
Figure 9.

13. Once the head unit begins installation, the update will take approximately 10 minutes.

- Do NOT turn OFF the ignition or ACC BEFORE the software is ready for updating.
- Do NOT remove the USB flash drive until instructed in step 17.

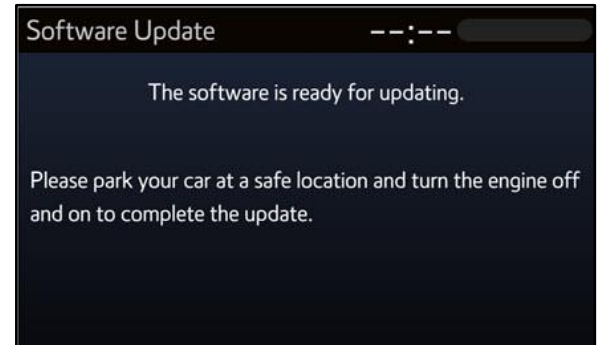
Figure 10.

14. When the “The software is ready for updating” screen appears, turn OFF the ignition.

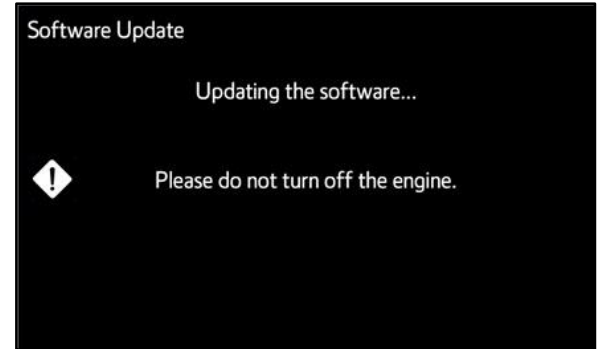
Figure 11.

15. Turn the ignition ON to complete the software update.
16. AFTER turning the ignition ON, the Software Update screen will appear. Do NOT turn OFF the ignition or remove the USB flash drive. The head unit will reboot during this time.

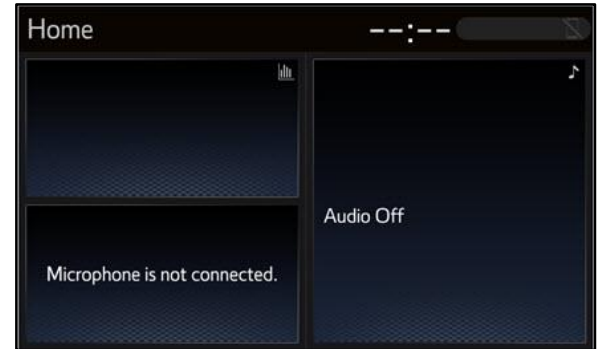
Figure 12.

17. Once the software update is complete and the Home screen appears, remove the USB flash drive.

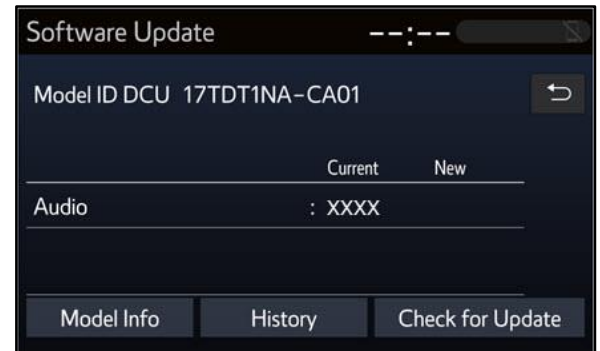
Figure 13.

18. Perform steps 3 – 6 to verify the software version matches the current software version information table below.
