GROUP
ELE
NUMBER
220 (Rev 1, 02/03/2021)

MODEL
2020-2021MY
Sportage (QL)
DATE
November 2020

TECHNICAL SERVICE BULLETIN

**SERVICE ACTION: FRONT CAMERA
OPERATION LOGIC IMPROVEMENT (SA449)**

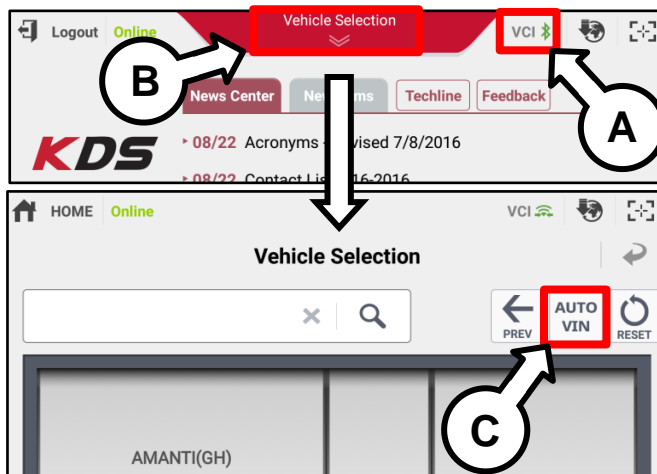
3. Confirm communication with VCI (A) and then configure the vehicle (B) using the **AUTO VIN** (C) feature.

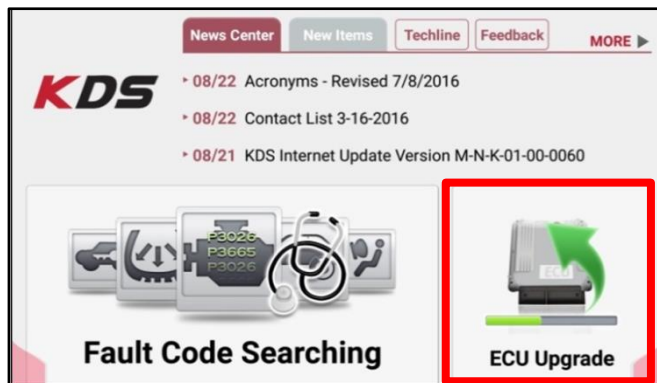
4. Select **ECU Upgrade**.

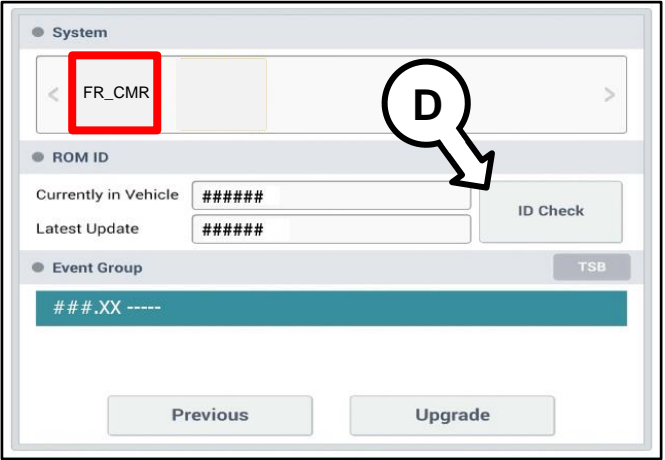
- Select the **FR_CM** system under the System selection menu.

Touch **ID Check** (D) and confirm that the latest update is available.

Select **Upgrade Event #511** and select **Upgrade** to continue.

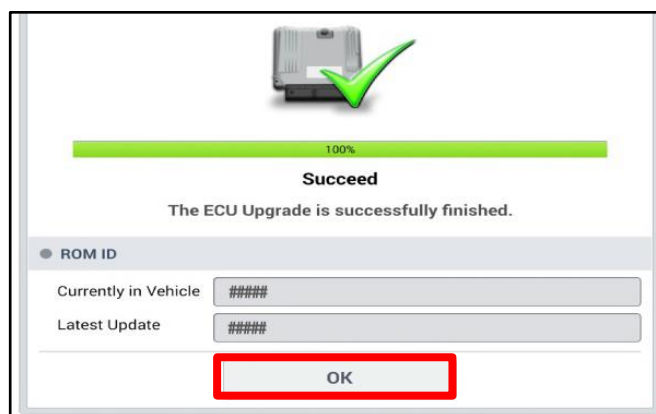
9. If a “Communication Fail” screen appears, verify that the VCI-II and KDS are communicating properly. Touch **OK** and restart the procedure from step 4.

10. When instructed on the KDS, turn the ignition **OFF** for ten (10) seconds then back on. Touch **OK** to continue.

11. Once the upgrade is complete, touch **OK** to finalize the procedure.

12. When prompted, select **YES** to check for Diagnostic Trouble Codes (DTC) and erase any DTCs stored such as EPS, ESC, and TPMS that may have been set during the upgrade.
