MODEL
2021MY
Seltos (SP2)

NUMBER
224 (Rev 1, 02/01/2021)

TECHNICAL SERVICE BULLETIN

SERVICE ACTION: FRONT CAMERA OPERATION LOGIC IMPROVEMENT (SA453)

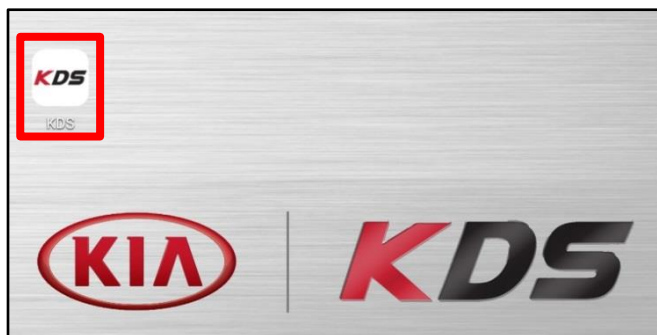
2. With the ignition ON, turn ON the KDS tablet. Select **KDS** from the home screen.

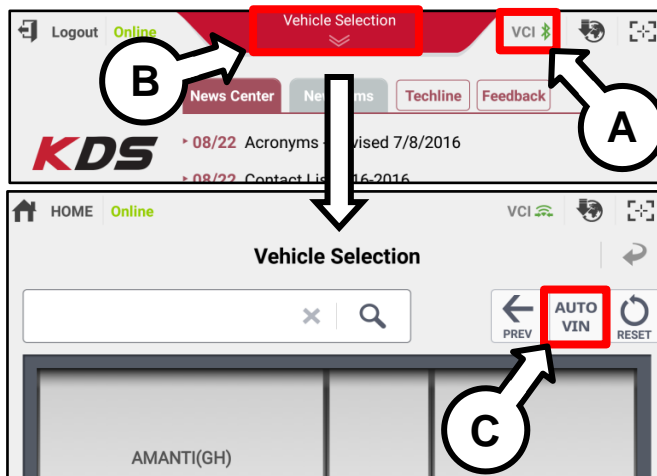
3. Confirm communication with VCI (A) and then configure the vehicle (B) using the **AUTO VIN** (C) feature.

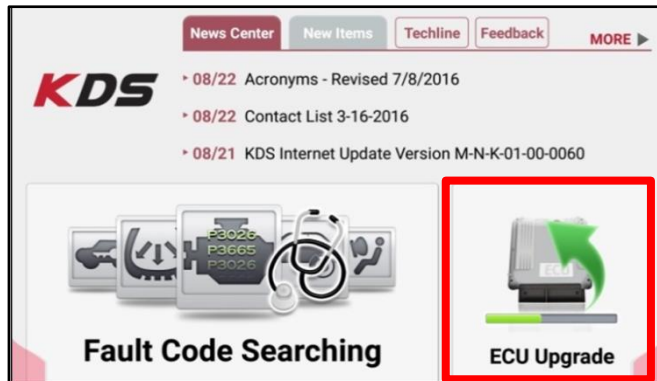
4. Select **ECU Upgrade**.

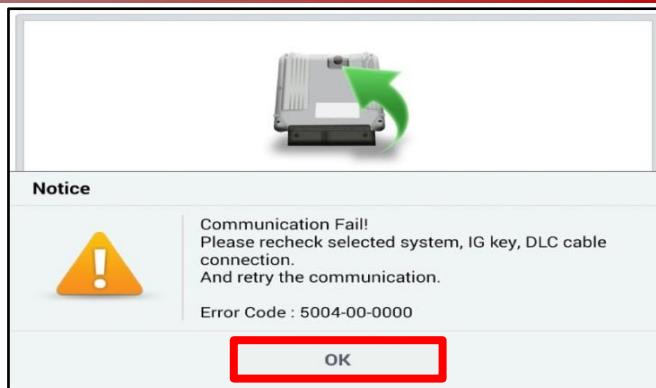
9. If a “Communication Fail” screen appears, verify that the VCI-II and KDS are communicating properly. Touch **OK** and restart the procedure from step 4.

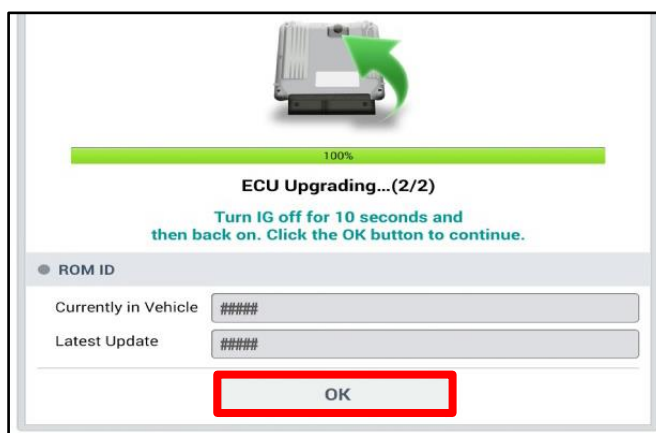
10. When instructed on the KDS, turn the ignition **OFF** for ten (10) seconds then back on. Touch **OK** to continue.

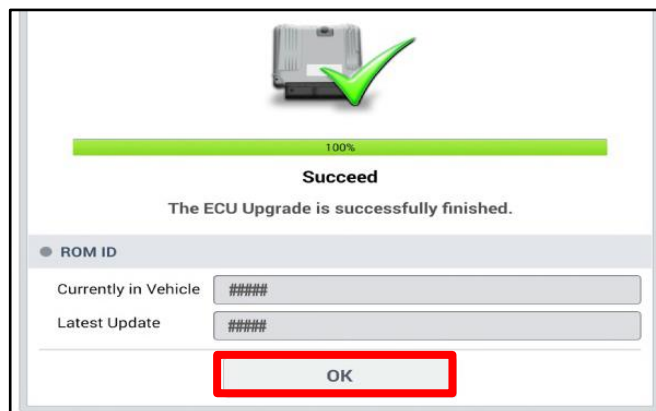
11. Once the upgrade is complete, touch **OK** to finalize the procedure.

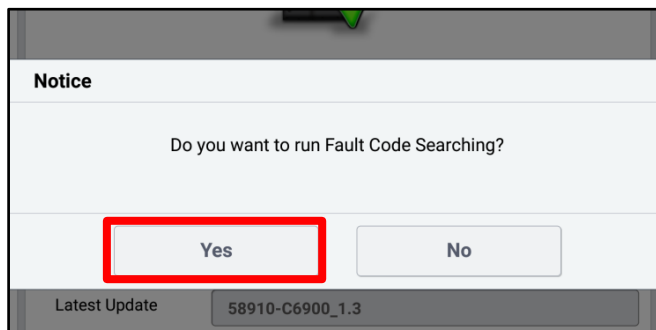
12. When prompted, select **YES** to check for Diagnostic Trouble Codes (DTC) and erase any DTCs stored such as EPS, ESC, and TPMS that may have been set during the upgrade.
