GROUP <b>ENG</b>	MODEL <b>2020MY Telluride (ON)</b>
	NUMBER <b>228</b>	DATE <b>January 2021</b>
<b>TECHNICAL SERVICE BULLETIN</b>		
<b>SUBJECT: 3.8L GDI MISFIRE DTC JUDGMENT LOGIC IMPROVEMENT</b>

This bulletin provides the procedure to improve the logic of the Engine Control Module (ECM) on some 2020MY Telluride (ON) vehicles with 3.8 GDI Atkinson ULEV engines, produced from January 9, 2019 through May 19, 2020, which may exhibit a cold start misfire with MIL ON for the misfire related DTC(s) listed below. To correct this concern, apply the improved logic to the Engine system using the KDS ECU Upgrade function as described in this bulletin. For confirmation that the latest reflash has been applied to a vehicle you are working on, verify the ROM ID using the table on page 3 of this bulletin.

518. ON 3.8GDI ATKINSON ULEV AT MISFIRE DTC JUDGMENT LOGIC IMPROVEMENT

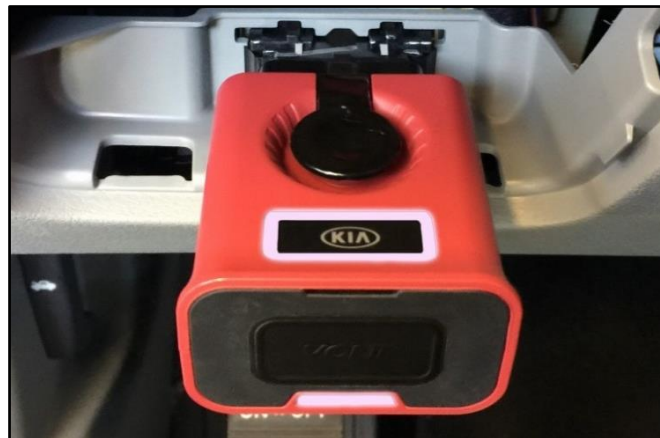
1. Connect the VCI-II to the OBD-II connector, located under the driver's side of the instrument panel.

The ECU upgrade function on KDS operates wirelessly. It is not necessary to perform the upgrade via USB cable.

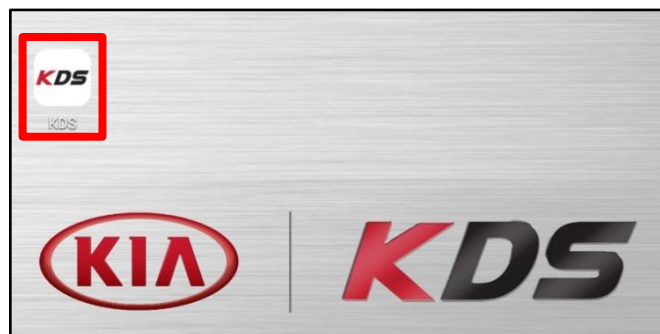
2. With the ignition ON, turn ON the KDS tablet. Select **KDS** from the home screen.

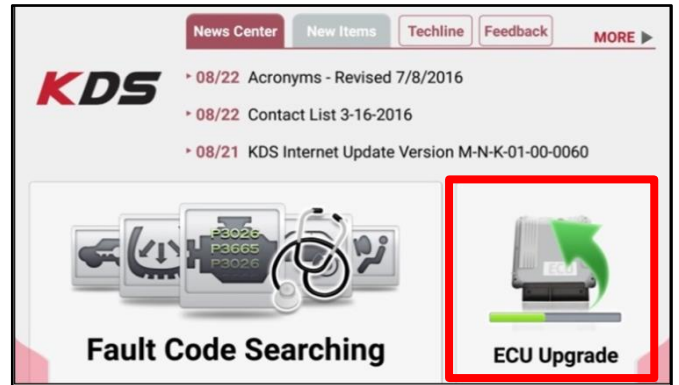
4. Select **ECU Upgrade**.

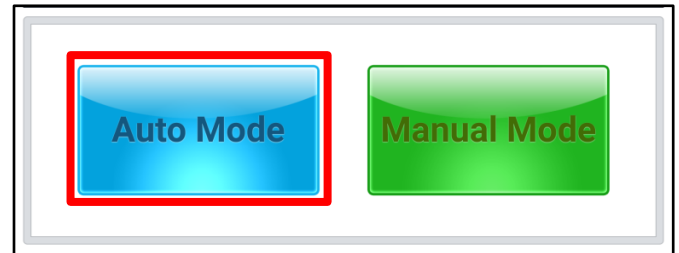
6. Select **Auto Mode**.

**CAUTION**  
 Do NOT attempt to perform a Manual Mode upgrade UNLESS Auto Mode fails. Always follow the instructions given on the KDS in either Auto or Manual mode.

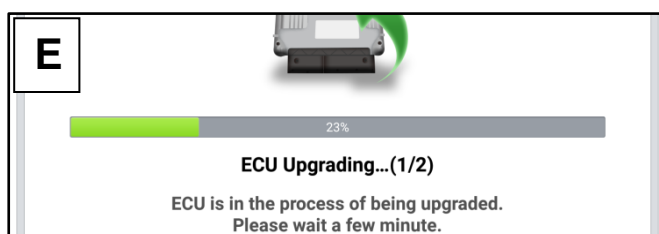
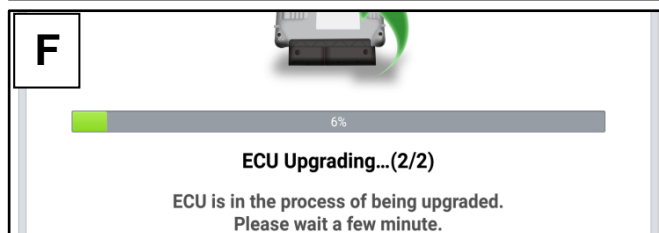
8. The ECU upgrade will begin and the progress of the upgrade will appear on the bar graph. Upgrade part (1/2) (E) will download the upgrade event to the VCI-II. Upgrade part (2/2) (F) will upgrade the ECU.

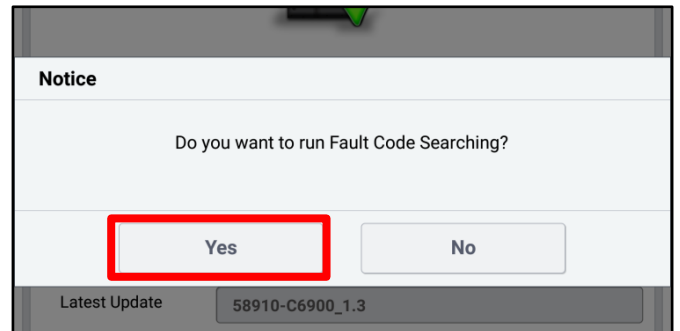
12. When prompted, select **YES** to check for Diagnostic Trouble Codes (DTC) and erase any DTCs stored such as EPS, ESC, and TPMS that may have been set during the upgrade.
