GROUP <b>ENG</b>	MODEL <b>2020-2021MY Soul (SK3) 2021MY Seltos (SP2)</b>
NUMBER <b>227</b>	DATE <b>February 2021</b>

## TECHNICAL SERVICE BULLETIN

**SUBJECT: SERVICE ACTION: MIL ON DTC P0605 AND/OR P2181  
ECM LOGIC IMPROVEMENT (SA463)**

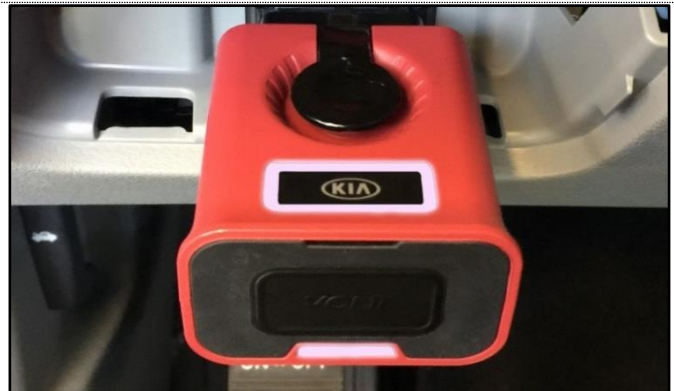
1. Connect the VCI-II to the OBD-II connector, located under the driver's side of the instrument panel.

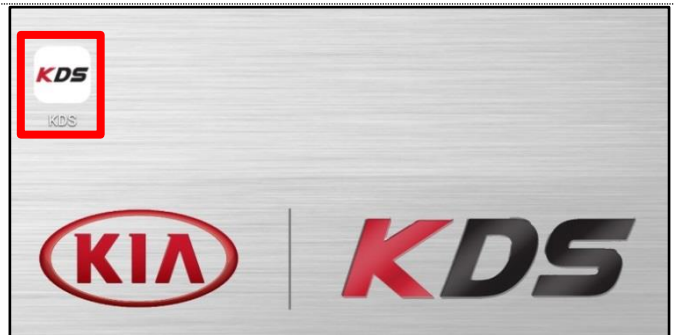
2. With the ignition ON, turn ON the KDS tablet. Select **KDS** from the home screen.

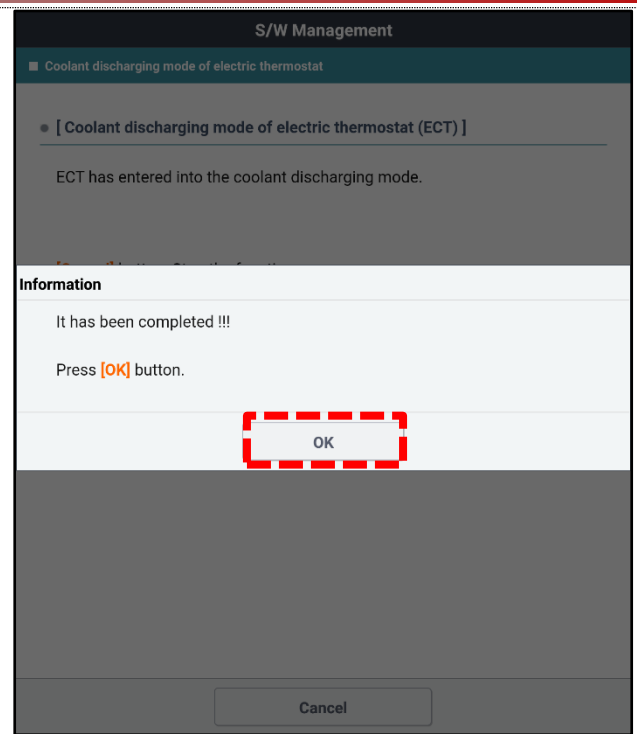
6. When the procedure is completed select **'OK'**.

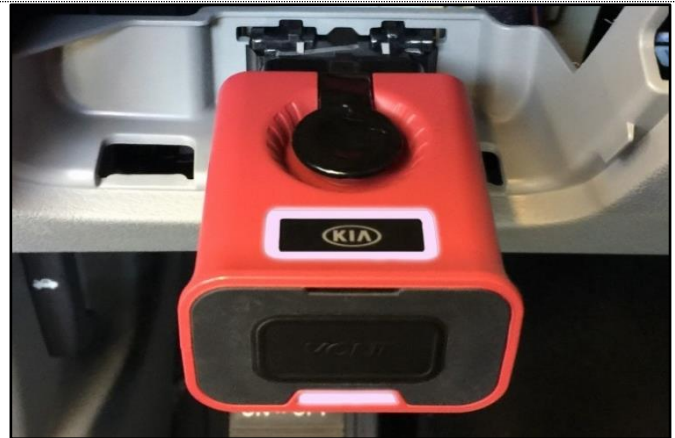
1. Connect the VCI-II to the OBD-II connector, located under the driver's side of the instrument panel.

**The ECU upgrade function on KDS operates wirelessly. It is not necessary to perform the upgrade via USB cable.**

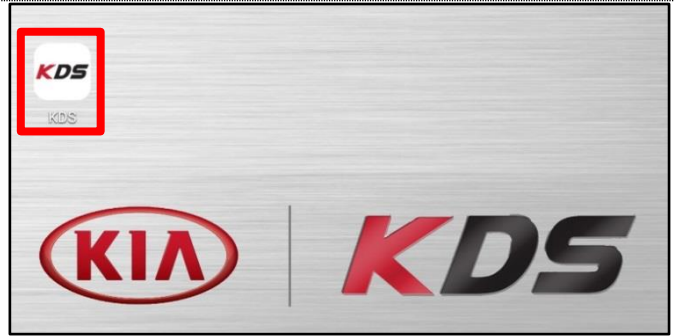
2. With the ignition ON, turn ON the KDS tablet. Select **KDS** from the home screen.

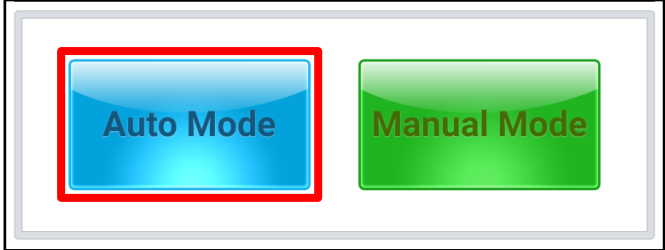
<p>6.</p>	<p>Select <b>Auto Mode</b>.</p> <div style="border: 1px solid black; padding: 5px; margin-top: 10px;"> <p style="background-color: yellow; display: inline-block; padding: 2px 5px;"><b>CAUTION</b></p> <p><b>Do NOT attempt to perform a Manual Mode upgrade <u>UNLESS Auto Mode fails</u>. Always follow the instructions given on the KDS in either Auto or Manual mode.</b></p> </div>

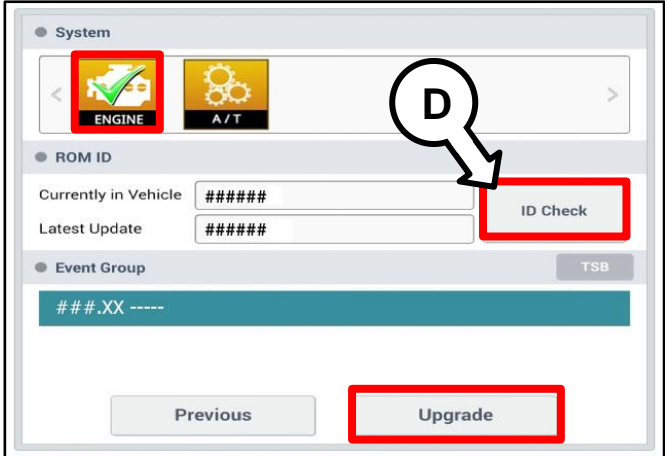
<p>7.</p>	<p>Select the <b>Engine</b> system under the System selection menu.</p> <p>Touch <b>ID Check (D)</b> and confirm that the latest update is available.</p> <p>Select <b>Upgrade Event #519 (SK3)</b> <u>or #520 (SP2)</u> and select <b>Upgrade</b> to continue.</p>

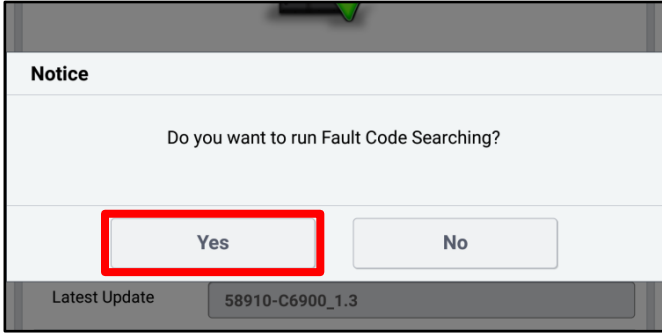
<p>12.</p>	<p>When prompted, select <b>YES</b> to check for Diagnostic Trouble Codes (DTC) and erase any DTCs stored such as EPS, ESC, and TPMS that may have been set during the upgrade.</p>
