SOFTWARE UPDATE FOR INFOTAINMENT ISSUES

APPLIED VEHICLES: 2020 Q50 (V37)
2020 Q60 (CV37)
2020 QX50 (J55)
2020 QX80 (Z62)

APPLIED SYSTEM: Audio Infotainment System

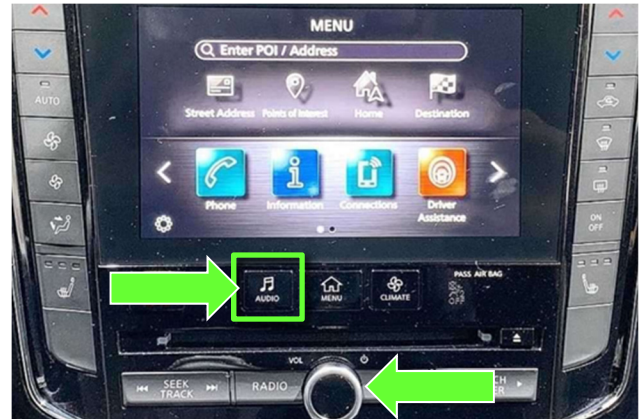
Figure 2

1. Press and hold the **AUDIO** button and at the same time rotate the volume knob left and right until the second screen appears.

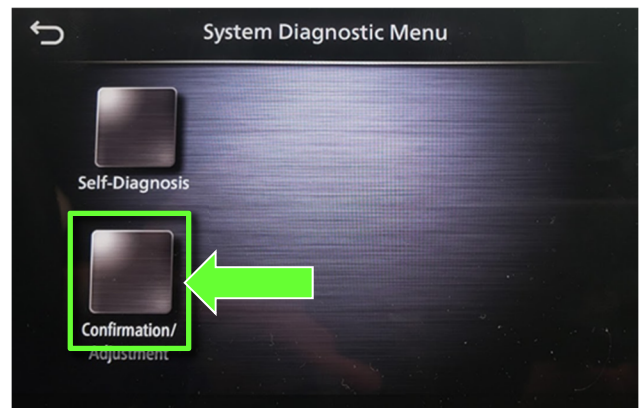
Figure 3

2. Select **Confirmation/Adjustment**.

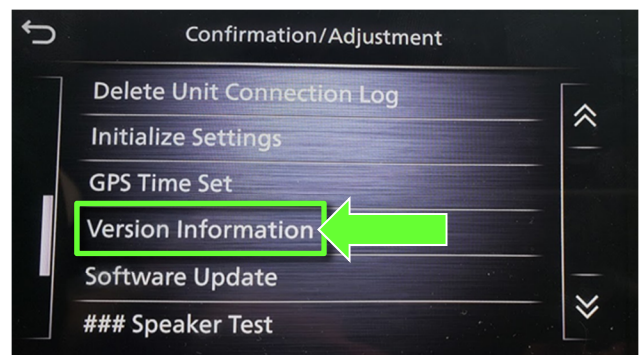
Figure 4

3. Scroll down and select **Version Information**.

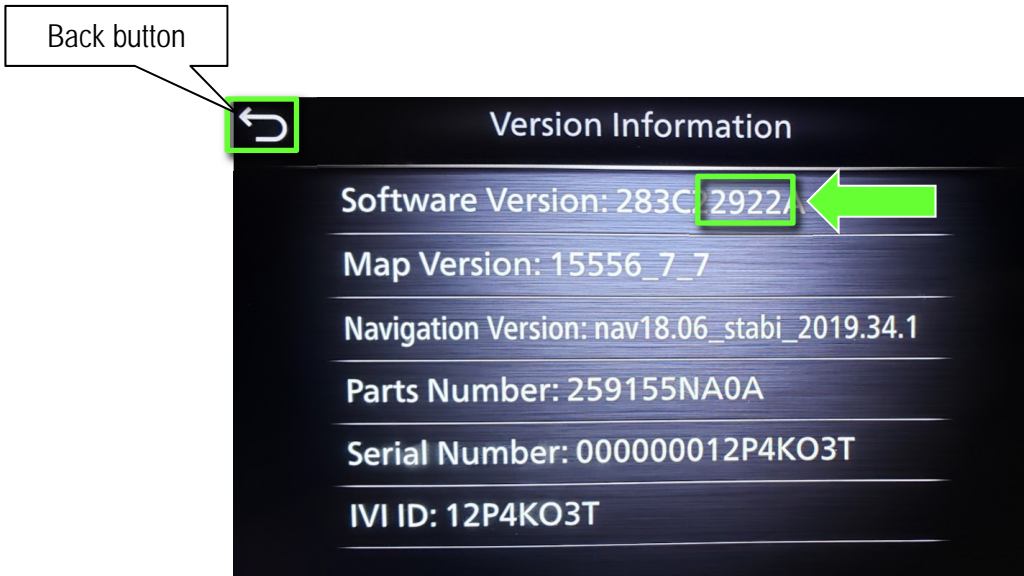
Figure 5

4. Confirm the **Software Version** number (Figure 5).

- If the Software Version (digits 6-9 as shown in Figure 6) is **lower** than xxxxx**2959**x, select the back button and continue to step 5 on the next page.
- If the Software Version is xxxxx**2959**x or higher (digits 6-9), select the back button; this bulletin does not apply. Refer to ASIST for further diagnostic information.

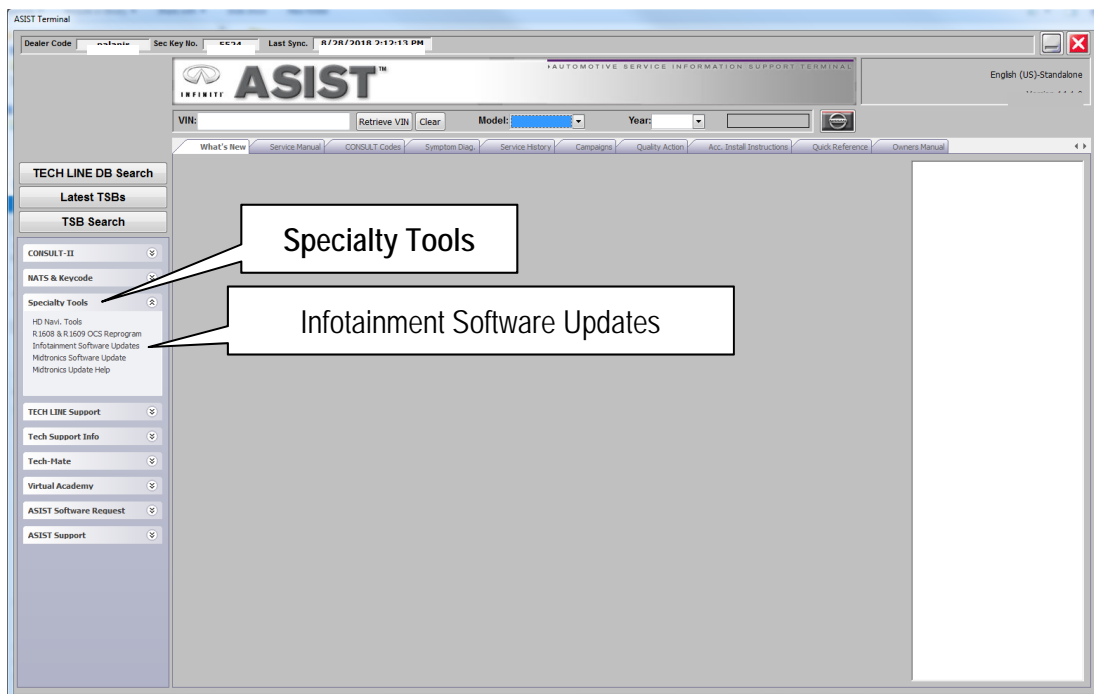
Figure 6

7. Select **Specialty Tools**, and then select **Infotainment Software Updates**.

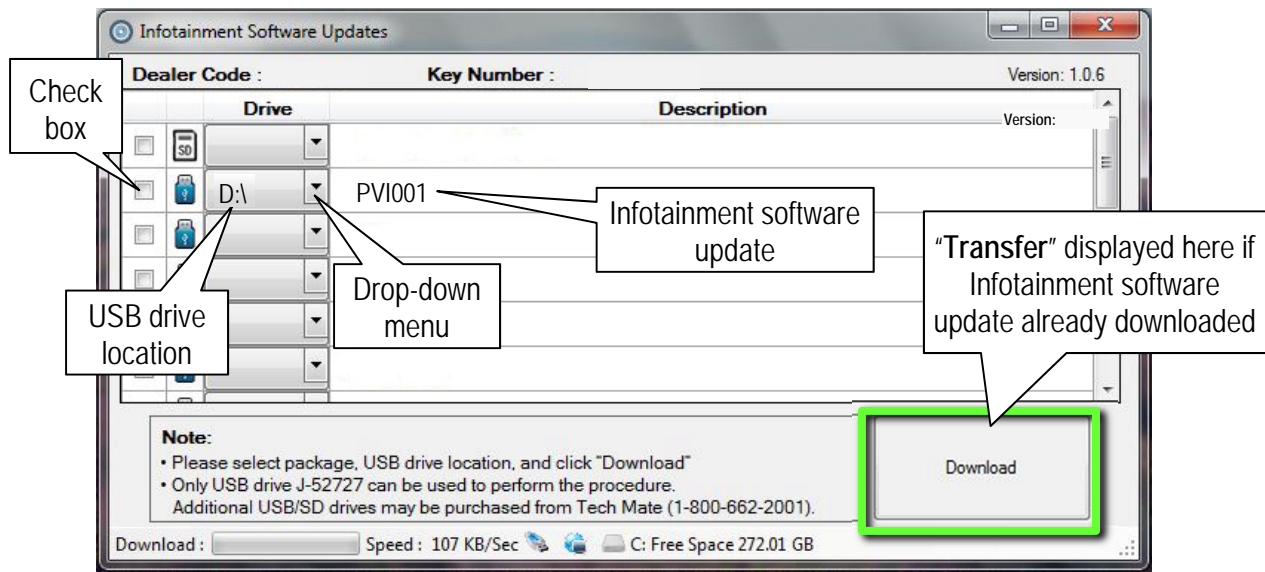
8. Select the check box next to **PVI001** infotainment software update (refer to Figure 7 below).
 - If **PVI001** infotainment software update has already been downloaded, when the infotainment software update box is checked, **"Transfer"** will be displayed instead of **Download**.
9. Use the drop-down menu and select the location of the USB drive that was inserted in step 5.

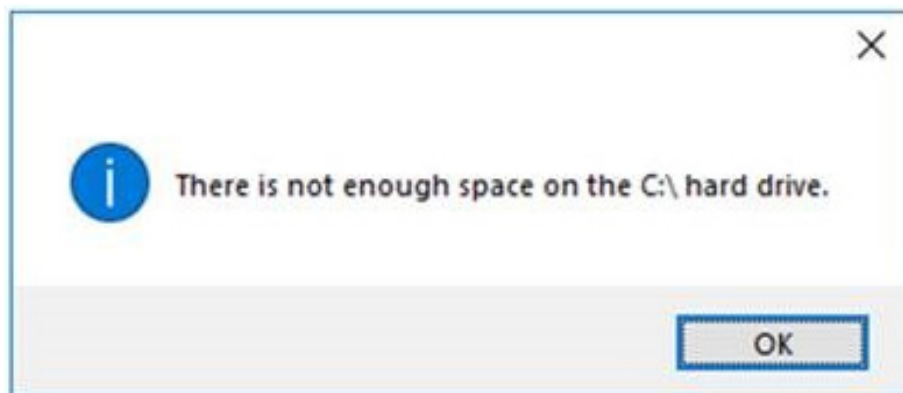
Figure 8

- The update is estimated to take **6 hours** to download to the USB drive.
- If while attempting to download the software to the ASIST Station, you receive the message shown in Figure 8:
 - a. First attempt to clear space on the ASIST station hard drive (40 GB required).
 - b. If space cannot be cleared and a second CONSULT PC\Unit is available with space, use it and start over from step 5.
 - c. If a second CONSULT PC\Unit is not available, and space on the hard drive cannot be cleared, email Bosch at nissan.dealers@us.bosch.com for additional options.

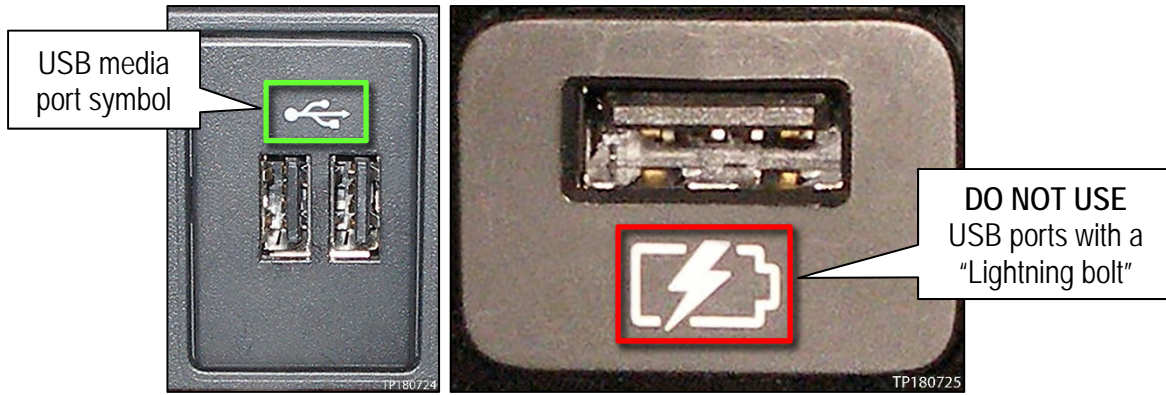
Figure 11

16. Insert the USB drive with infotainment update software into the vehicle's USB media port (see Figure 11).
- Do not remove the USB drive during the update to the vehicle until instructed to.

HINT: Charging ports are marked in the vehicle with a "lightning bolt" symbol.

NOTICE Do not insert the USB drive into a charging port. If used, the software update and/or USB drive may become damaged. Only insert the USB drive in a USB media port.

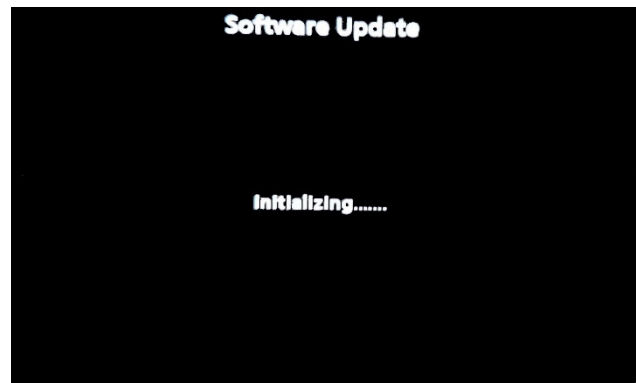
17. Wait approximately 10-30 seconds for the screen in Figure 13 to appear.

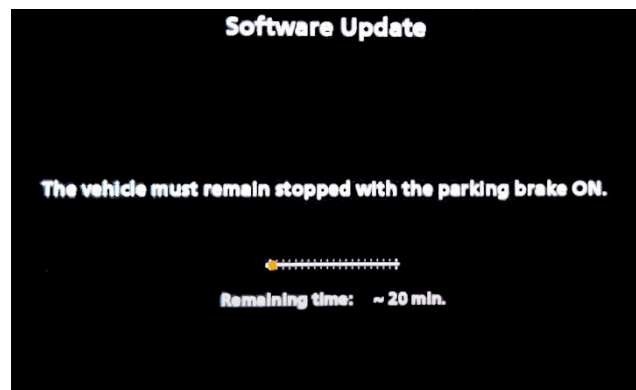
- The screen in Figure 14 may briefly appear. Do not remove the USB drive. The audio system will detect the USB drive and continue the update.

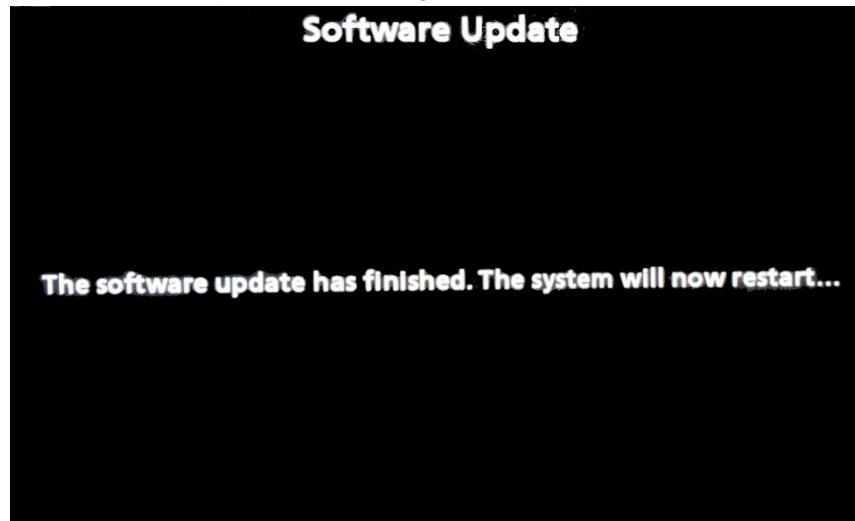
Figure 15

19. Once the update is complete (Figure 15), remove the USB drive; the system will reboot (restart).

HINT: The system will not reboot until the USB drive is removed.

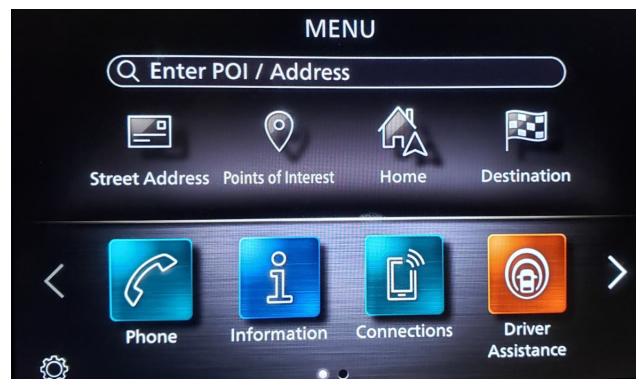
- The MENU (Home) screen in Figure 18 will be displayed.
