SERVICE BULLETIN

Classification: AN20-008d	Reference: NTB20-016d	Date: February 4, 2021
------------------------------	--------------------------	---------------------------

RADIO INTERMITTENTLY REBOOTS DURING AUDIO PLAYBACK VIA BLUETOOTH CONNECTED IPHONE

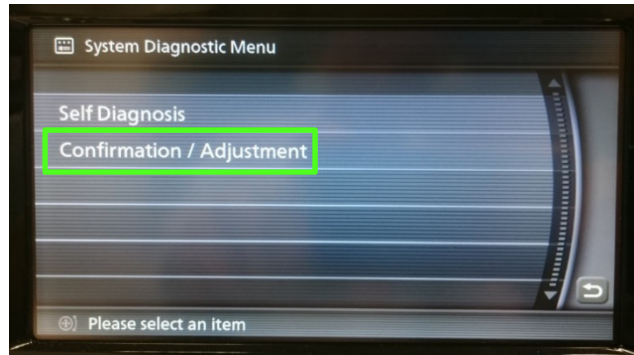
Figure 3

4. Select **Confirmation / Adjustment**.

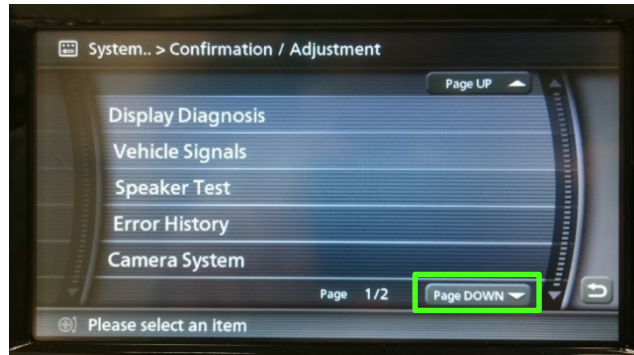
Figure 4

5. Select **Page DOWN**.

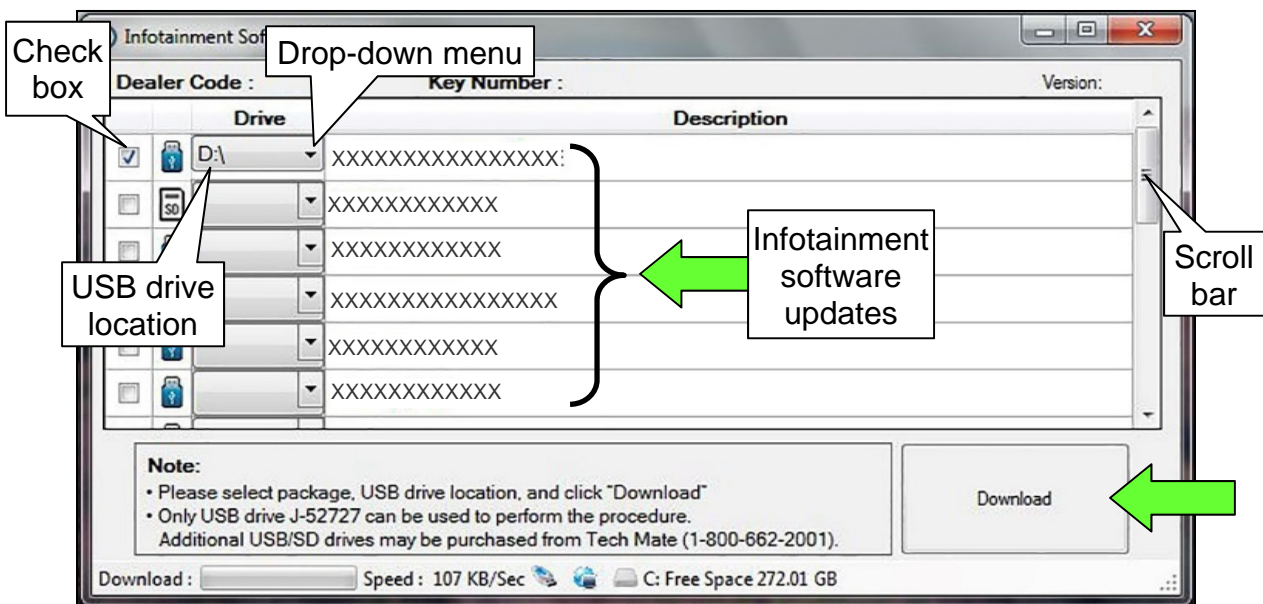
10. Select the check box next to the correct update software package (Figure 8).
- Locate update file #1 (LD001) and update file #2 (see **Table A** above).
 - Only one (1) update will be loaded at a time, starting with update #1 (LD001).

HINT: The **Description** section in Figure 8 may be different than on your C-III plus screen.

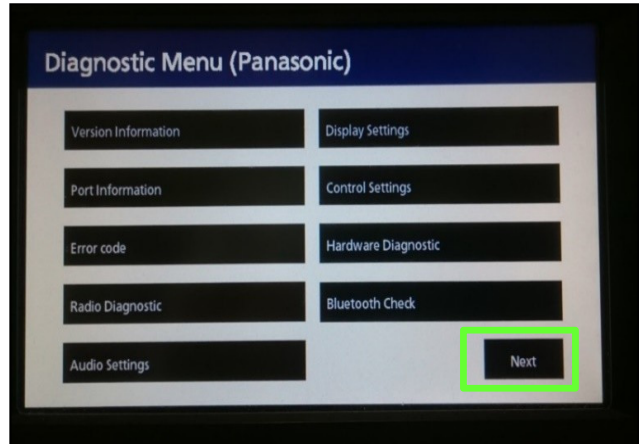
- a. Press and hold the **Menu** button.
- b. Press and hold the **Audio** button.
- c. Press the **Seek right** button three (3) times.

HINT: A screen similar to the one in Figure 15 will appear.

- d. Select the **Next** button at the bottom right side of the screen.

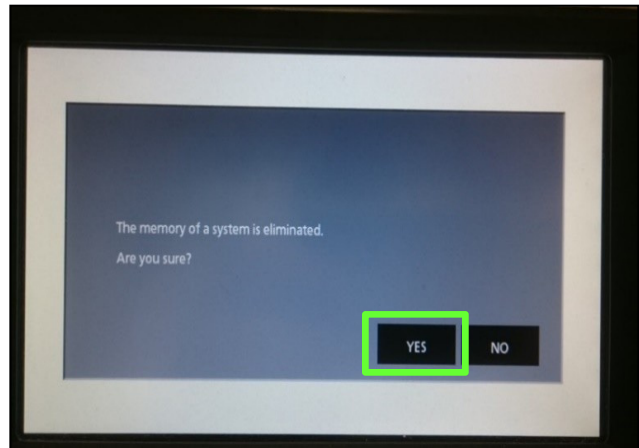
Figure 16

- f. Select **Yes** on the confirmation screen shown in Figure 16.

HINT: Initialization is complete after the audio unit reboots.
