Emissions Service Action Code: 37K8

Transmission Control Module (TCM)

Update transmission control module (TCM) software - OR - install a new mechatronic unit.

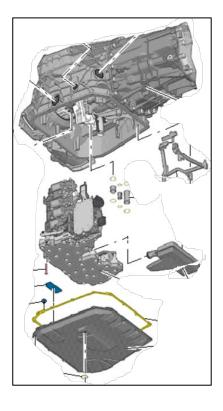
Repair Overview

Update mechatronic (TCM) software or replace mechatronic.

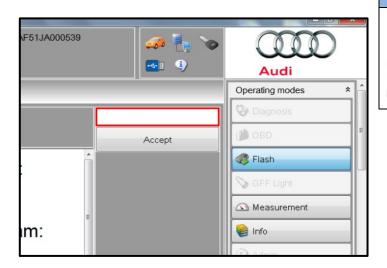
Select "Perform test".

Using <u>Bluetooth or WiFi</u> for this action is <u>PROHIBITED!</u>

- The VAS Diagnostics Interface MUST ONLY be connected to the tester with a USB cable.
 - Performing a software update using a Bluetooth or WiFi connection increases the risk of losing connection during the update, which could result in damage to the control module. It also greatly increases the time required to perform the update. Requests for additional time or parts will be denied if the GFF log shows the update was performed using Bluetooth or WiFi.

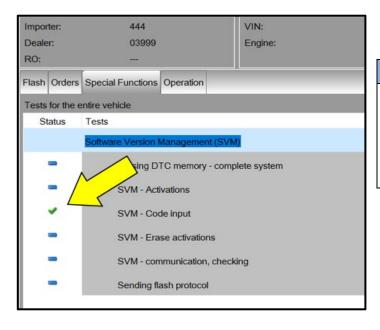
SVM code 37K8A848

- · Select "Accept".
- Follow the on-screen prompts.

This extra ignition cycle step must be followed, otherwise faults stored during the update may not be cleared upon exiting the Flash program.
