MODEL
2020MY
Niro (DE
HEV/PHEV)

NUMBER
224 (Rev 1, 03/17/2021)

TECHNICAL SERVICE BULLETIN

SUBJECT: SERVICE ACTION: ACTIVE AIR FLAP (AAF)
MIL ON JUDGMENT LOGIC IMPROVEMENT (SA459)

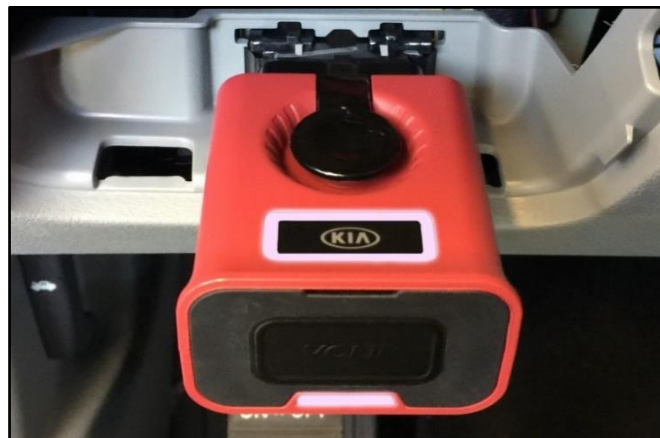
The ECU upgrade function on KDS operates wirelessly. It is not necessary to perform the upgrade via USB cable.

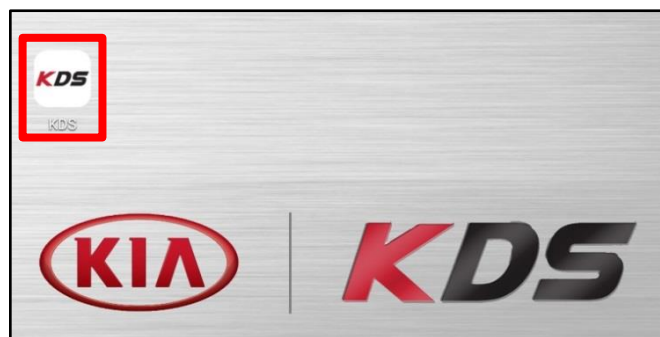
2. With the ignition ON, turn ON the KDS tablet. Select **KDS** from the home screen.
