Updating HVAC ECU Software to Fix Front HVAC Evaporator Freezing and Improve Espar Heater Cool Down

54-338

**Freightliner
Service Bulletin**

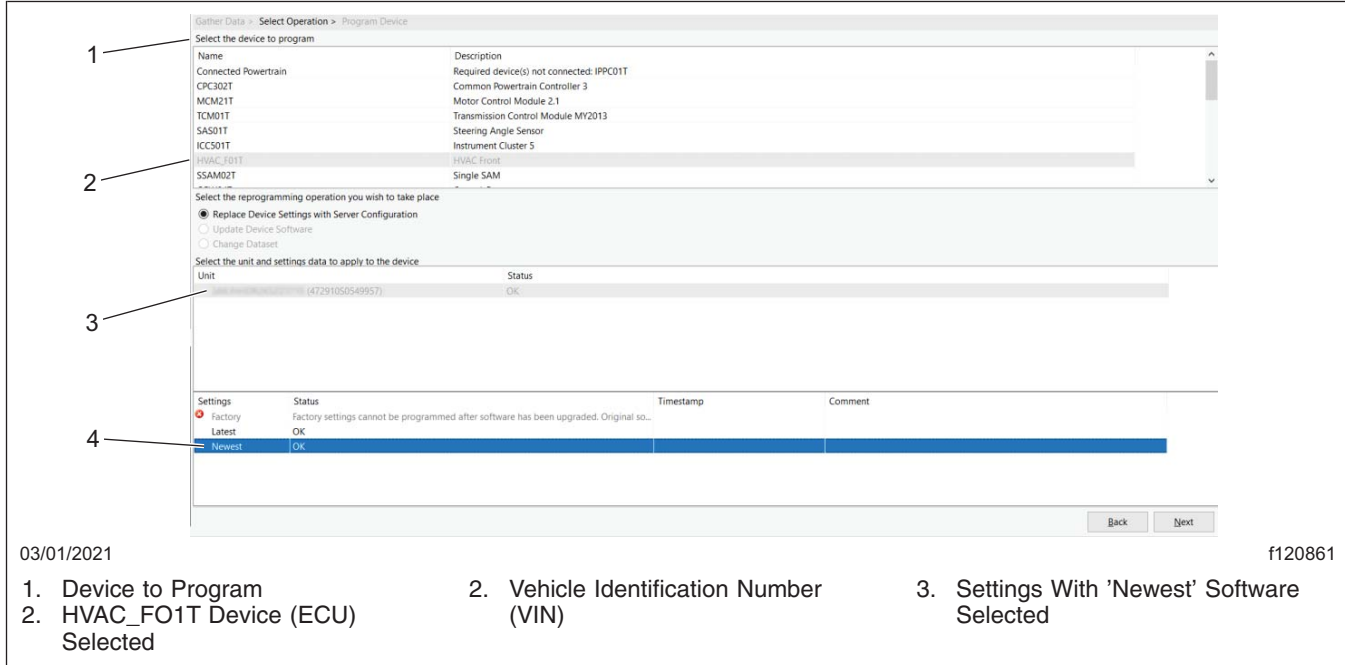
11. Select either the HVAC_F01T ECU, HVAC_R01T ECU, or HVAC_P01T ECU to program, select the VIN, and select 'Newest' if available.

If 'Newest' is not available, the selected ECU has the most up to date software. If this is the case, select the second ECU to program, select the VIN, and select 'Newest.'

Select 'Next.' See [Fig. 9](#)

Fig. 9, Selecting ECU to Program, VIN, Software Version

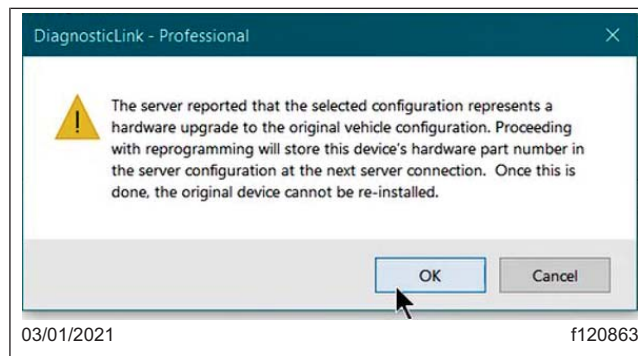
12. If the ECU currently installed has a different part number than what is stored on the server, the pop-up note shown in **Fig. 10** may appear. If this happens, select OK and continue to the next step.

Fig. 10, Device (ECU) a Different Part Number Pop-Up
