Release Date	03/23/2021	Technical Service Bulletin		
72K6 UPDATE Service Package – (NVLW)

Topic	Models Affected	Topic Details
1	ALL	Front seats entry assistance sporadically inoperative
2	ALL	Adaptive Cruise Assist is not available
3	Q8/RSQ8	Front parking aid provides false warnings.
4	A6 Variants/A7	Central locking/parking brake warning, alarm and exterior mirror issues

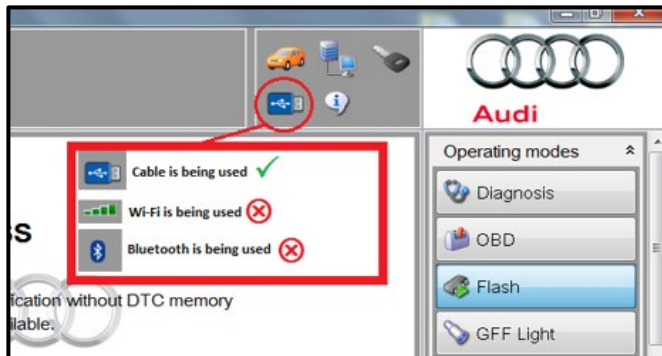
- Confirm that scan tool is communicating with the diagnostic head by USB cable.
 - If the Bluetooth or WiFi symbol is shown, then disconnect the diagnostic head from the vehicle and reconnect the USB cable to the diagnostic head and then reattach to the vehicle.
