SERVICE BULLETIN

APPLICABILITY: 2016-18MY Legacy/Outback
 2016-18MY Impreza
 2016-18MY Crosstrek
 2016-18MY Forester
 2017-18MY WRX

NUMBER: 15-280-21R

SUBJECT: Gen1 Telematics Reprogramming for 3G Sunset

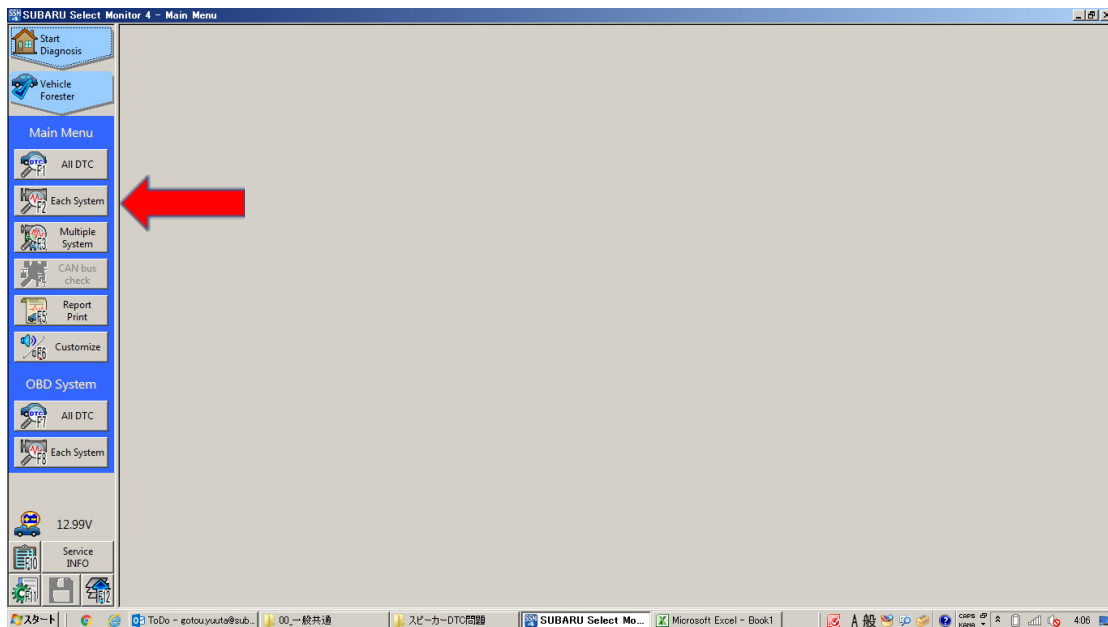
- a. Click “Each System” on the left-hand menu.

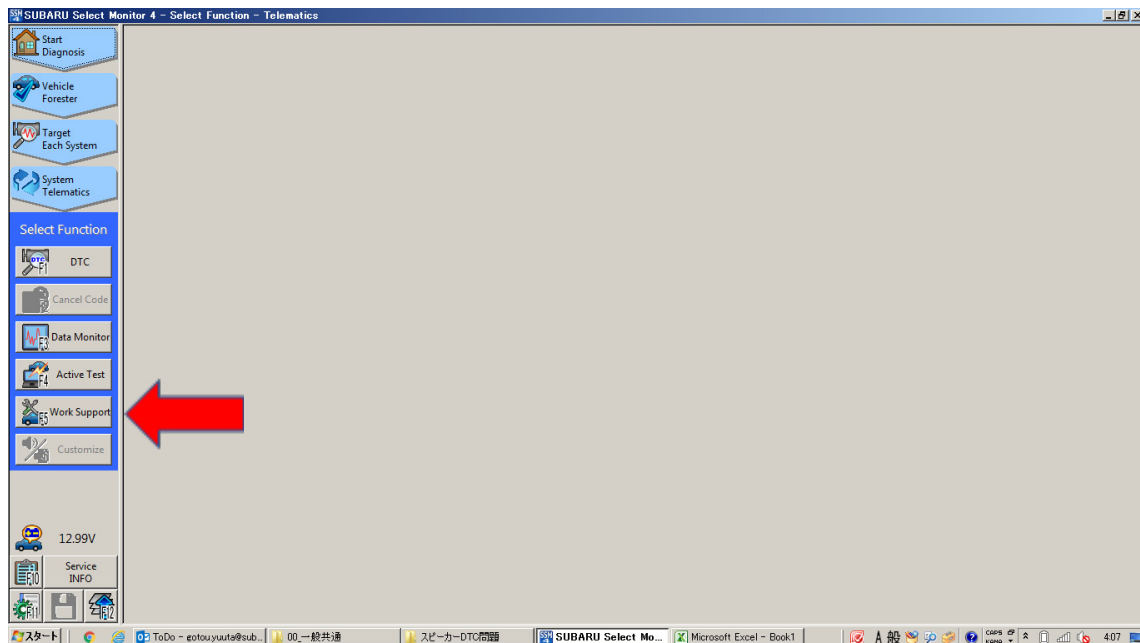
c. Click “Work Support” on the left-hand menu.

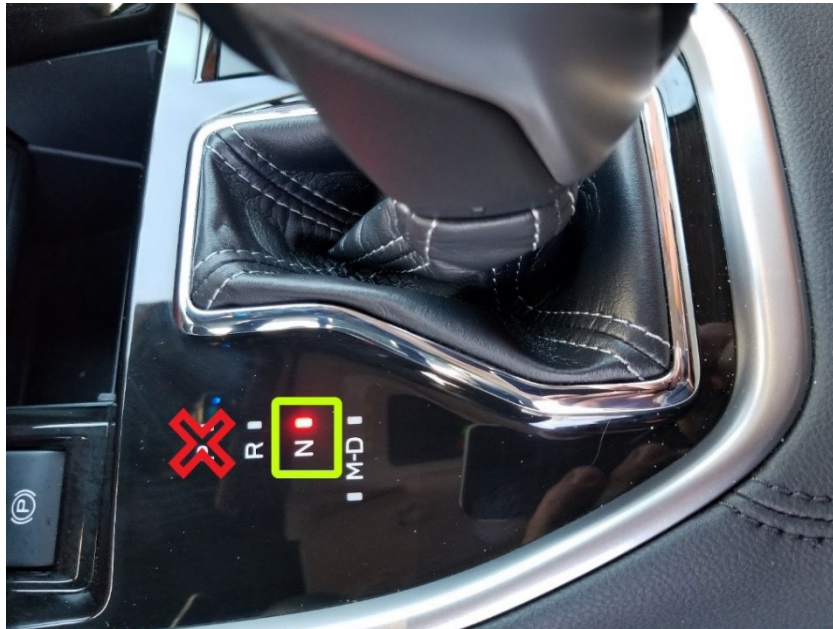
WARNING: Ensure the Midtronics GR8 / Midtronics DCA-8000 set to Power Supply Mode is connected to the vehicle, the parking brake is engaged, ignition is in the “ON” position, the engine is OFF, the shift selector in NEUTRAL and the wheels are blocked. The reason this must be done is to ensure the power supplied to the DCM is not turned off. If this step is not performed, the CAN will power down the DCM during the reflash and the reflashing will fail resulting in irreparable damage to the DCM.

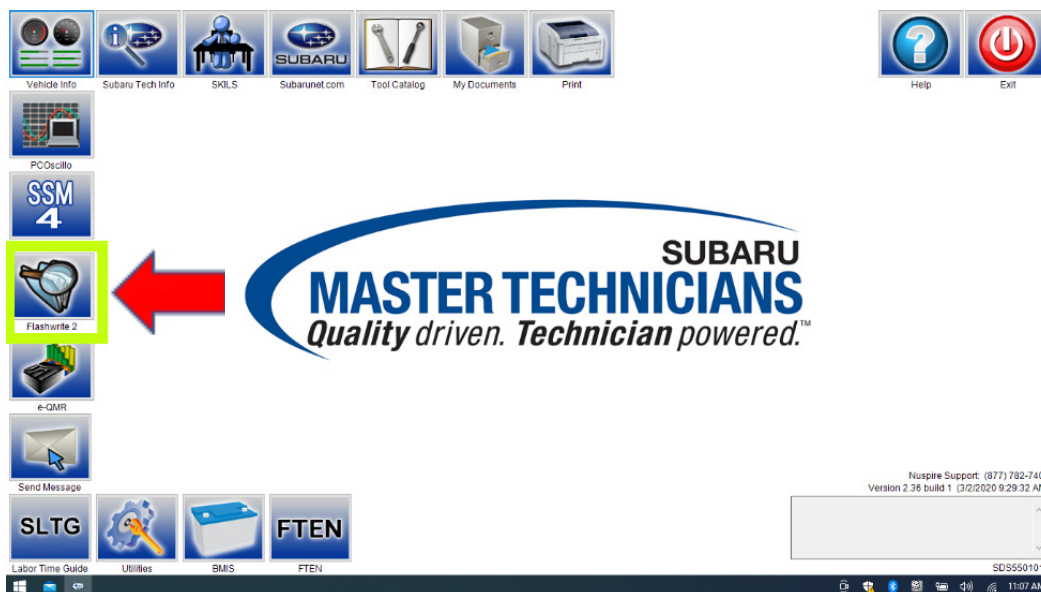
1. Connect the SDS Notebook and DSTi. Select **FlashWrite2** from the SDS Notebook GUI screen.

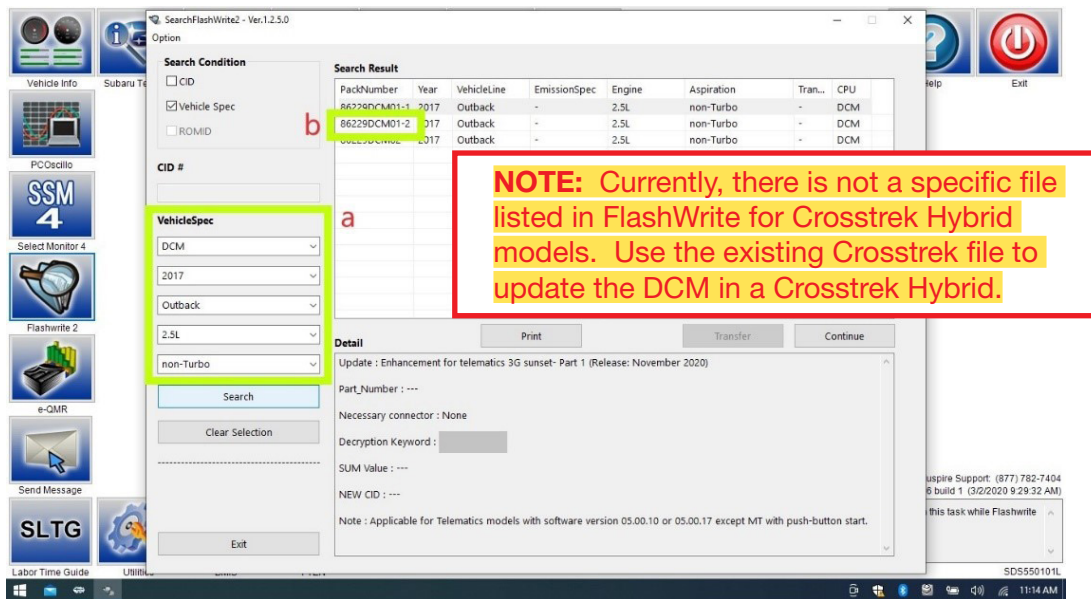
2. Once FlashWrite 2 opens, select DCM from the VehicleSpec drop down.
 - a) Complete entering the Vehicle Spec information.
 - b) Click and select the PK2 file **86229DCM01-2.pk2** intermediate image in FlashWrite.

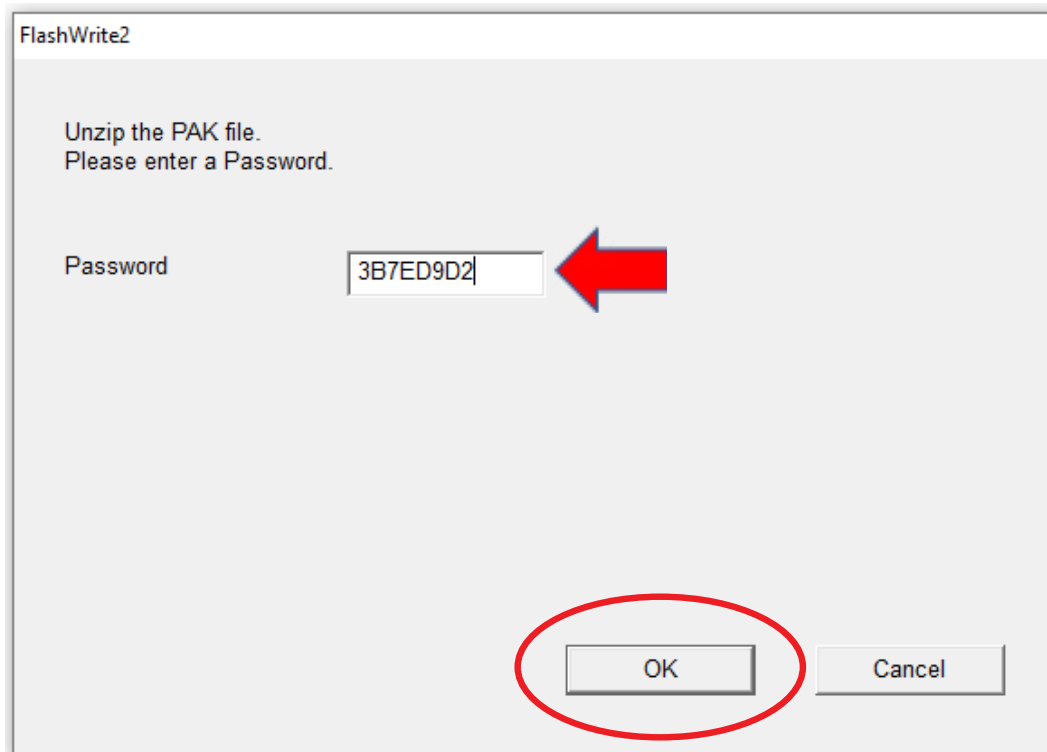
3. Enter the Decryption Keyword from the table above (3B7ED9D2) and click “OK.”

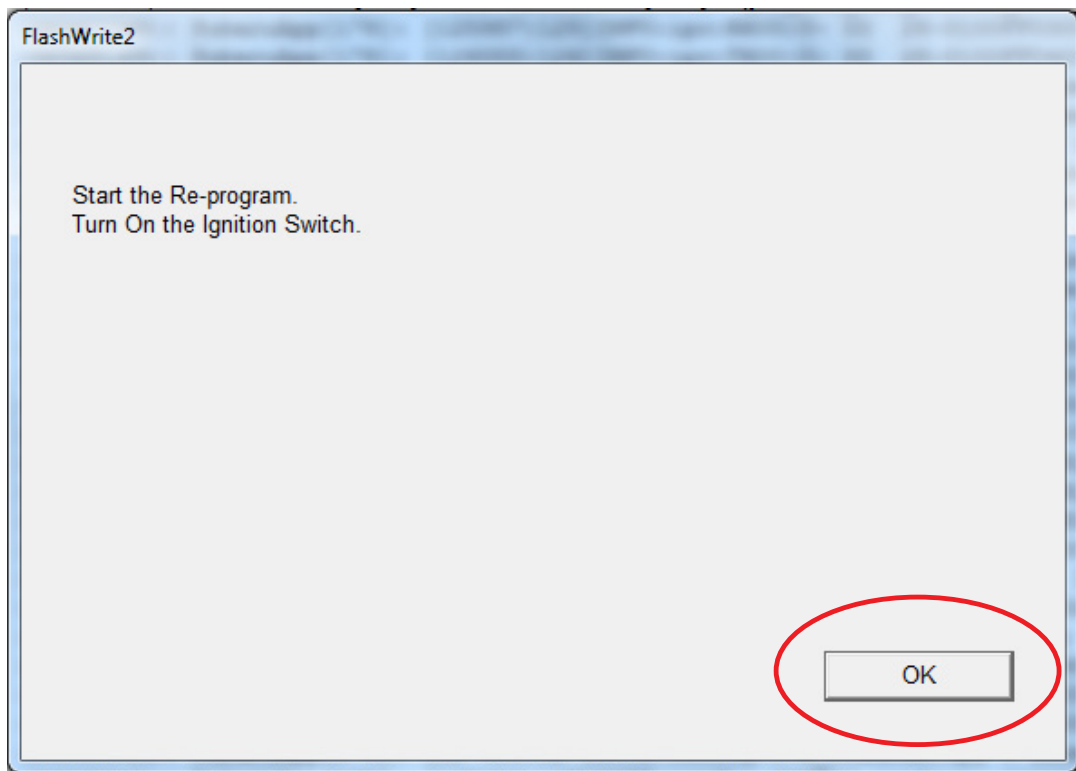
4. Turn the ignition ON and Click on 'OK' to start the reprogram.

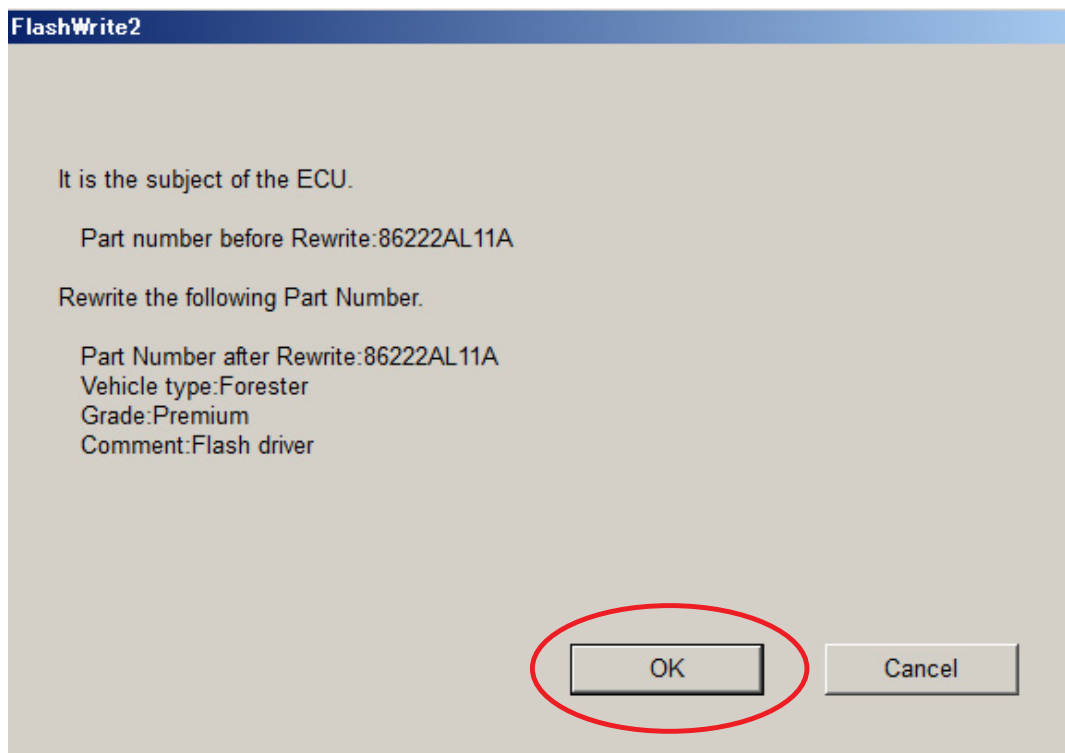
- a) Part number before and after reflash will be displayed. Click 'OK'.

(NOTE: This screen image is an example and may not represent the installed part number. These values will be the same before and after any reflashing. The Screen will always indicate "Forester" no matter what model or model year is being reflashed.)

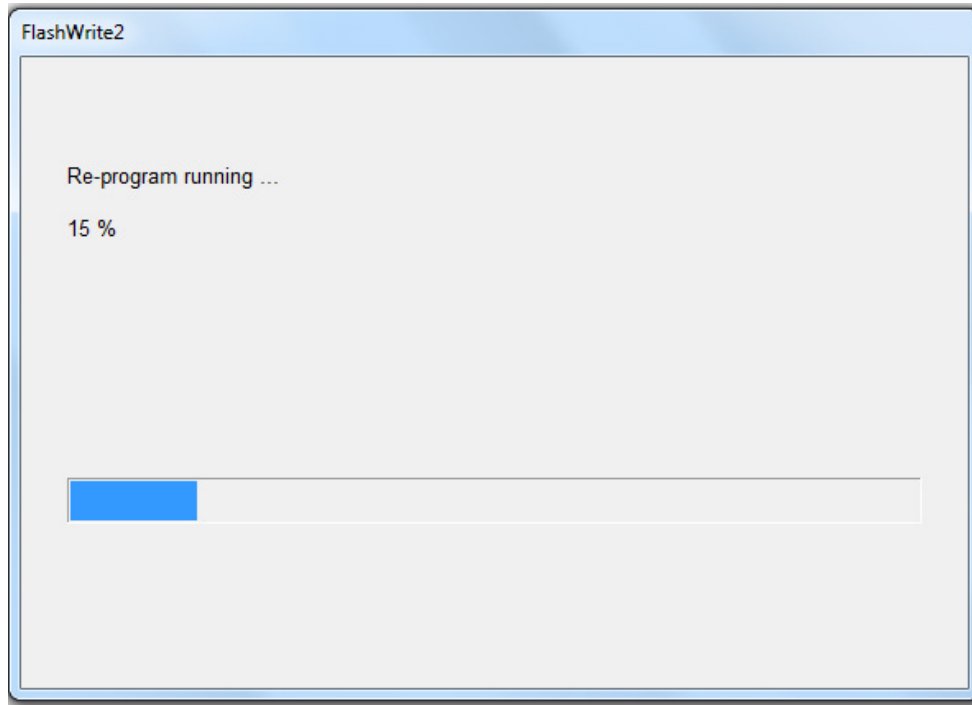
- b) A CAN flashing progression bar will appear and start incrementing toward 100%. The update may take up to 60 minutes to complete.

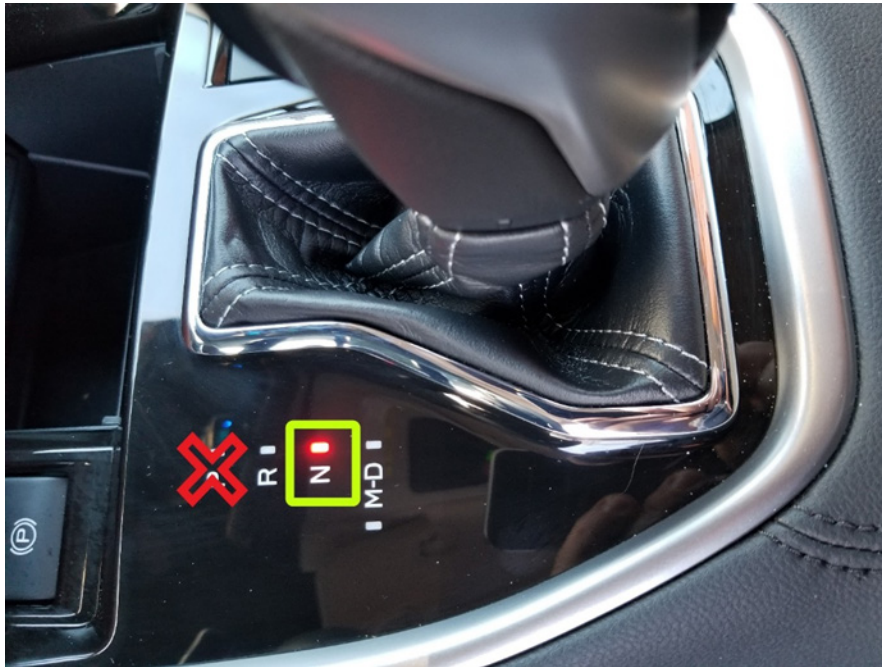
WARNING: Ensure the Midtronics GR8 / Midtronics DCA-8000 in Power Supply Mode is connected to the vehicle, the parking brake is engaged, ignition is in the “ON” position, the engine OFF, the shift selector in NEUTRAL and the wheels blocked. The reason this must be done is to ensure the power supplied to the DCM is not turned off. If this step is not performed, the CAN will power down the DCM during the reflash and the reflashing will fail resulting in irreparable damage to the DCM.

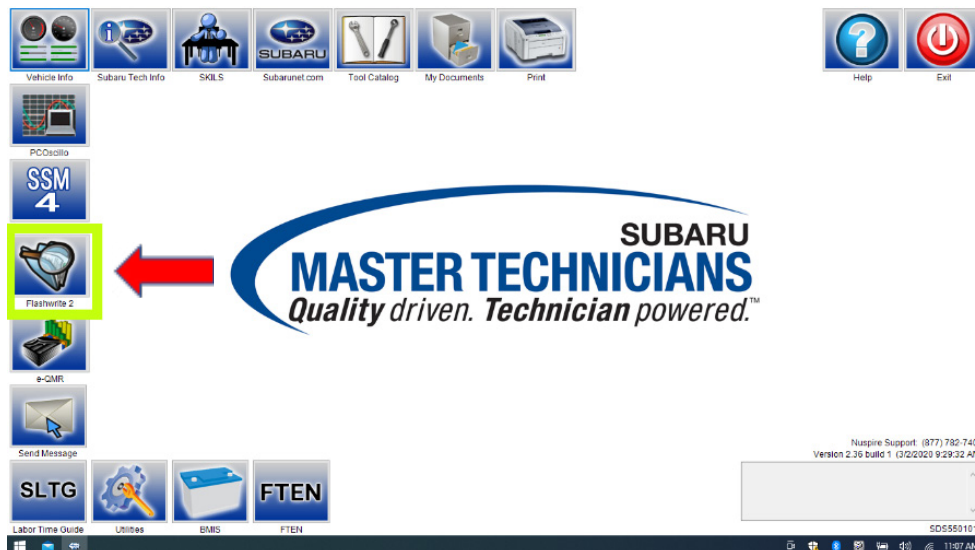
1. Connect the SDS Notebook and DSTi. Select **FlashWrite2** from the SDS Notebook GUI screen.

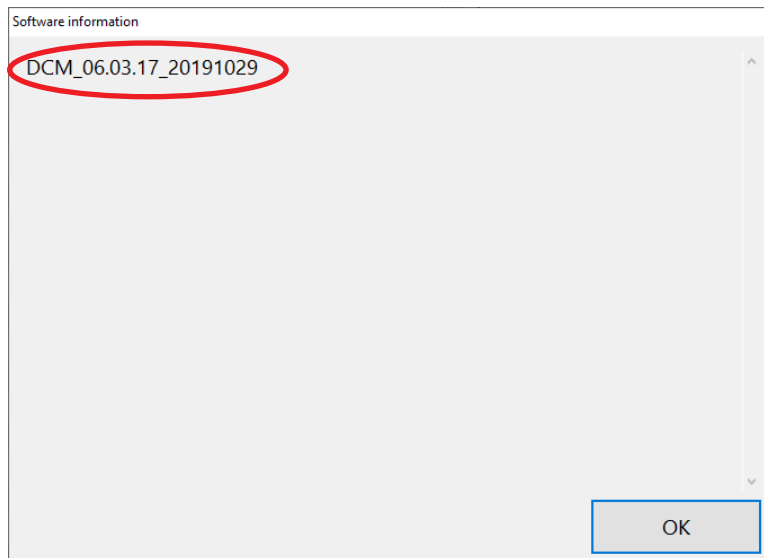
- a) Confirm SSM4 and DCM communication by retrieving the current software version.
- b) Click “Each System” on the left-hand menu.
- c) Select “Telematics” from the Systems List.
- d) Click “Work Support” on the left-hand menu.
- e) Select “Software Information” from the Work Support Items List.
- f) Record the current version of software on RO for reference.
 - i. After successful retrieval of the software version, proceed to **Step 14**.

NOTE: If SSM4 cannot communicate with DCM, DCM DTCs are current, or the DCM software version cannot be retrieved, contact Techline for assistance before proceeding.

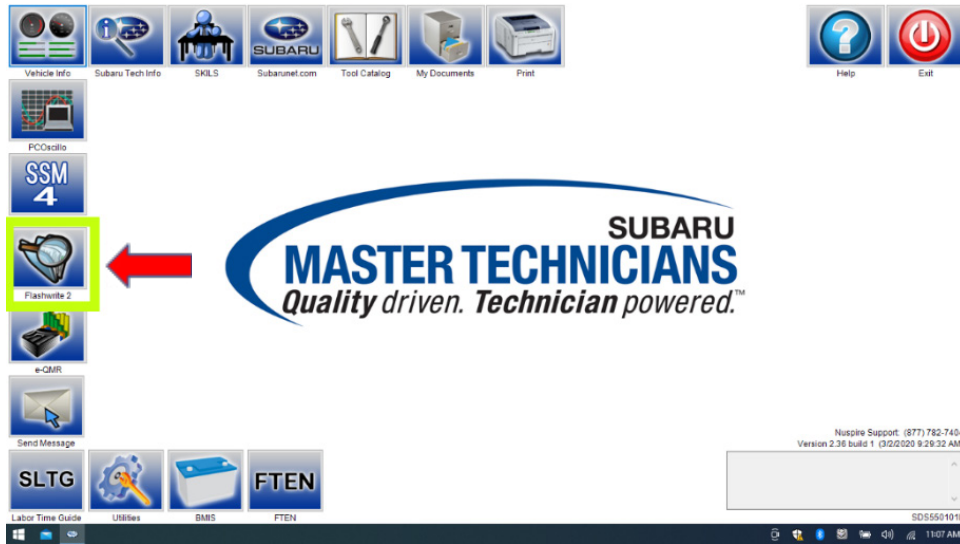
1. Connect SDS Notebook and DSTi. Select **FlashWrite2** from the SDS Notebook GUI screen.

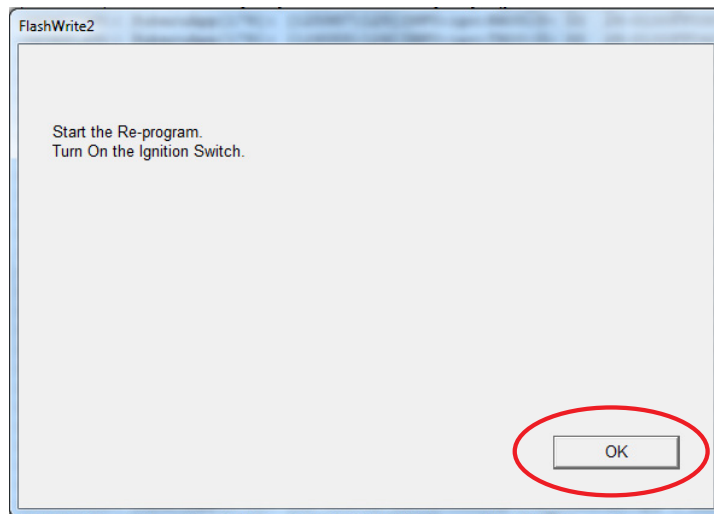
a) Turn the ignition switch ON and Click on ‘OK’ to start the reprogram.

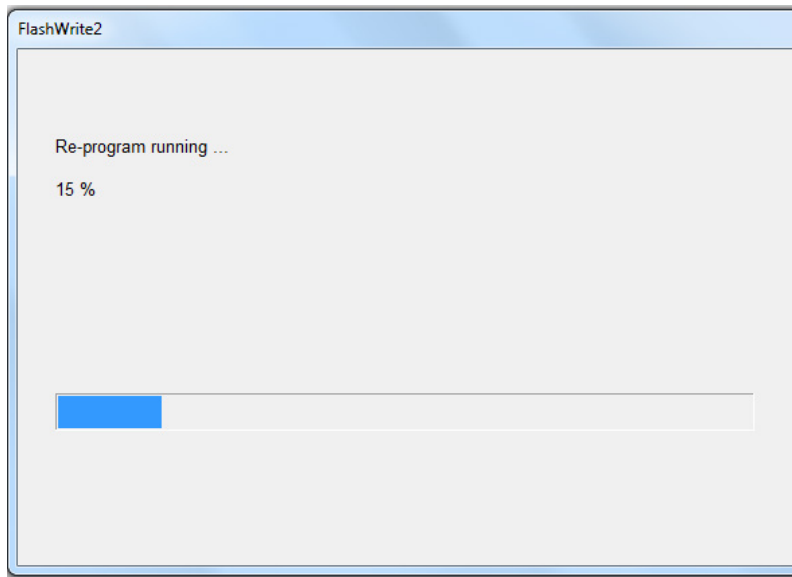
A CAN flashing progression bar will appear and start incrementing toward 100%. The update may take up to 60 minutes to complete.

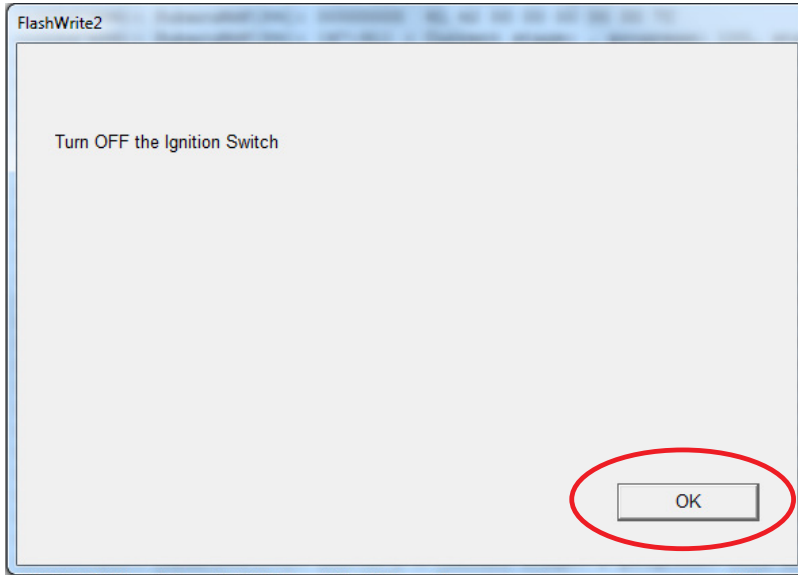
- c) **CRITICAL STEP:** After finishing the reprogramming, always put a CVT equipped vehicle in PARK. A prompt for toggling the ignition to OFF will be displayed. Click **OK**.

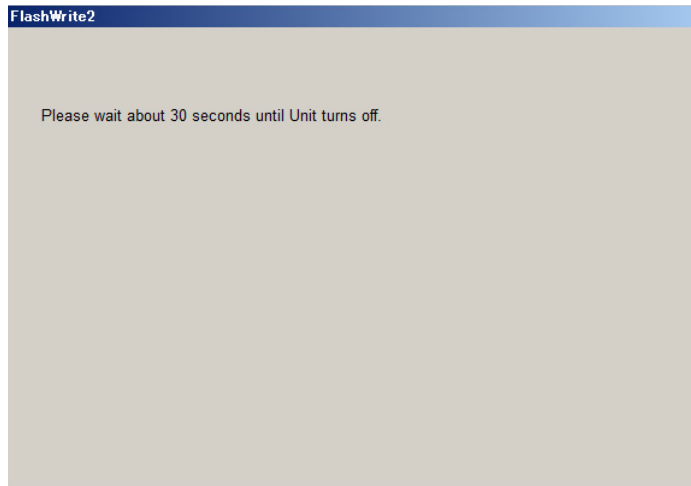
- d) **CRITICAL STEP:** FlashWrite will display the banner message “Please wait about 30 seconds until Unit turns off.”

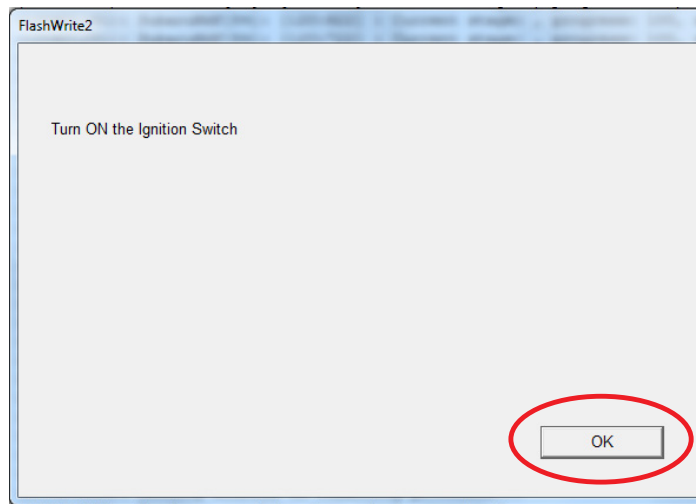
- e) The prompt for toggling ignition to ON will be displayed. Click on ‘OK.’

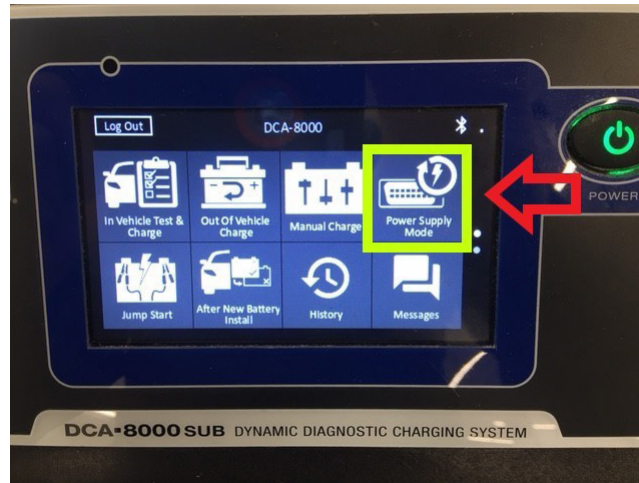
- **NEVER** connect the DST-i until the Power Supply Mode function has completed its battery test mode and the Charging Voltage has dropped to a steady 13.5 Volts on the display.
- Once Power Supply Mode reaches a steady 13.5 volts, connect the DST-i to the OBD connector.
- **If the battery voltage rises above 14V while the reprogramming is in process, the procedure will abort.** Charging voltage above 14V can indicate a need to test or charge the vehicle battery before any further reprogramming attempt is made.

CRITICAL: Power Supply Mode voltage must be stabilized at **13.5** Volts before proceeding.
