WMA6 - Updating Software for Various Control Units ((Workshop Campaign)

Model Year: 2021

Model Line: Taycan (Y1A)

Concerns: Software update (software version VR12.1.1)

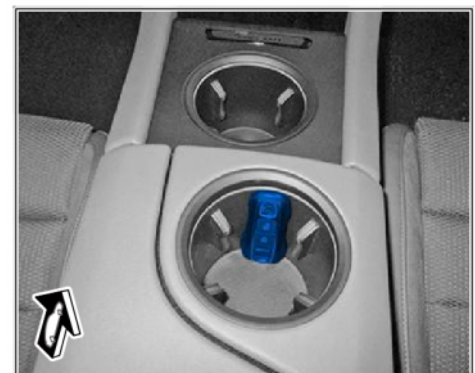
Emergency start tray

2 Position the **driver's key** with the back facing forward upright between the holding struts in the rear cupholder (**emergency start tray**) to guarantee a permanent radio link between the vehicle and remote control ⇒ *Emergency start tray*.
