Complaint – Charging is Canceled / Check Engine Warning Light is Active: Re-Program High-Voltage Charger (OBC) Control Unit (36/21)

Vehicle Type: **Panamera 4 E-Hybrid (971)**
Panamera 4S E-Hybrid (971)
Panamera Turbo S E-Hybrid (971)

Concerns: **High-voltage charger (OBC) control unit**

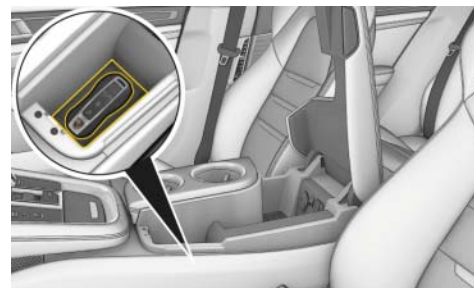
Emergency start tray

- Work Procedure: 1 Place the driver's key with the back facing down into the front left storage compartment in the center console (emergency start tray) to guarantee a continuous radio link between the vehicle and the driver's key ⇒ *Emergency start tray*.
- 2 Carry out general preliminary work for control unit programming as described in ⇒ *Workshop Manual '9X00IN Basic instructions and procedure for control unit programming - section on "Preliminary work"*.

- If the driver's key is not recognized in the vehicle, programming cannot be started or will be interrupted.
- ⇒ Place the driver's key with the back facing down into the front left storage compartment in the center console to guarantee a continuous radio link between the vehicle and the driver's key.

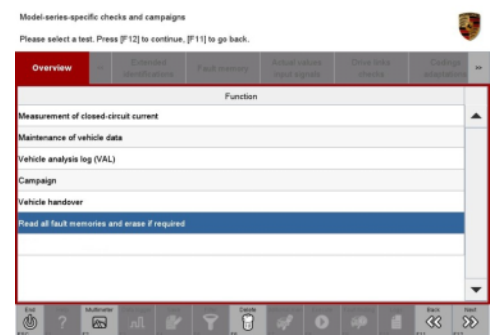
Erasing fault memories

- 2.1 Press **•F7** in the control unit selection screen ('Overview' menu) to call up the Additional menu.
- 2.2 Select the function 'Read all fault memories and erase if required' and press **•F12** ('Next') to confirm your selection ⇒ *Erasing fault memories*.

- 2.4 Press **•F8** to delete fault memory entries.

- 2.5 Press •F12“ ('Yes') in response to the question asking whether you really want to delete all fault memory entries.

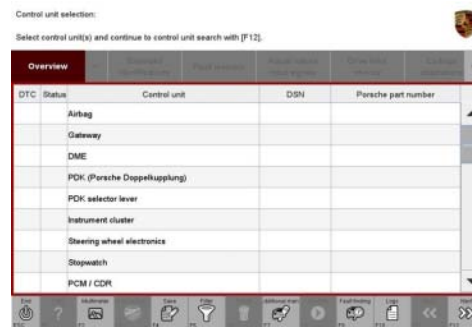
Control unit selection

- 2.6 Once you have erased the fault memories, select the **'Overview'** menu to return to the control unit selection screen ⇒ *Control unit selection*.
