**Complaint – Charging is Canceled / Check Engine Warning Light is Active: Re-Program High-Voltage Charger (OBC) Control Unit (36/21)**

Vehicle Type: **Cayenne E-Hybrid (9YA / 9YB)  
Cayenne Turbo S E-Hybrid (9YA / 9YB)**

Concerns: **High-voltage charger (OBC) control unit**

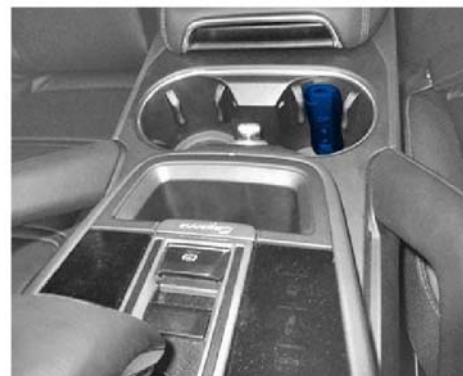
*Emergency start tray*

- Work Procedure: 1 Position the driver's key in the rear area of the left cupholder in the center console between the holding struts (emergency start tray) in order to guarantee a permanent radio link between the vehicle and driver's key ⇒ *Emergency start tray*.
- 2 Carry out general preliminary work for control unit programming as described in ⇒ *Workshop Manual '9X00IN Basic instructions and procedure for control unit programming - section on "Preliminary work"*.

- If the driver's key is not recognized in the vehicle, programming cannot be started or will be interrupted.
- ⇒ Place the driver's key with the back facing down into the front left storage compartment in the center console to guarantee a continuous radio link between the vehicle and the driver's key.

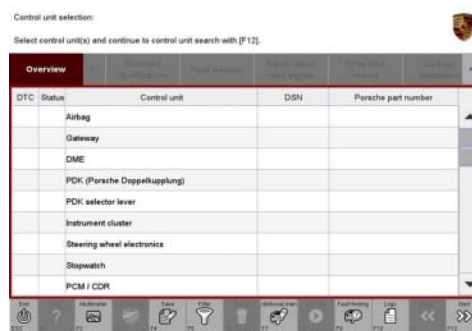
*Control unit selection*

2.6 Once you have erased the fault memories, select the '**Overview**' menu to return to the control unit selection screen ⇒ *Control unit selection.*

- 2.1 Press **•F7** in the control unit selection screen ('Overview' menu) to call up the Additional menu.
