WMA5 - Updating Software for Various Control Units (Workshop Campaign)

Model Year: 2020

Model Line: Taycan (Y1A)

Concerns: Software update (software version VR12.1.1)

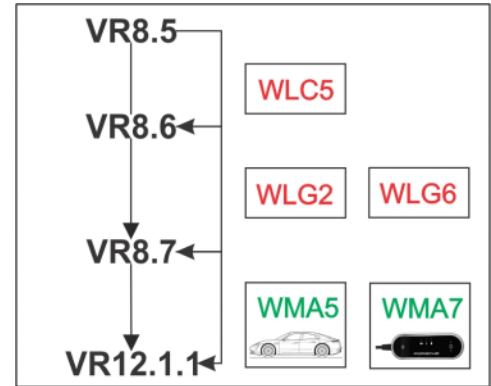
Evolution Taycan Software Versions

Overview of control units for software version VR12.1.1			
Control unit	Programming time	Action required	
		program	code
<p>Sequence 1: Combined software update for various control units (Update via PIWIS Tester)</p> <p>Includes:</p> <ul style="list-style-type: none"> Distance measuring sensor control unit (ACC) Front-end electronics control unit (BCM1) Rear-end electronics control unit (BCM 2) Radar sensor for front corner radar Lane Change Assist control unit, left and right Central control unit for assistance systems (zFAS) Airbag control unit Reversing camera Interior surveillance sensor Seat occupancy detection Weather sensor 	approx. 125 minutes		
		■	■
		■	■
		■	■
		■	■
		■	■
		■	■
		■	■
		■	■
		■	■
		■	■
		■	■
		■	■
		■	■

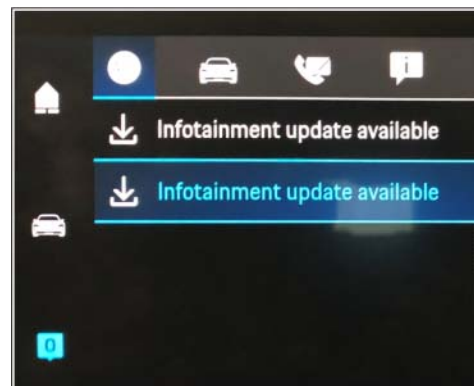
Infotainment update in central display

After carrying out the campaign, please inform customers that Infotainment updates are available via the central computer (PCM) and provide them with any help and support they need during installation ⇒ *Infotainment update in central display*.

These updates are only available if the customer has logged in on the vehicle using his/her main user credentials (Porsche ID). Several updates are available depending on equipment and these must be installed one after the other in steps. It can take several minutes to install these. New functions can only be used when all updates have been completed and the vehicle has established bus idle for at least 15 minutes.

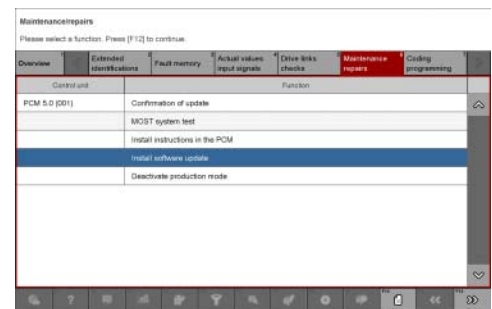
Installing PCM 6.0 software update

- 5.6 Once the PCM central computer control unit has been found and is displayed in the 'Overview', select the **'Maintenance/repairs'** menu.
- 5.7 Select the **'Install software update'** function and press •F12" ('Next') to perform the software update ⇒ *Installing PCM 6.0 software update*.

- 5.8 Confirm the information that is displayed by pressing •F12" ('Next').
- 5.9 After meeting the preconditions, confirm by ticking the 'Status' column. Then, press •F12" ('Next') to continue.

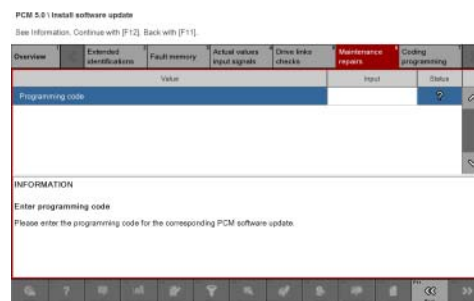
Entering PCM 6.0 programming code

5.10 Enter the programming code **K4M4S** in the relevant column ⇒ *Entering PCM 6.0 programming code* and press •F12" ('Next') to confirm ⇒ *Entering PCM 6.0 programming code*.

Once the update has started, the PCM is restarted in the Update menu and the individual components are then updated.

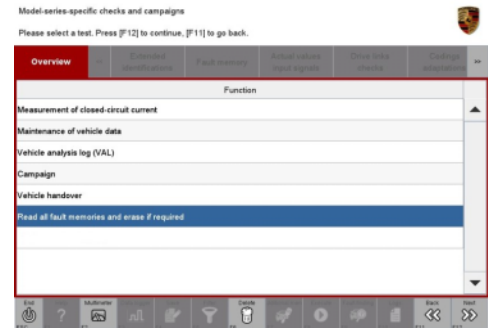
Erasing fault memories

If fault memory entries for individual control units cannot be deleted, proceed as follows:

- End operational readiness (switch off ignition).
- Disconnect the PIWIS Tester diagnostic connector from the diagnostic socket.
- Lock the vehicle using the driver's key and remove the driver's key from the proximity of the vehicle (approx. 10 meter/ 32.8 ft).
- Unlock the vehicle again after waiting for at least 15 minutes.
- Restore operational readiness (switch on ignition).
- Plug the PIWIS Tester diagnostic connector into the diagnostic socket again and restore communication with the vehicle.
- Read out the fault memory again and delete any fault memory entries that are stored.

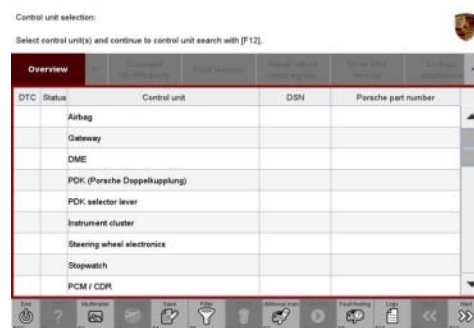
Control unit selection

9.6 Once you have erased the fault memories, select the **'Overview'** menu to return to control unit selection ⇒ *Control unit selection*.

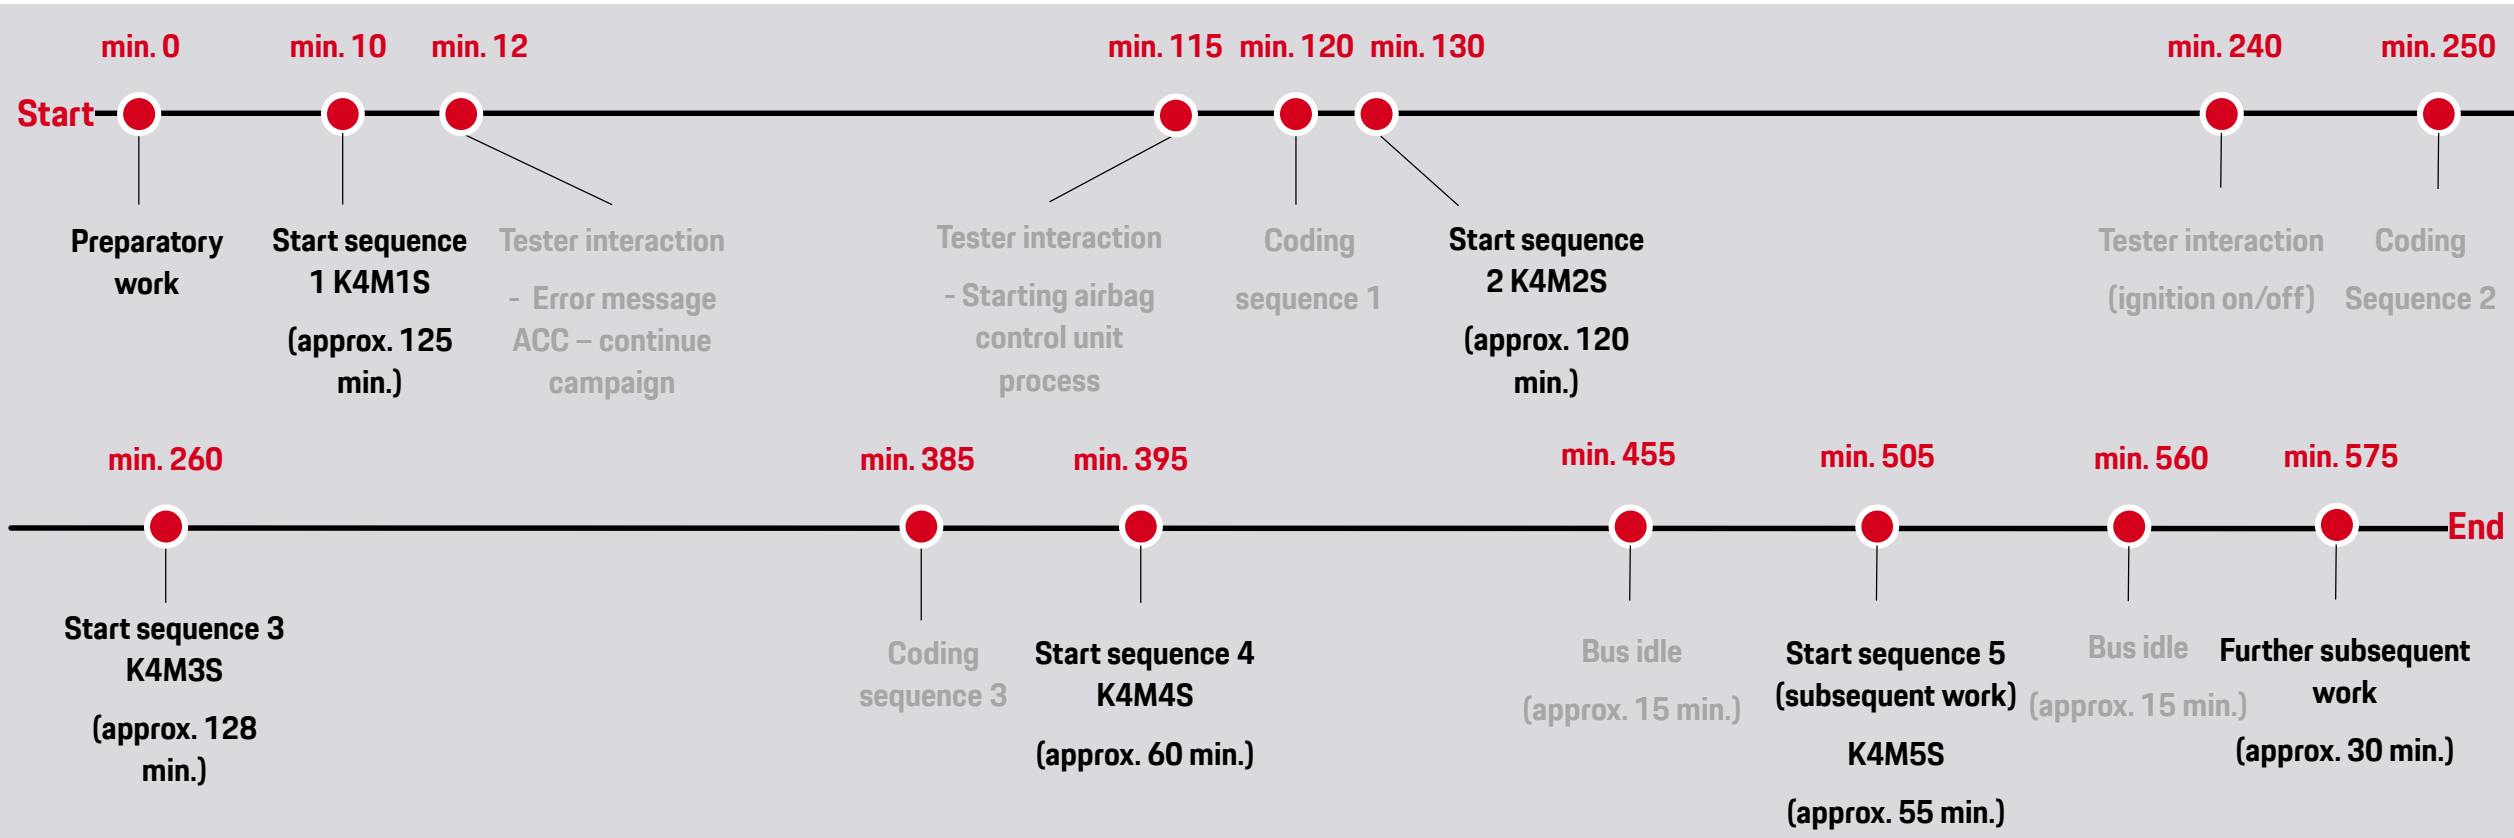
Rough time schedule supplement for workshop campaign WMA5 – Scope 3

Please note that this chart only represents a supplement to Technical Information WMA5 (TI 15/21). The listed times are for orientation purposes only and may vary depending on vehicle equipment.
