<b>Subject:</b>  <b>CONNECTED VEHICLE SYMPTOM TROUBLESHOOTING</b>	<b>Service Alert No.:</b> SA-013/21
	<b>Last Issued:</b> 03/15/2021

**IMPORTANT NOTE:** Some 2020 Mazda3 vehicles may have incorrect infotainment software version 10042 installed. The incorrect software will cause MyMazda App Connected Vehicle enrollment errors. Go to [SSPC1](#).

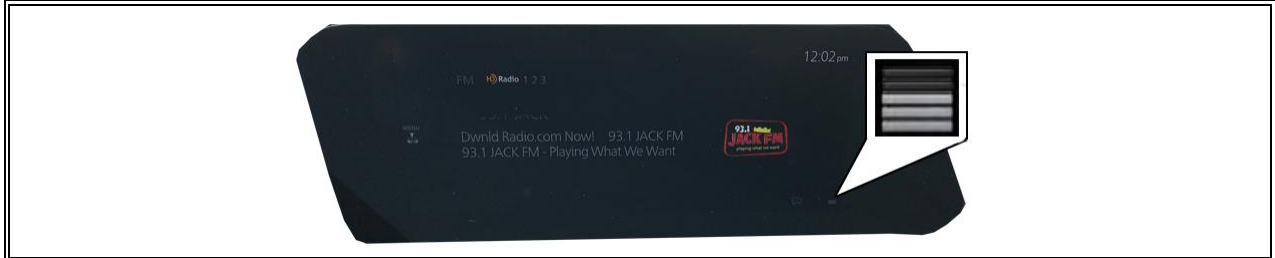
Confirm the customer's phone and vehicle have good to strong reception during the concern as shown in the table below.

Indication	Explanation

Radio waves are not being received. Move to a location with good reception.

Weak reception.

Good Reception

Strong reception.

Currently conducting an operation check of the communication unit. If this condition continues, consult an Authorized Mazda Dealer.

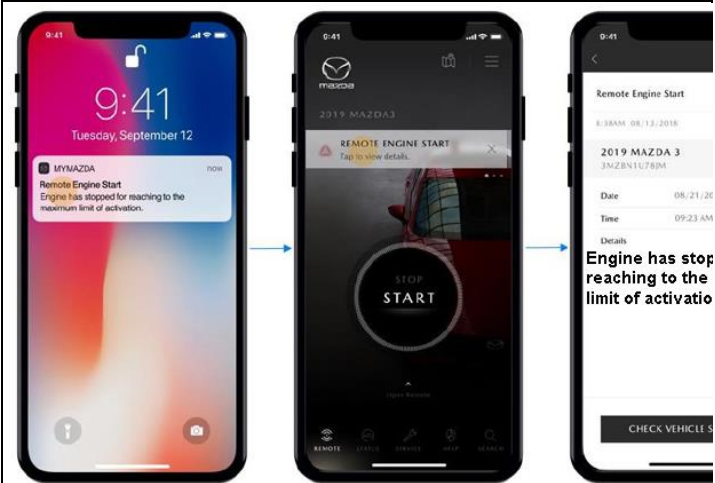
Customer Complaint	Action
<ol style="list-style-type: none"> <li>1. Vehicle Center Display does not provide the Authorization Code during the MyMazda App Connected Vehicle enrollment.</li> <li>2. Remote function(s) inoperative.                             <ol style="list-style-type: none"> <li>1. Engine Start / Stop</li> <li>2. Door Lock / Unlock</li> <li>3. Lights ON / OFF</li> </ol> </li> </ol>	<p>Go to Step 2.</p> <p><b>NOTE:</b> The customer can view the reason for remote function failure.</p> <p><b>Example 1 (Push notification)</b></p>

<table border="1"><tr><td data-bbox="735 203 1003 319"><b>OS Lock Screen</b> Tap the push notification</td><td data-bbox="1003 203 1198 319"><b>Home</b> Tap the alert card</td><td data-bbox="1198 203 1446 319"><b>Inbox Detail</b> Tap "check vehicle status"</td></tr></table> <p><b>Example 2 (Activity History)</b></p>

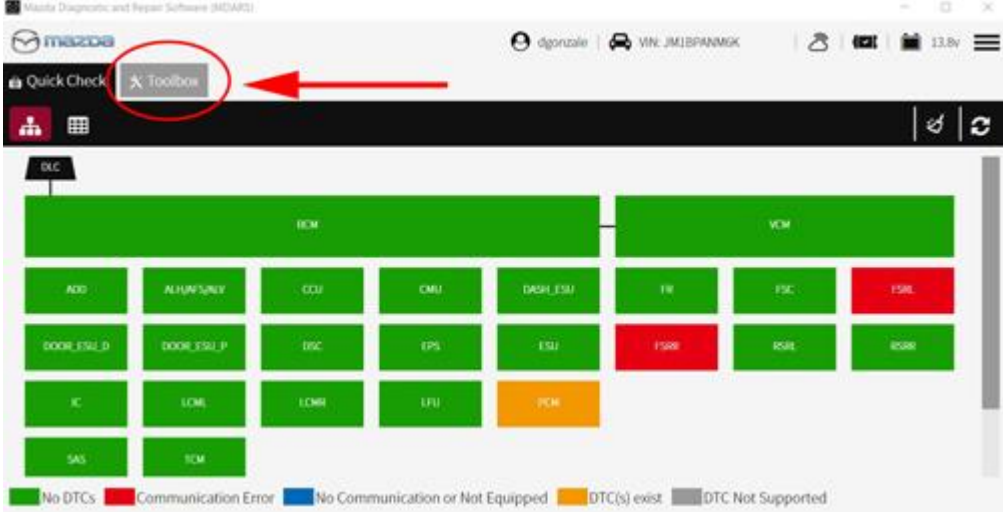
<p>1. ID the vehicle using MDARS</p>	<p>---</p>
<p>2. Select "Toolbox"</p>

<p>The screenshot shows the Mazda MDARS software interface. At the top, there is a navigation bar with 'Quick Check' and 'Toolbox' buttons. The 'Toolbox' button is circled in red, and a red arrow points to it from the right. Below the navigation bar, there is a grid of colored buttons representing various vehicle systems: ECM, VCM, ADD, ALUW/SUNV, CCU, CMU, DASH_ESU, TR, FSC, FSR, DOOR_ESU_D, DOOR_ESU_P, EDC, EPS, ESU, FSR, RSR, RSR, IC, LCM, LCM, LFI, PCN, SAS, and TCM. A legend at the bottom indicates: Green for 'No DTCs', Red for 'Communication Error', Blue for 'No Communication or Not Equipped', Orange for 'DTC(s) exist', and Grey for 'DTC Not Supported'.</p>
<p>3. Select Vehicle Icon</p>

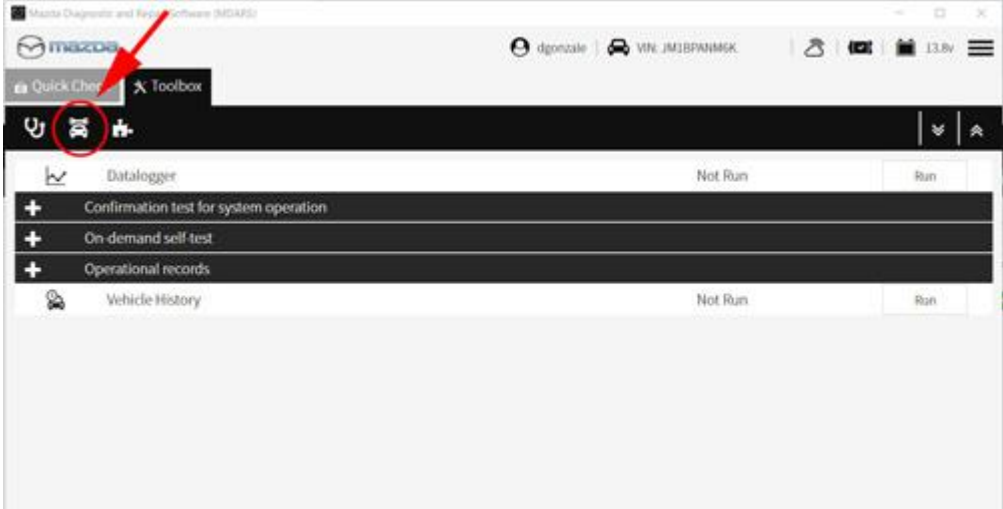
<p>The screenshot shows the Mazda MDARS software interface with the 'Toolbox' menu open. A red circle highlights the vehicle icon in the 'Toolbox' menu, with a red arrow pointing to it. Below the 'Toolbox' menu, there are sections for 'Datalogger' and 'Vehicle History'. The 'Datalogger' section has a 'Not Run' status and a 'Run' button. The 'Vehicle History' section also has a 'Not Run' status and a 'Run' button. The 'Datalogger' section includes expandable items: 'Confirmation test for system operation', 'On-demand self test', and 'Operational records'.</p>

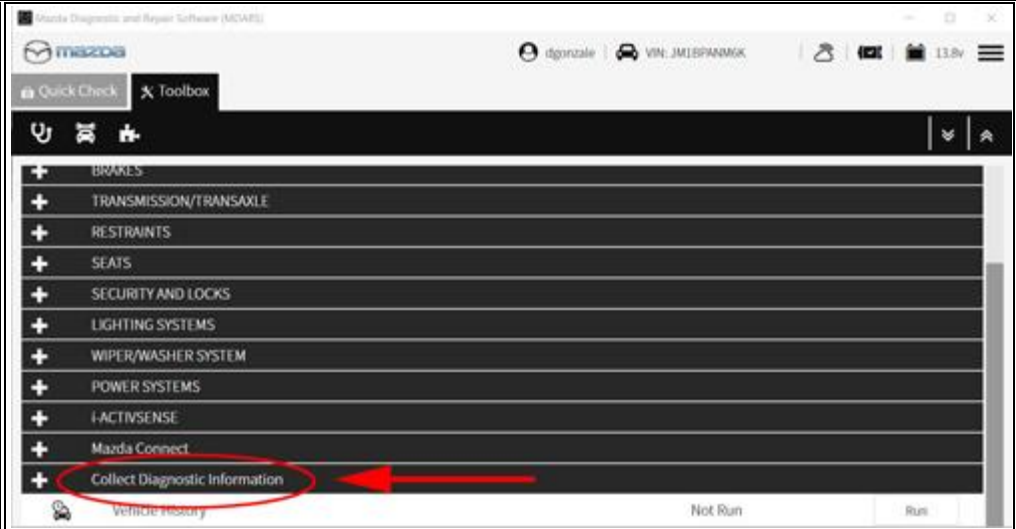
4. Select "Collect Diagnostic Information"

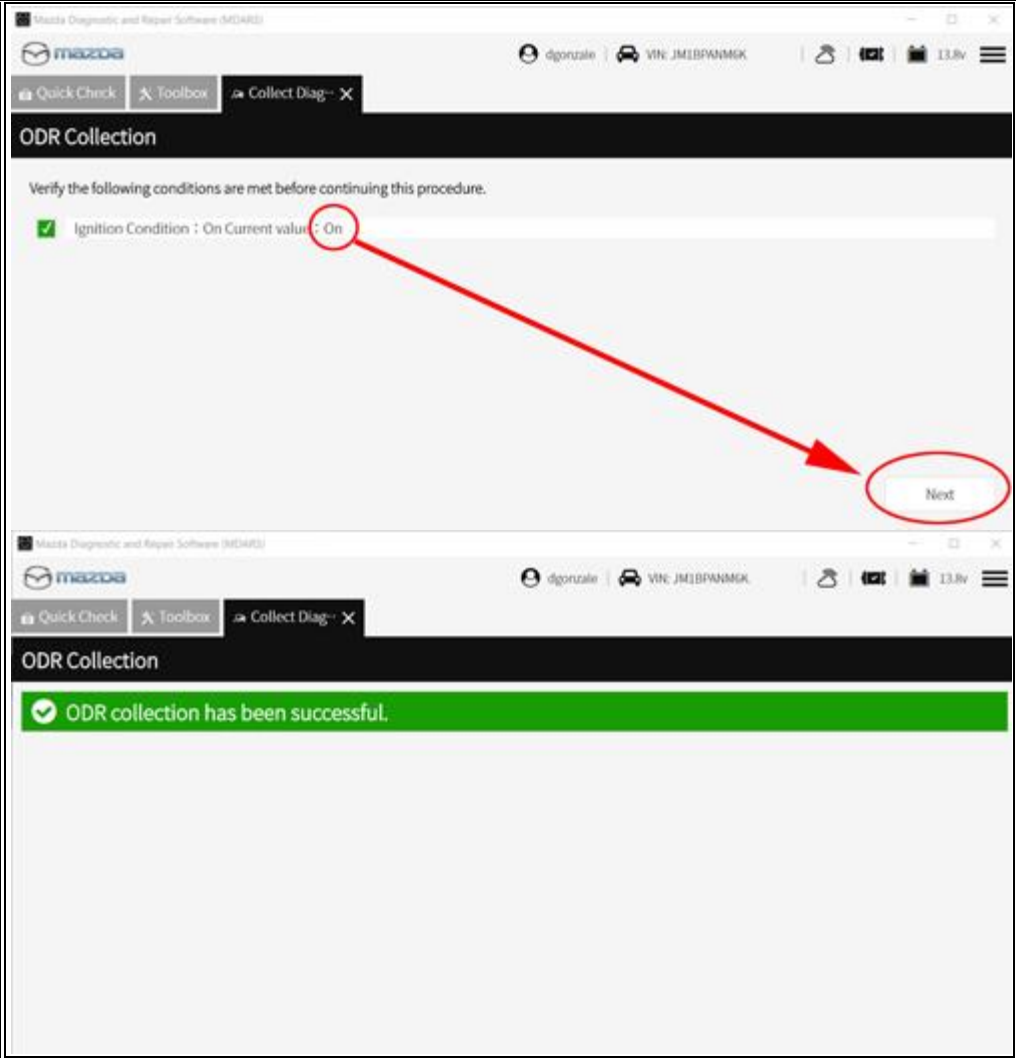
6. Turn Ignition ON,  
then select "Next"

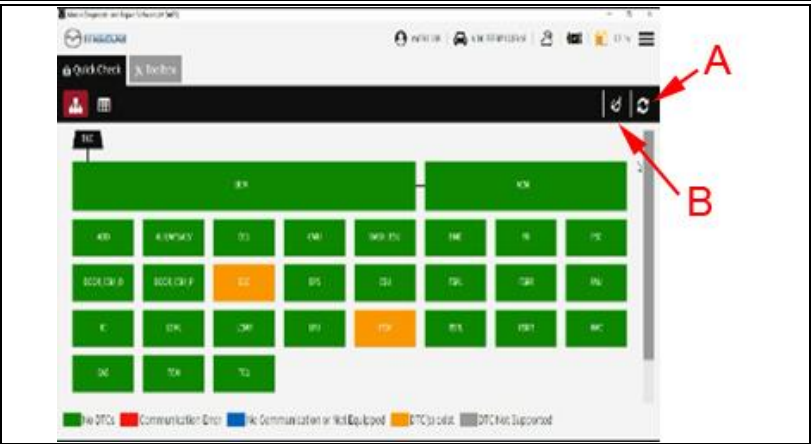
5. Select Quick Check (A), then start the engine and select the DTC Clear icon (B).

**CAUTION:** If the engine is not started, DTC P2610 is stored and cannot be erased.
