# Technical product information

<b>Topic</b>	Mulsanne Premium Audio Amplifier-No sound with DTC's-UD140600 and/or UD140B00
<b>Market area</b>	Bentley: worldwide (2WBE)
<b>Brand</b>	Bentley
<b>Transaction No.</b>	2062569/1
<b>Level</b>	EH
<b>Status</b>	Approval
<b>Release date</b>

## Technical background

The Premium Amplifier does not shut down when the vehicle ignition is deactivated, this is due to a missing or ignored message between the Amplifier Power Board and the Amplifier Main Controller

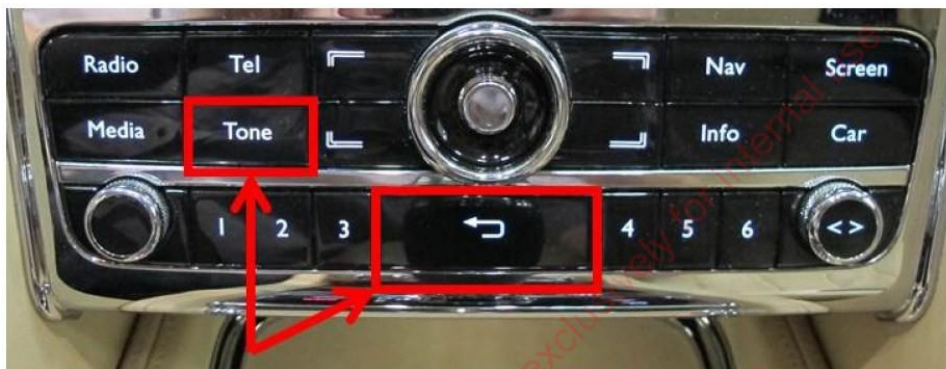
2) Referring to Figure 1 - Press and hold the “Tone” key on the Infotainment Control Panel and immediately press and hold the “back” key

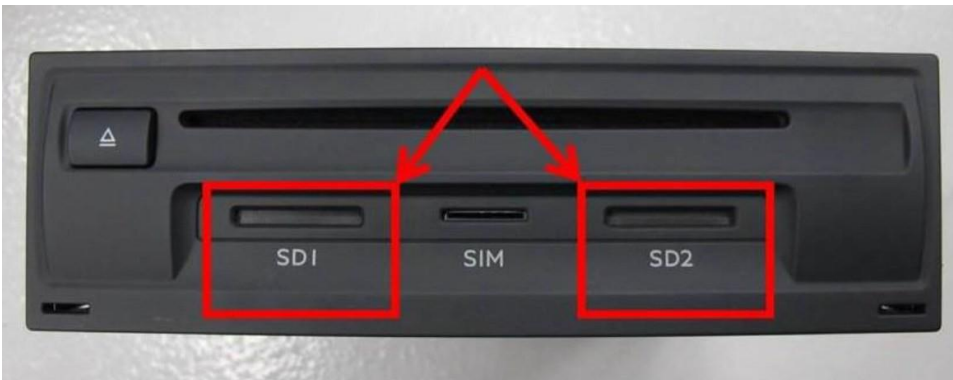
Figure 3

3) Insert the update SD card WT10380 – “SD CARD SW UPDATE AMP0120” - into the media unit located within the vehicle glove compartment (Figure 3)

NOTE: Media card reader SD1 or SD2 may be used for the update.

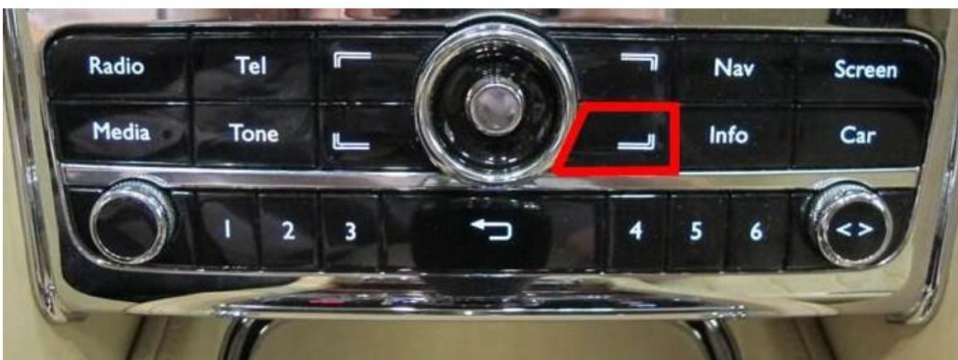
Figure 4

4) Press the lower right menu key on the on the Infotainment Control Panel to start the update (Figure 4)

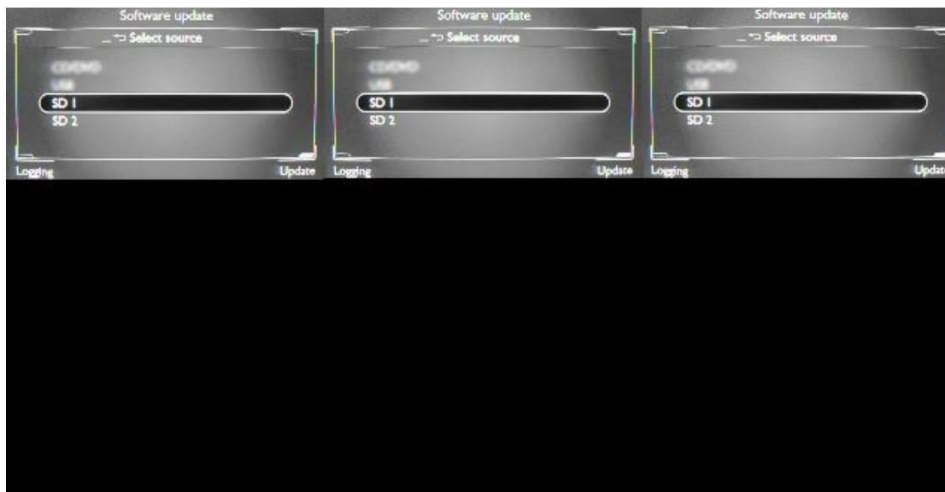
Figure 7

- Using the Rotary Push Knob, select the source location on the Infotainment Display Screen to correspond to the location of the SD Card within the Media Card Reader, depress the Rotary Push Knob to confirm the selection (Figure 7)

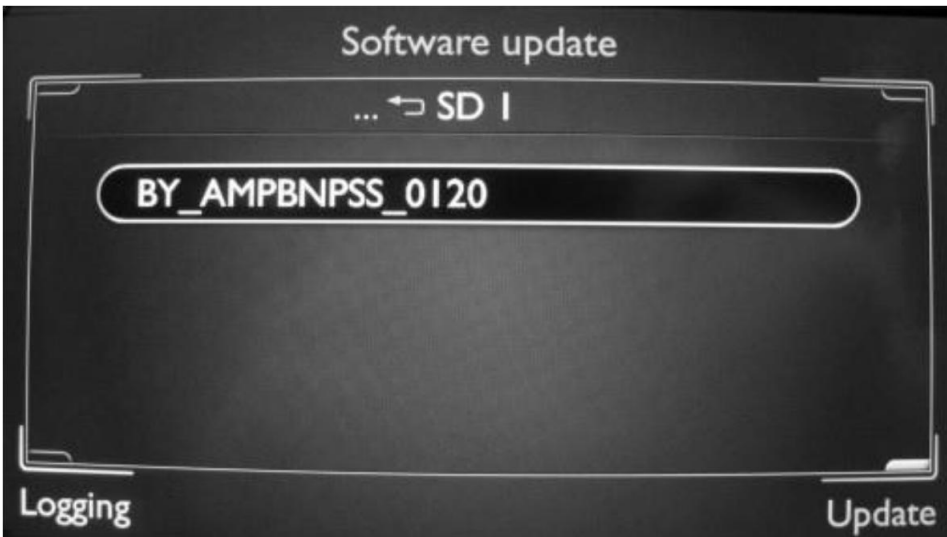
Figure 8

- Ensure the Infotainment Display Screen is showing the software –BY\_AMPBNPSS\_0120 (Figure 8)

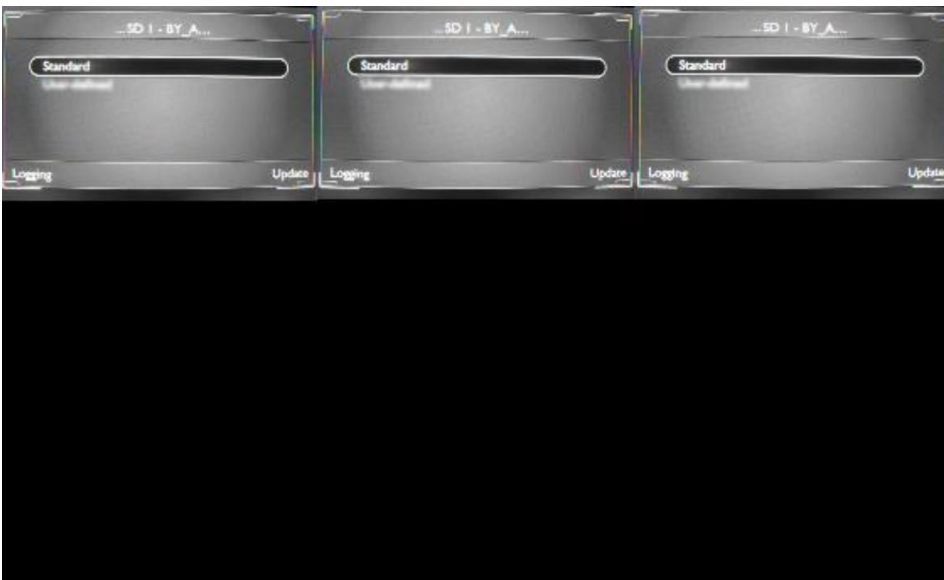
Figure 9

- When requested - Select "standard" (Figure 9) depress the Rotary Push Knob to confirm, then if requested select "start" and depress the Rotary Push Knob.

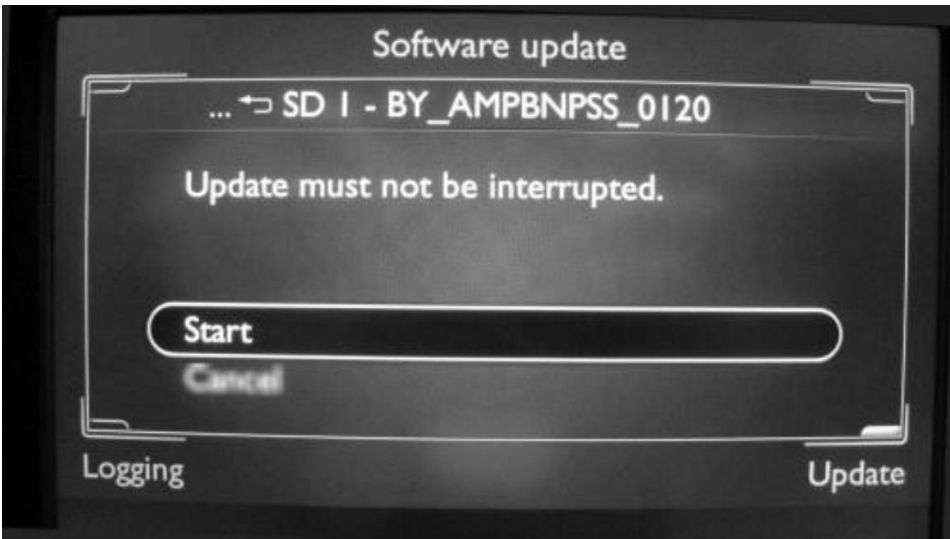
Figure 11

- Next, if requested, select "Start" - Depress the Rotary Push Knob (Figure 11)

NOTE – During the update process the “Update Progress” screen will show the percentage progression of the installation, the numerical values may increase and decrease during the update.

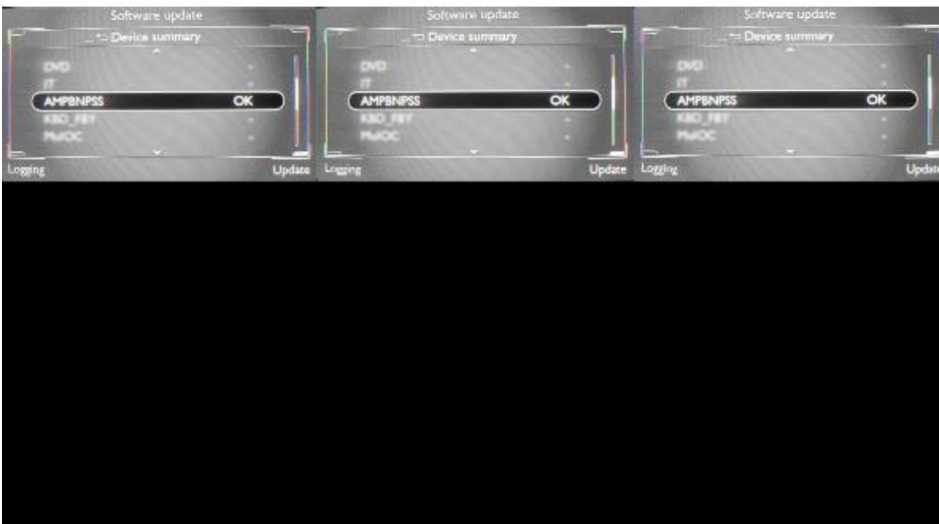
Figure 12

- Following the software installation and at the “Device Summary” screen scroll down and check AMPBNPSS is showing OK (Figure 12)

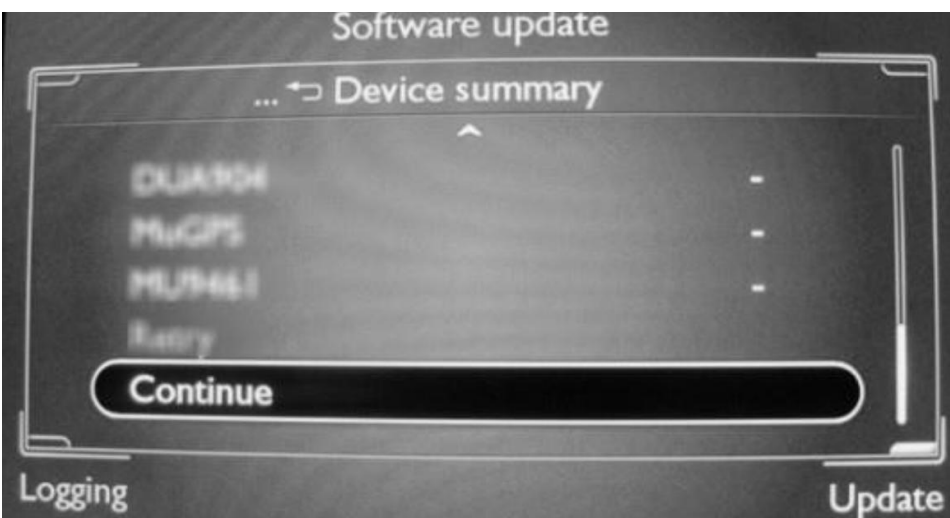
Figure 13

- Scroll down to “Continue” and depress the Rotary Push Knob (Figure 13)

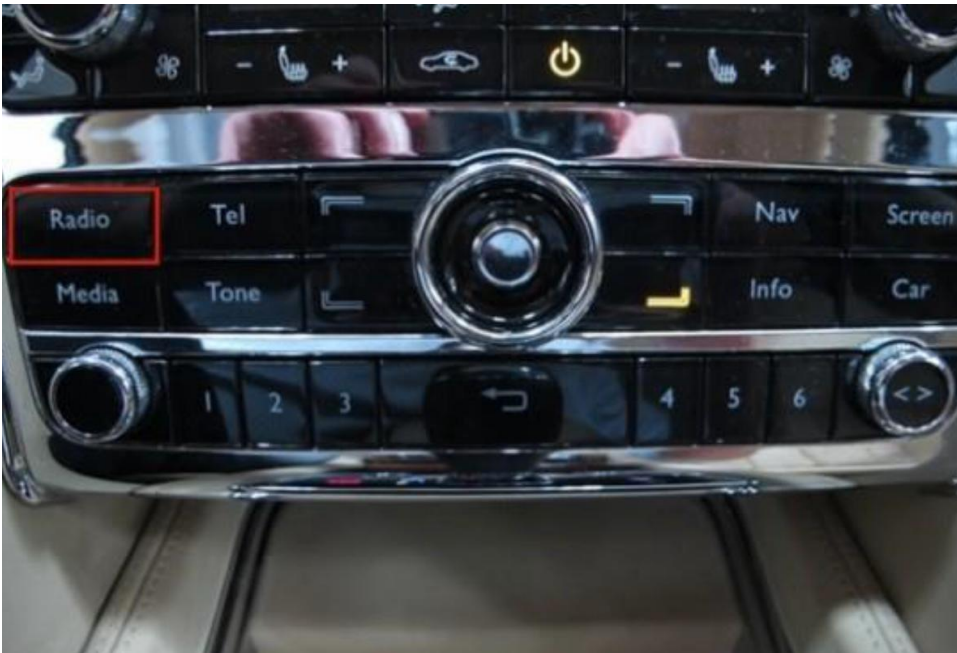
Figure 14

- Depress the “Radio” button on the Infotainment Control Panel and ensure audio output is present. (Figure 14)

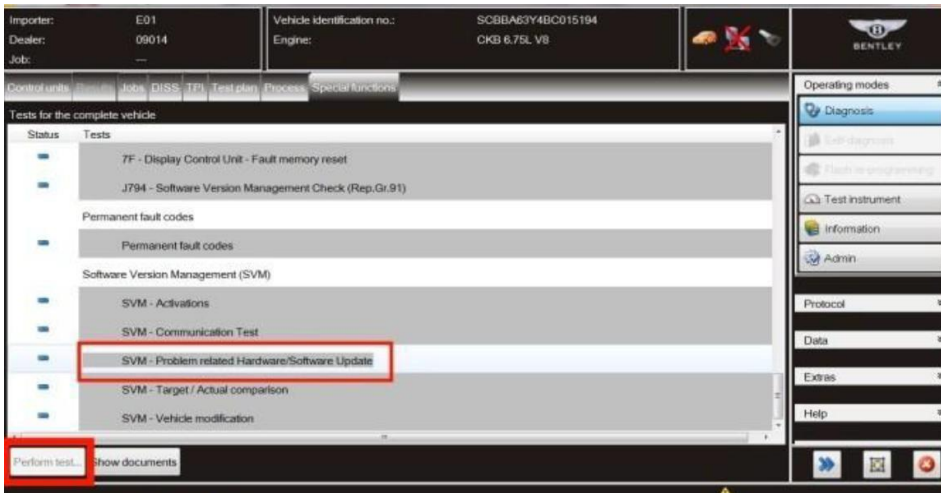
Figure 15

6) Select and run Guided fault finding. Within the Special functions tab select ‘SVM – Problem related Hardware/Software Update’ then select Perform test (Figure 15)

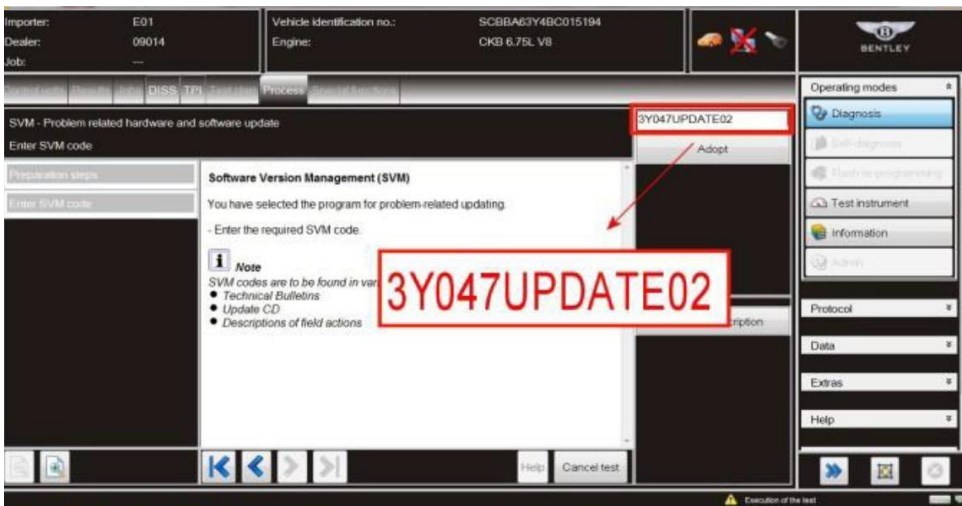
Figure 16

7) In the red box displayed on the diagnostic tool screen, type in the code 3Y047UPDATE02 and select “Adopt” (Figure 16)

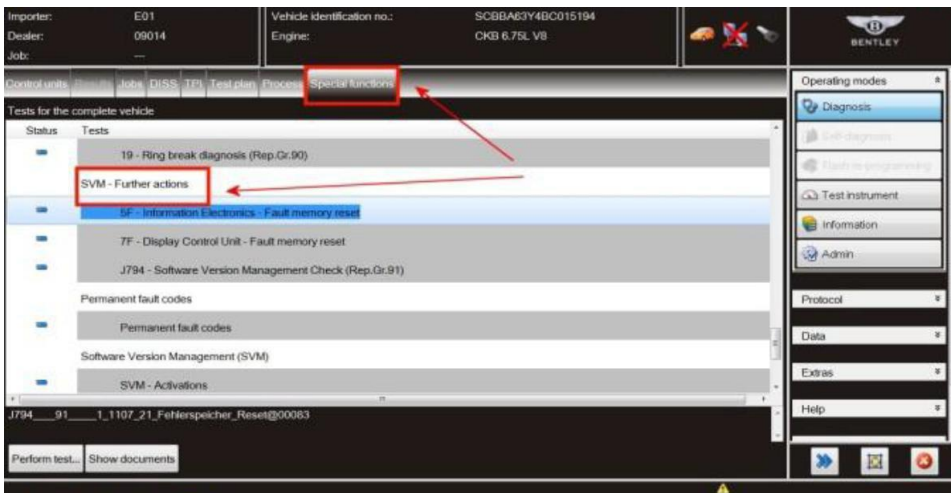
Figure 17

8) There is now a requirement to change control unit parameters – follow the on screen prompts until Programme End. Next select the “Special Functions” tab and scroll down to “SVM – Further Actions” (Figure 17)

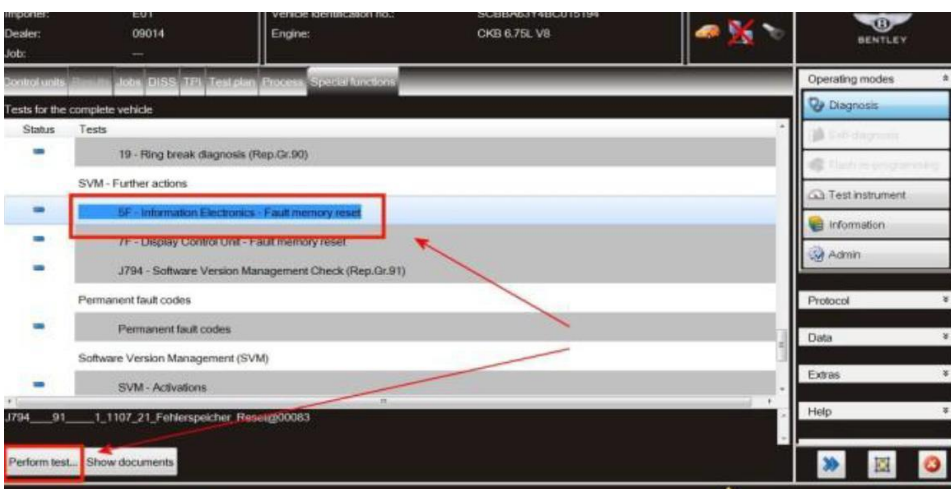
Figure 18

- Select “Information Electronics - Fault Memory Reset” and then select “perform test” (Figure 18) Follow the on screen prompts until End Of Test.
