# Technical product information

| <b>Topic</b> | New Continental GT and GTC- Repeat window drop glass concerns |
| <b>Brand</b> | Bentley |

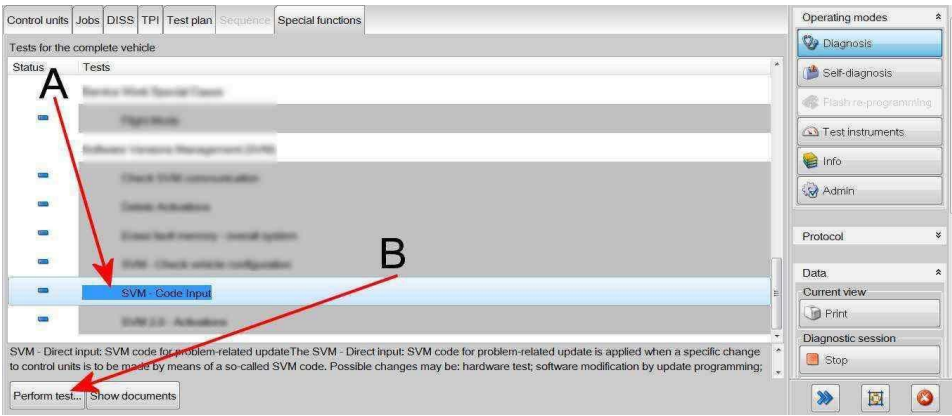
- Referring to Figure 1 - Within the Special functions tab - Select SVM- Code Input (Point A)
- Select Perform test (Point B)

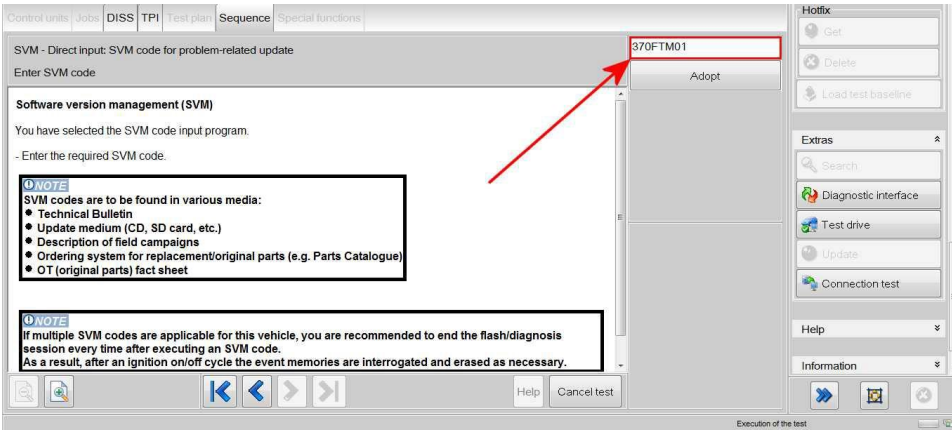
2) Referring to Figure 2 – Enter the SVM code 370FTM01

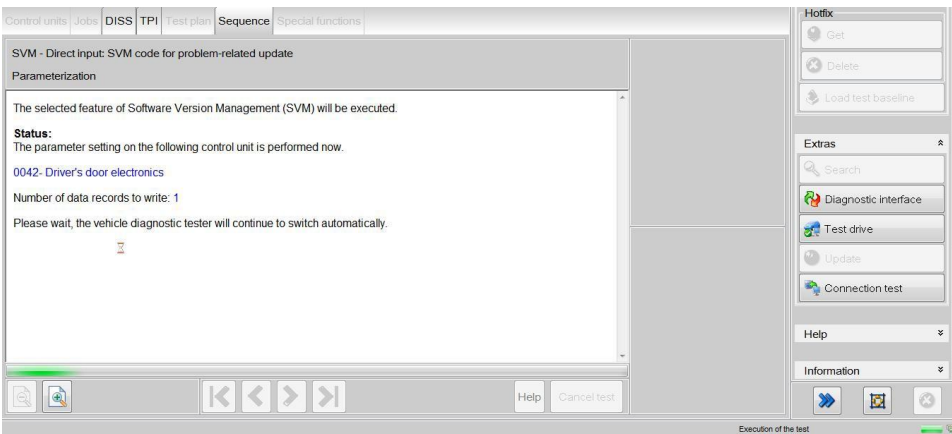
Figure 3

3) The Required control units will be automatically updated in the order shown in Figures 3 through to 6

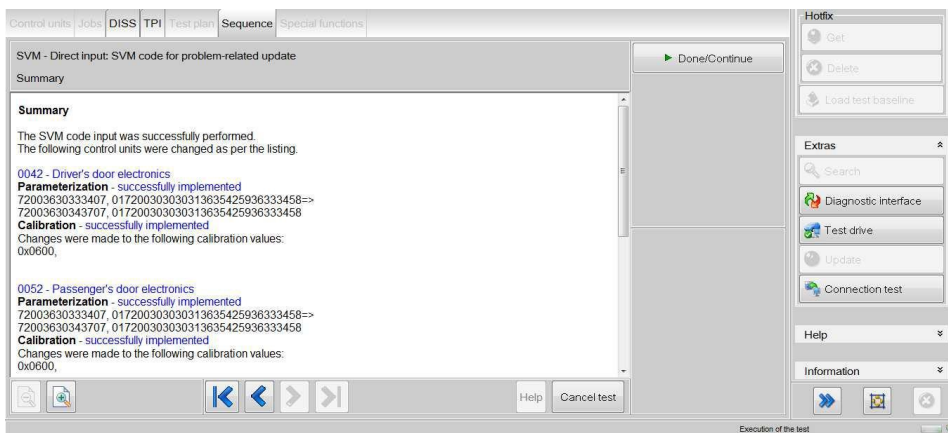
4) Once the update is complete the screen shown in Figure 7 will be evident
