Technical product information

Topic	New Continental GT and GTC- Repeat window drop glass concerns
Market area	Russische Föderation (5RU),Australia E04 Bentley rest Asia and Australia (6E04),China 796 VW Import Comp. Ltd (Vico), Beijing (6796),Germany E02 Bentley rest Europe (6E02),Japan E03 Bentley Japan (6E03),Korea, (South) E08 Bentley South Korea (6E08),United Arab Emirates E06 Bentley Middle East and Africa (6E06),United Kingdom E01 Bentley UK (6E01),United States E05 Bentley USA and rest America (6E05)
Brand	Bentley
Transaction No.	2062035/3
Level	EH
Status	Approval
Release date

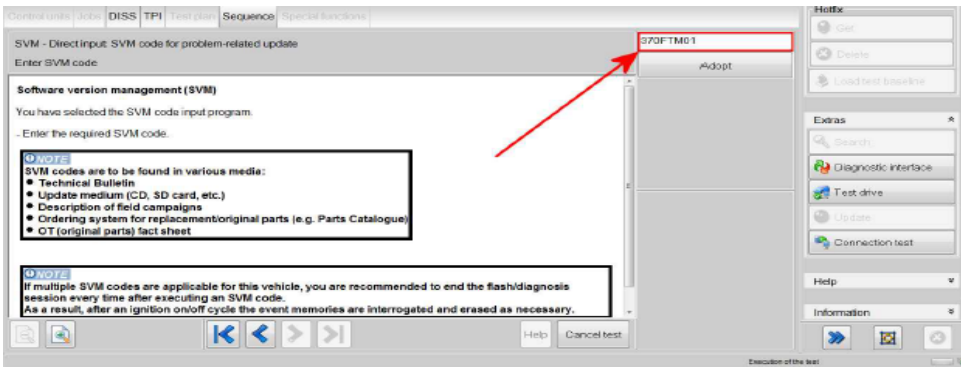
2) Referring to Figure 2 – Enter the SVM code 370FTM01

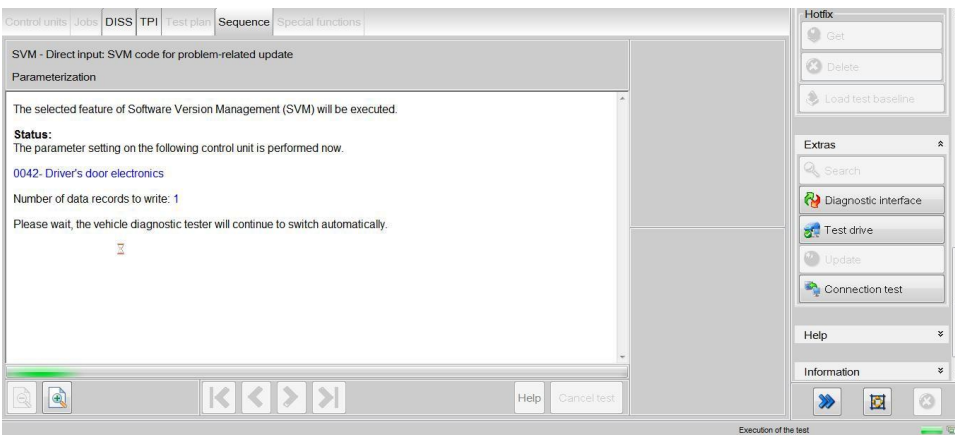
- When prompted enter your global user ID and password
 - Follow all on screen prompts to continue through the procedure, the identification data will be transferred
- 3) The Required control units will be automatically updated in the order shown in Figures 3 through to 6

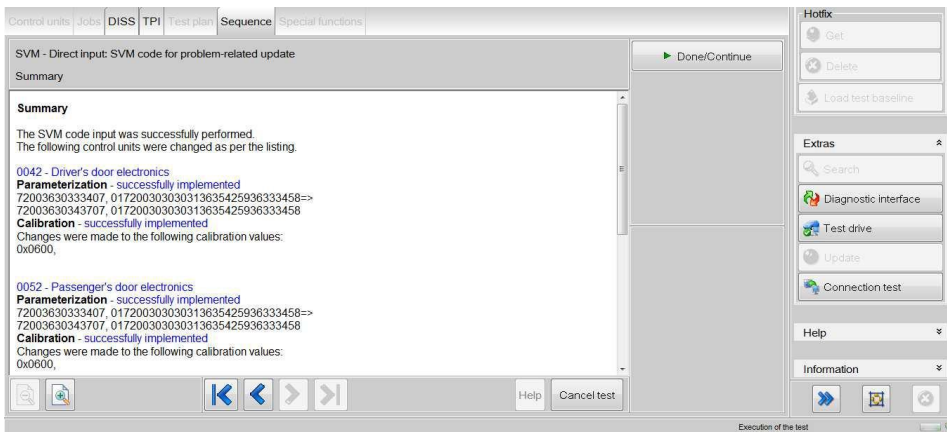
4) Once the update is complete the screen shown in Figure 7 will be evident
