# SERVICE BULLETIN

Classification: AN13-048G	Reference: NTB13-106G	Date: March 17, 2021
------------------------------	--------------------------	-------------------------

## CORRECT OPERATION OF AUDIO CONTROLS AND BACK-UP CAMERA REQUIRES CONFIGURATION WITH C-III PLUS

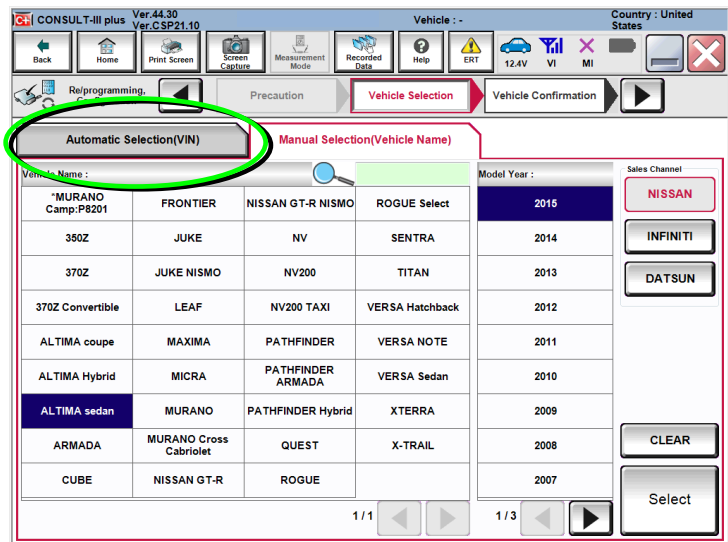
24. If the screen shown in Figure 16 is displayed, select **Automatic Selection(VIN)**.

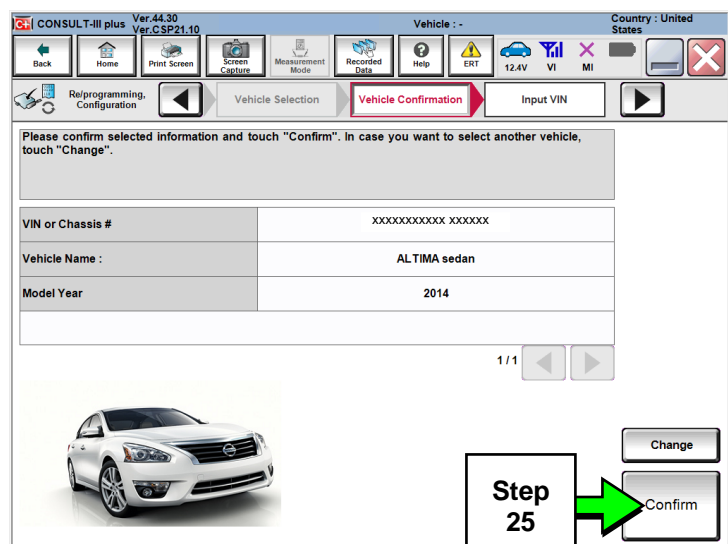
Figure 17

25. Confirm the correct **Vehicle Name** and **Model Year** are displayed.

When finished, select **Confirm**.
