SERVICE BULLETIN

Classification: AN20-036B	Reference: NTB20-080B	Date: March 12, 2021
------------------------------	--------------------------	-------------------------

SOFTWARE UPDATE FOR INFOTAINMENT ISSUES

APPLIED VEHICLES: 2019-2020 Altima (L34)
 2018-2020 Kicks (P15) – SV and SR
 2019-2020 Murano (Z52)
 2020 NV200 (M20)
 2020 Versa (N18) – SV and SR

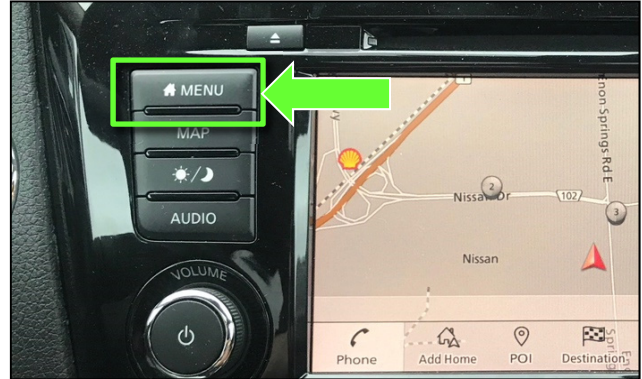
Figure 2

1. Push the **MENU** button.

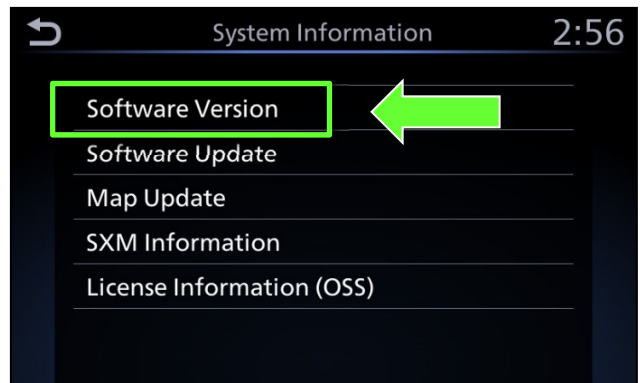
Figure 5

4. Select **Software Version**.

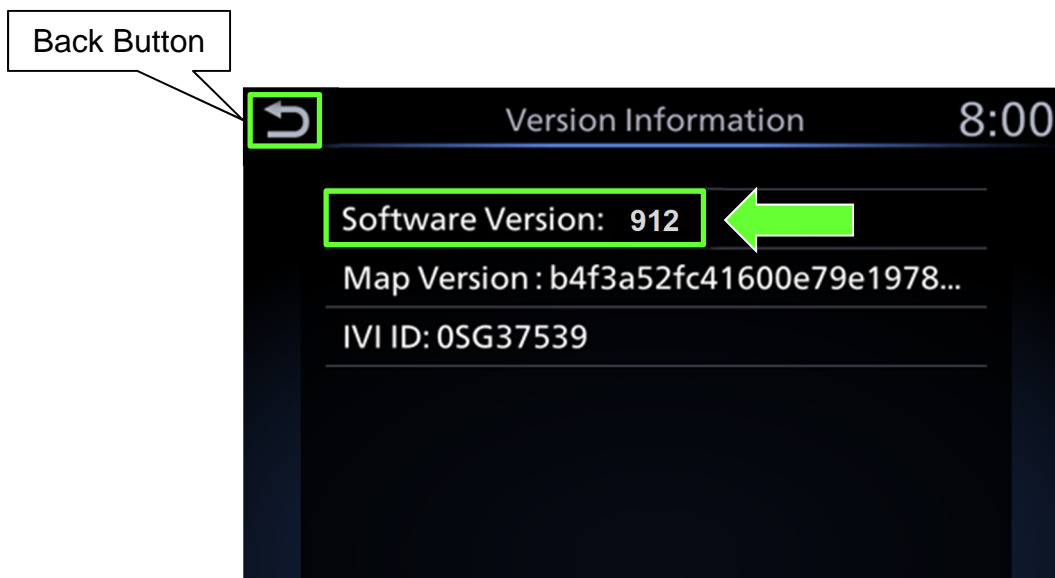
Figure 6

- If the Software Version is NOT a version listed in **Table A**, select the back button and continue to step 5 on the next page.
- If the Software Version is a version listed in **Table A**, select the back button, this bulletin **does not apply**.

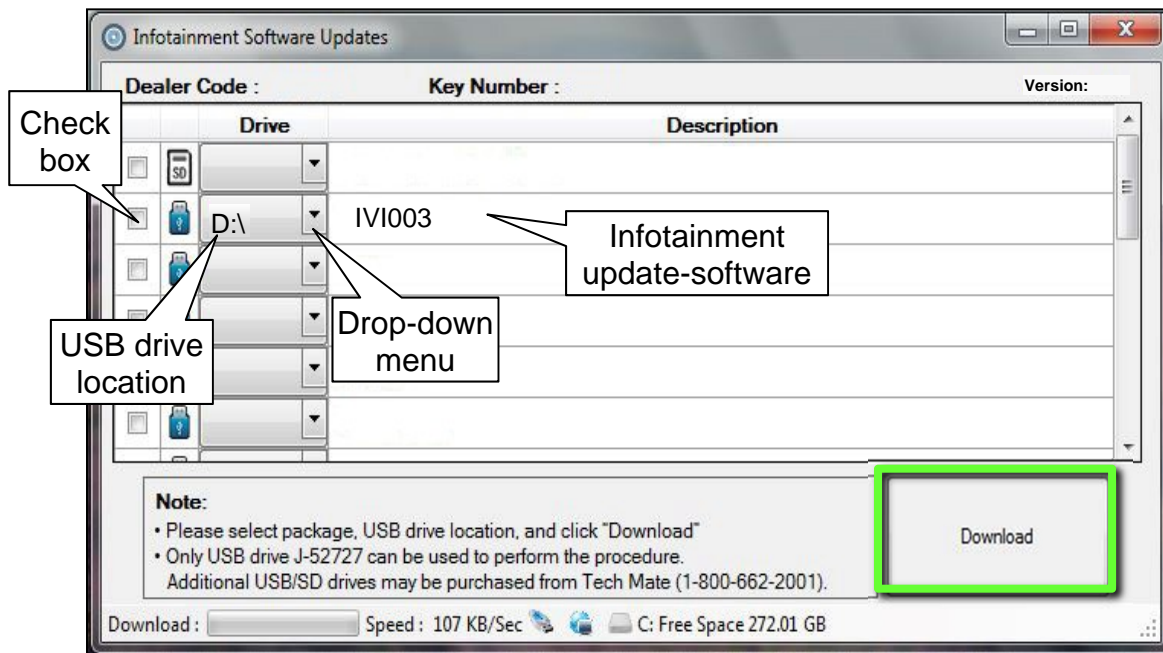
Figure 8

8. Select the check box next to the infotainment update-software ID (Figure 8).

9. Use the drop-down menu and select the location of the USB drive that was inserted in step 5.

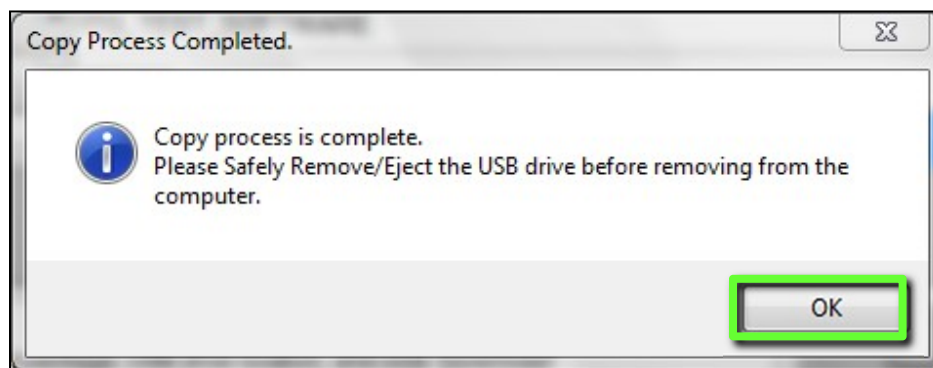
Figure 10

11. Select **OK**.

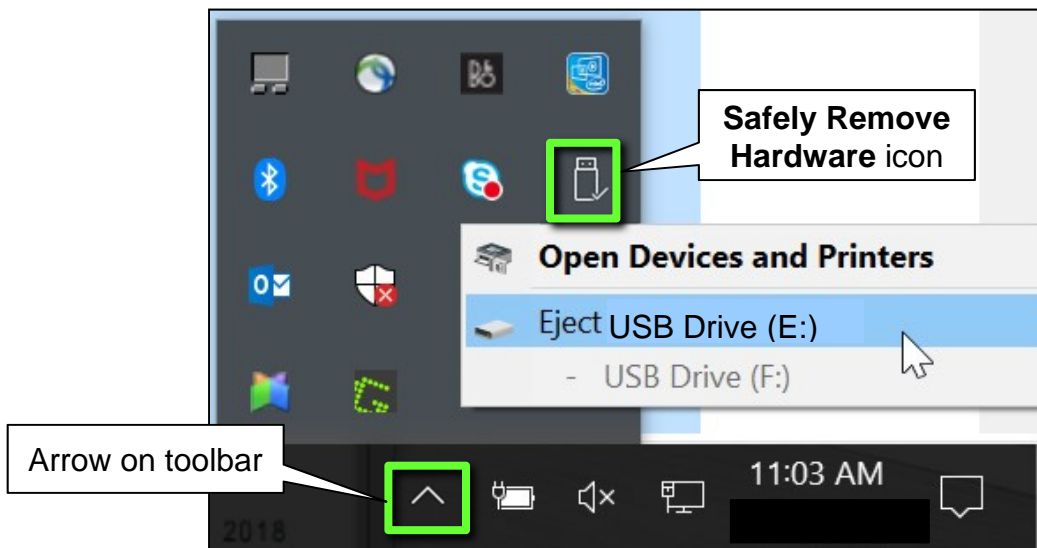
Figure 11

12. Once the transfer is complete, safely remove the USB drive from the ASIST Station.
 - a. From the PC toolbar, select the **Safely Remove Hardware** icon.
 - The icon is on the toolbar, or can be found after selecting the arrow.
 - b. Select the USB drive to be removed, and then remove the USB drive from the ASIST Station.

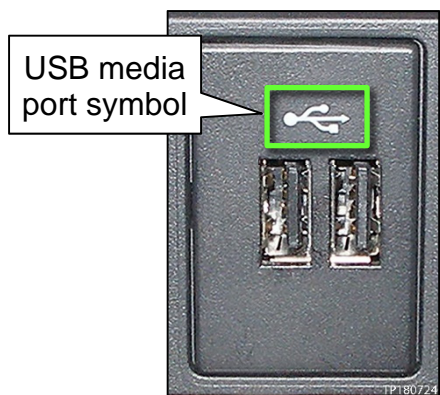
Figure 12

16. Insert the USB drive with the infotainment update-software into the vehicle's USB media port (see Figure 12).

HINT: Charging ports are marked in the vehicle with a “lightning bolt” symbol.

NOTICE Do not insert the USB drive into a charging port. If used, the update-software and/or USB drive may become damaged. Only insert the USB drive in a USB media port.

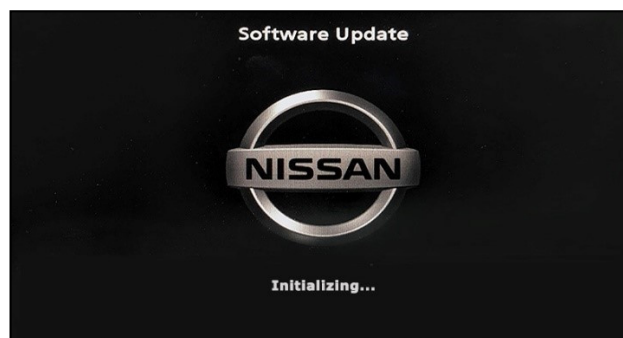
17. Wait approximately 10-30 seconds for the screen in Figure 14 to appear.

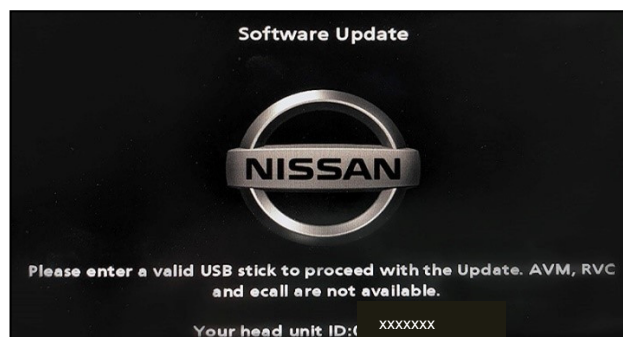
- The screen in Figure 15 may briefly appear. **Do not remove the USB drive**. The audio system will detect the USB and continue the update.

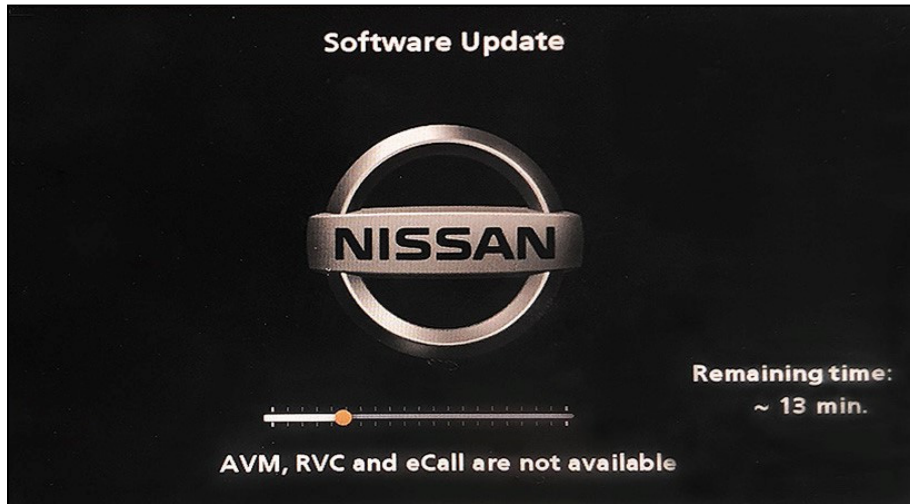
Figure 16

18. Wait for the update to complete.
- Follow the on-screen instructions while waiting.

HINT: The update may take 15-25 minutes.

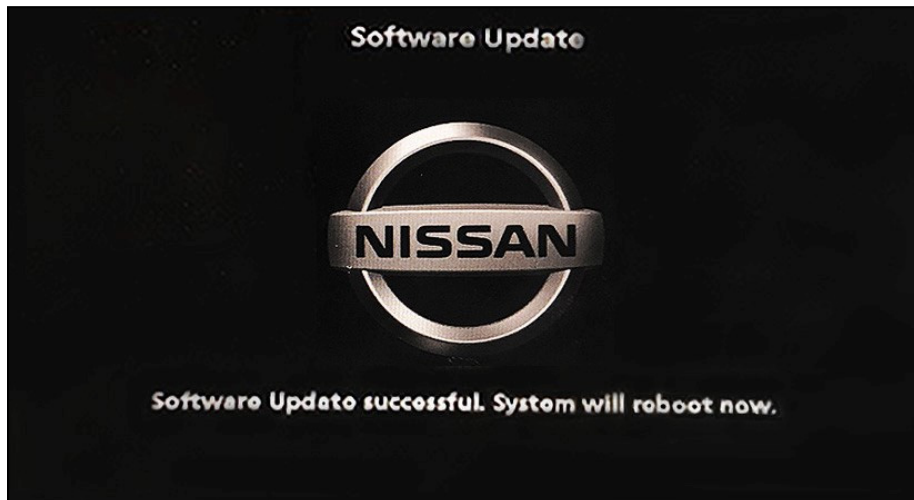
Figure 17

19. Once the update is complete (Figure 17), remove the USB drive; the system will reboot (restart).

HINT: The system will not reboot until the USB drive is removed.

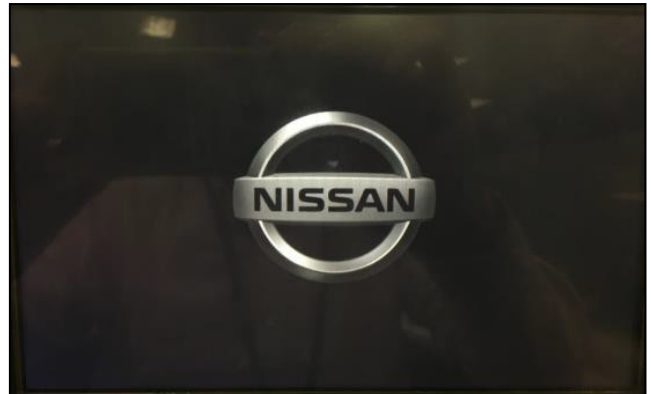
Figure 18

20. Allow the reboot to complete (approximately 30 seconds).
 - The Nissan logo will be displayed during the reboot.

24. Turn the ignition ON (engine OFF) and wait for the Nissan logo to appear (Figure 18).
 - If the Nissan logo does not appear (this might take up to 30 seconds), start over from step 21.

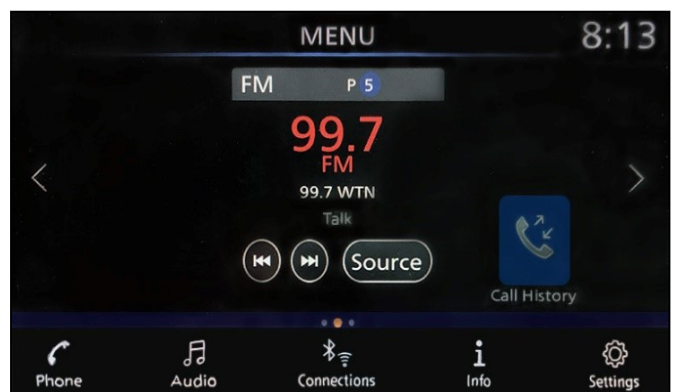
25. After the Nissan logo appears, wait about one (1) minute.
 - The MENU (Home) screen in Figure 19 will be displayed.
