**April 14, 2021**

Version 3

## 2017-18 Ridgeline: *Bluetooth*® HandsFreeLink® Will Freeze After Calls and Voice Tags are Missing at Startup

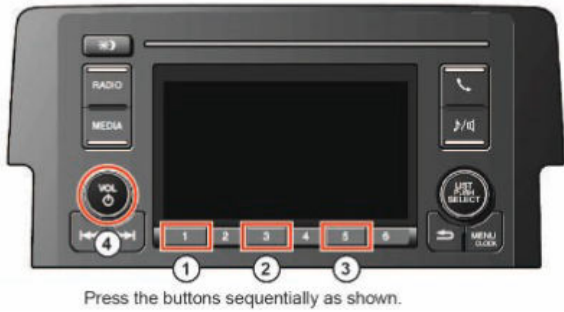
6. With the audio unit turned off, press the buttons in sequential order as shown.

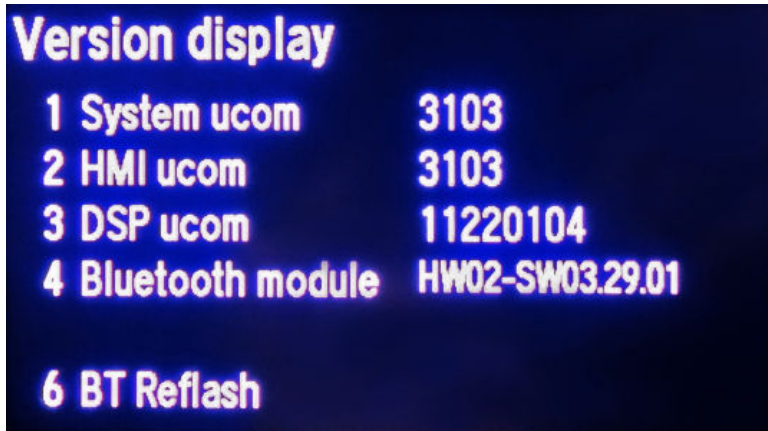
This will let you view the **Version display** screen and verify the candidate software version is up-to-date.

If the software versions do not match the ones listed in the table below, do not update the audio unit because you can damage it.

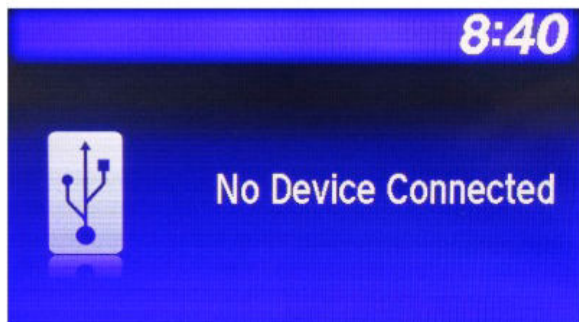
8. Set Audio Source to USB mode by pressing the MEDIA button.

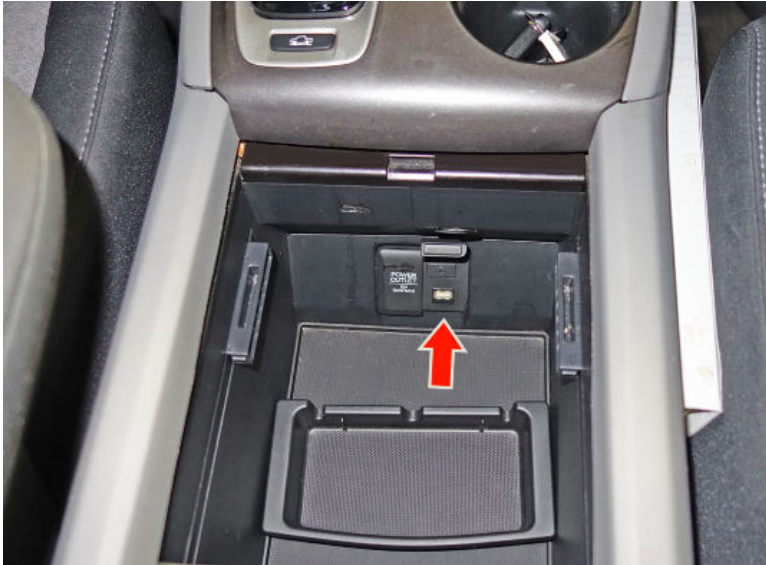
- Update the audio unit software by plugging in the USB drive into the USB port. The audio unit will automatically detect the USB drive tool and start the update process.

- Never disconnect the battery, turn the ignition to OFF, disconnect the USB drive tool, or press the **BACK** button while the update is in progress.

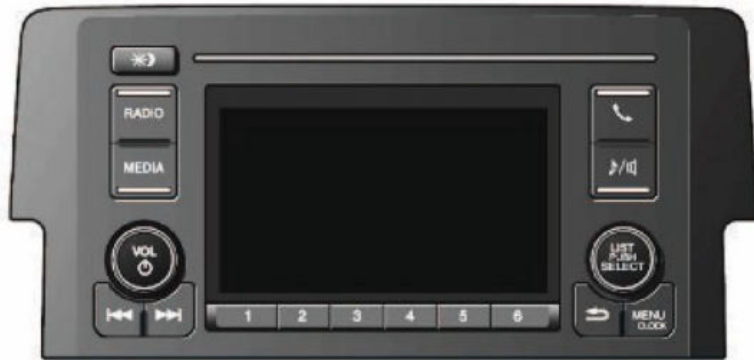
- The screen will go black and the buttons will begin blinking. The blinking will speed up every 10% of progress.

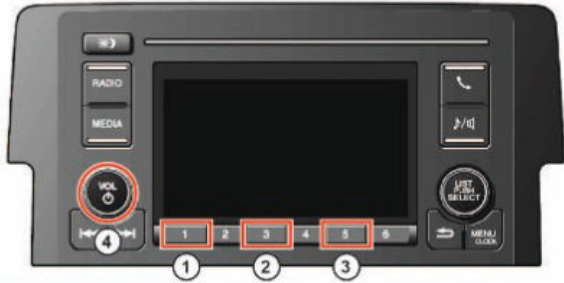
1. With the audio unit turned off, press the buttons in sequential order as shown.

Press the buttons sequentially as shown.

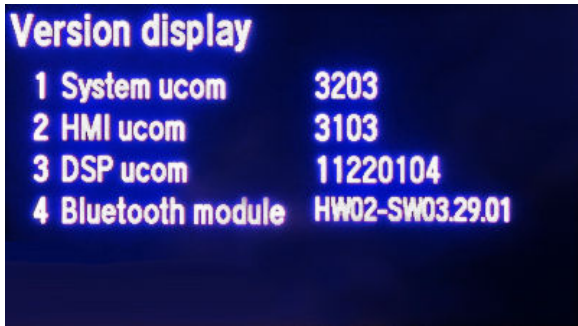
This will let you view the **Version display** screen and verify the software version was updated.

Software Details	Updated Software Version
System ucom	3203
HMI ucom	3103
DSP ucom	11220104
Bluetooth module	HW02-SW03.29.01

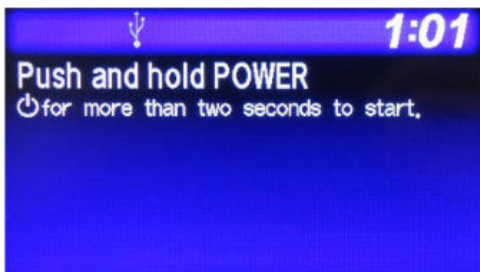
2. Press the **VOL/Power** button to exit the **Version display** screen.
3. Remove the USB drive tool.
4. Press and hold the **VOL/Power** button to sync the security code.
