Subject: N202326120 - Service Update
Air Ride Adaptive Suspension Incorrect Calibration

Models: 2021 Cadillac Escalade, Escalade ESV
2021 Chevrolet Suburban, Tahoe
2021 GMC Yukon XL
Equipped with Suspension System - FRT & RR, AIR (RPO F47)

N202326120 Air Ride Adaptive Suspension Incorrect Calibration

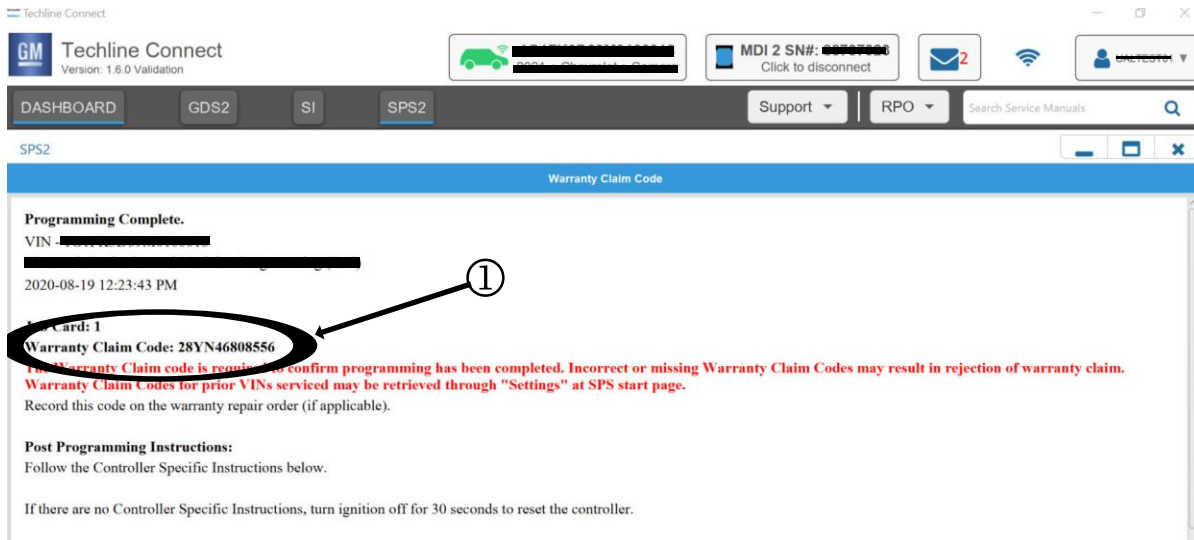
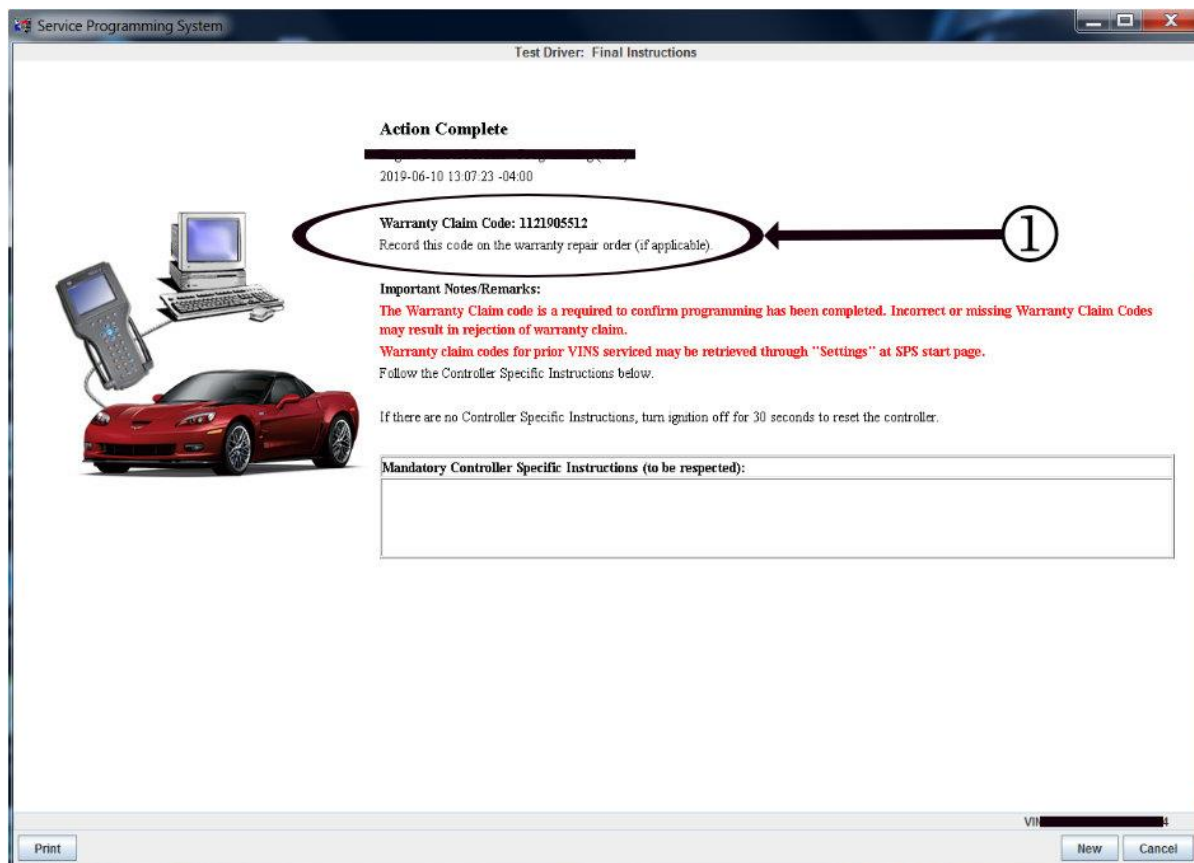
Note: The screenshots above are an example of module programming and may not be indicative of the specific module that is being programmed. Module selection and VIN information have been blacked out.

1. Reprogram the automatic level control module. Refer to *K5 Automatic Level Control Module: Programming and Setup* in SI.
