GROUP	MODEL
TRA	2019MY
	Sorento (UMa)
	w/3.3L GDI, 8AT
NUMBER	DATE
095	April 2021

TECHNICAL SERVICE BULLETIN

3.3L GDI 8AT TCU GEAR SHIFT LOGIC IMPROVEMENT

This bulletin provides the procedure to improve the gear shift logic of the Transmission Control Unit (TCU) on some 2019MY Sorento (UMa) vehicles produced from January 24, 2018 through September 24, 2018, equipped with Lambda 3.3L GDI engine and 8-speed automatic transmission, which may exhibit symptoms of acceleration delay and hesitation after vehicle speed is reduced and close to 0 mph. To correct this concern, apply the improved logic to the Transmission system using the KDS ECU Upgrade function as described in this bulletin. For confirmation that the latest reflash has been applied to a vehicle you are working on, verify the ROM ID using the table on page 3 of this bulletin.

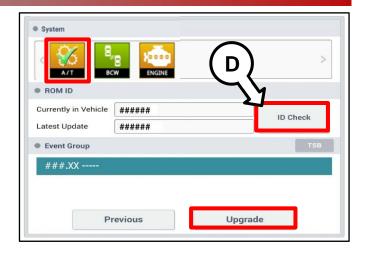
Touch **ID Check** (D) and confirm that the latest update is available.

Select **Upgrade Event #531** and select **Upgrade** to continue.

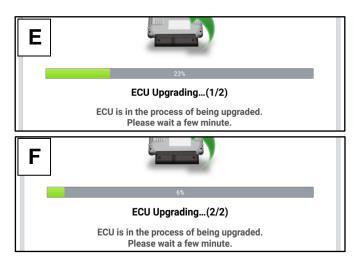
8. The ECU upgrade will begin and the progress of the upgrade will appear on the bar graph. Upgrade part (1/2) (E) will download the upgrade event to the VCI-II. Upgrade part (2/2) (F) will upgrade the ECU.
