GROUP CHA	MODEL 2021MY Seltos (SP2) Soul (SK3)
	NUMBER 110	DATE April 2021

TECHNICAL SERVICE BULLETIN

**SUBJECT: SERVICE ACTION: EPS LOGIC IMPROVEMENT
FOR DTC C160404 (SA466)**

This bulletin provides the procedure to improve the software logic of the Electronic Power Steering (EPS) system on some 2021MY Seltos (SP2) and Soul (SK3) vehicles produced in the date ranges shown below, which may exhibit an MIL on with DTC C160404 during the system start up diagnostic check. To correct this concern, apply the improved logic to the EPS system using the KDS ECU Upgrade function as described in this bulletin. For confirmation that the latest reflash has been applied to a vehicle you are working on, verify the ROM ID using the table on page 3 of this bulletin.

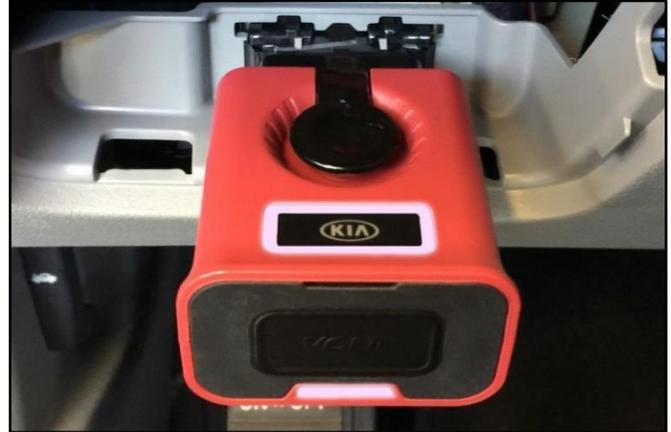
The ECU upgrade function on KDS operates wirelessly. It is not necessary to perform the upgrade via USB cable.

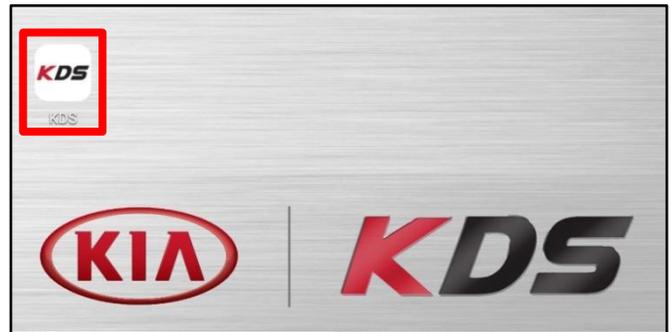
2. With the ignition ON, turn ON the KDS tablet. Select **KDS** from the home screen.

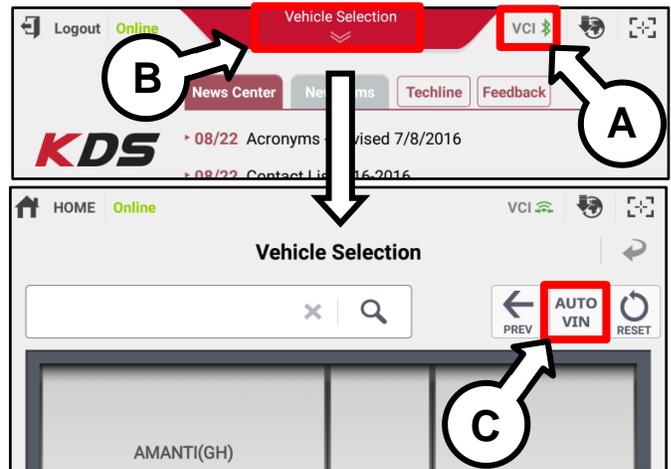
3. Confirm communication with VCI (A) and then configure the vehicle (B) using the **AUTO VIN** (C) feature.

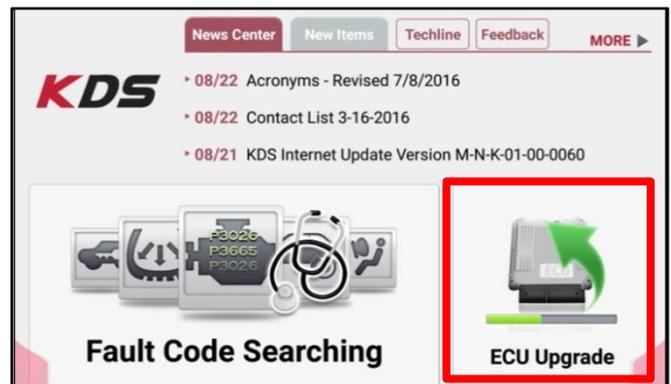
4. Select **ECU Upgrade**.

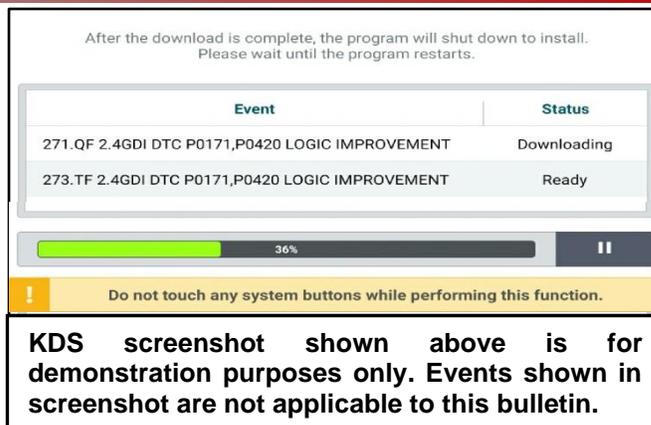
5. The KDS will check the server for recently uploaded Events and then automatically download **Upgrade Event #536 (SK3) OR #538 (SP2)**.

The vehicle must be identified in Vehicle Selection to download an Event for that vehicle.

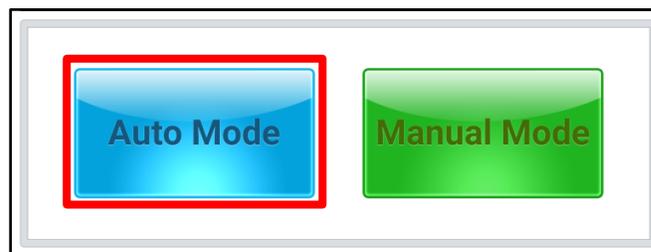
6. Select **Auto Mode**.

Do NOT attempt to perform a Manual Mode upgrade **UNLESS Auto Mode fails**. Always follow the instructions given on the KDS in either Auto or Manual mode.

The manual upgrade should ONLY be performed if the automatic upgrade fails.

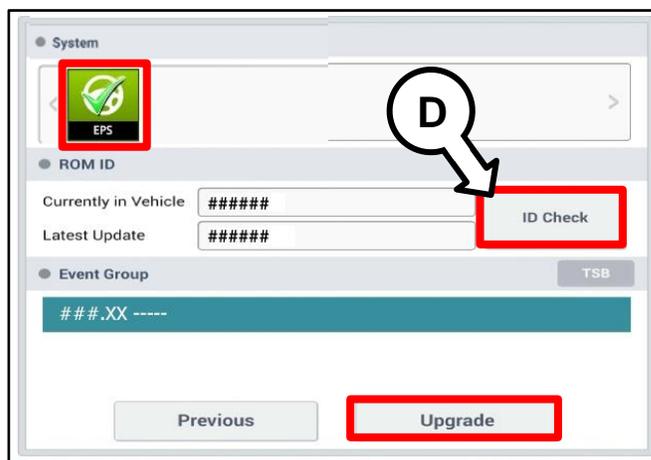
7. Select the **EPS** system under the System selection menu.

Touch **ID Check (D)** and confirm that the latest update is available.

Select **Upgrade Event #536 (SK3) OR #538 (SP2)**. and select **Upgrade** to continue.

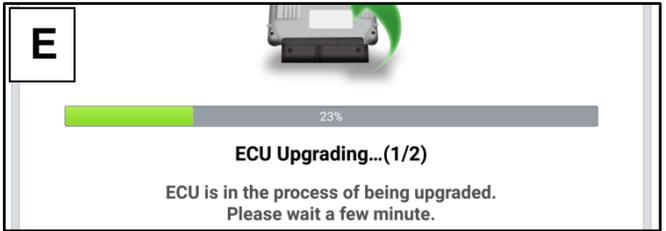
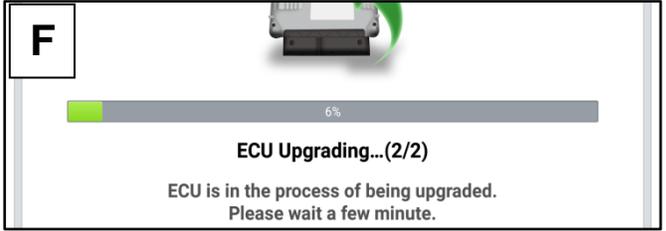
8. The ECU upgrade will begin and the progress of the upgrade will appear on the bar graph. Upgrade part (1/2) (E) will download the upgrade event to the VCI-II. Upgrade part (2/2) (F) will upgrade the ECU.

Do not touch the system buttons (like 'Back', 'Home', 'etc.') while performing ECU Upgrade.

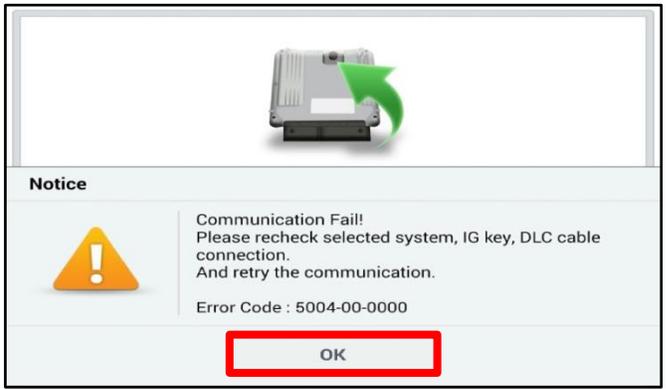
9. If a "Communication Fail" screen appears, verify that the VCI-II and KDS are communicating properly. Touch **OK** and restart the procedure from step 4.

If an error notice continues to appear or if the upgrade cannot be performed, DO NOT disconnect the KDS/VCI-II. Contact GIT America Help Desk at (888) 542-4371 or Techline.

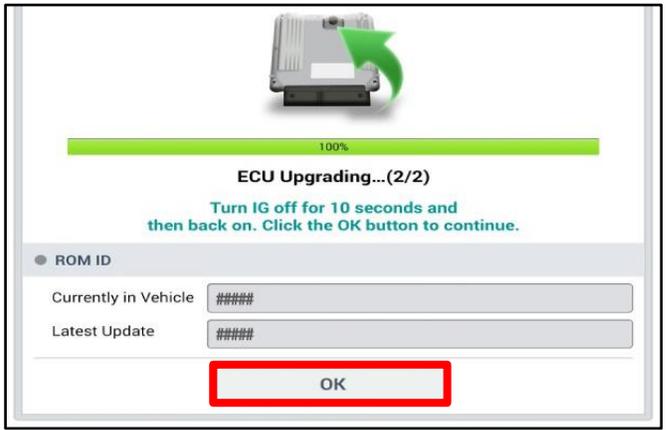
10. When instructed on the KDS, turn the ignition **OFF** for ten (10) seconds then back on. Touch **OK** to continue.

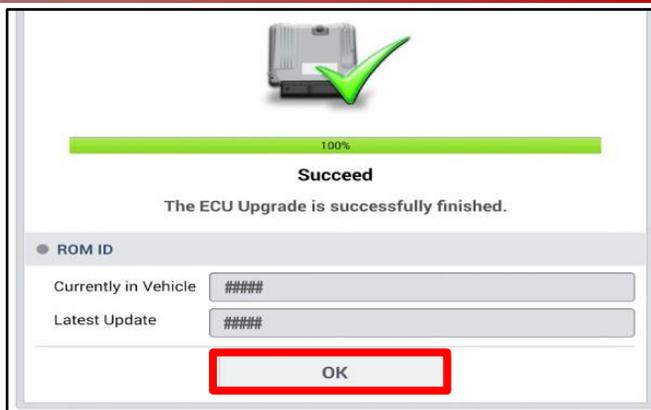
11. Once the upgrade is complete, touch **OK** to finalize the procedure.

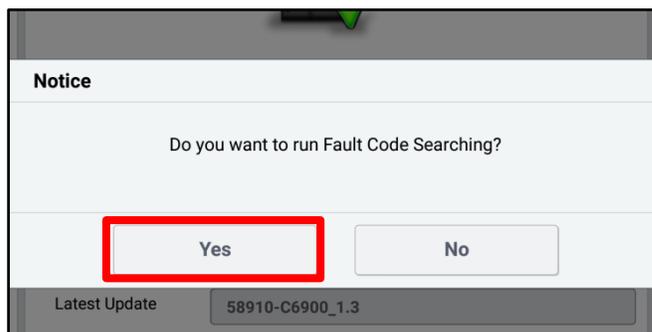
12. When prompted, select **YES** to check for Diagnostic Trouble Codes (DTC) and erase any DTCs stored such as EPS, ESC, and TPMS that may have been set during the upgrade.
