54-3

On some New Business Class M2 and 108SD/114SD vehicles, bulkhead module (BHM) fault code SPN 6918 FMI 7 displays at key ON, despite all switches showing that the correct parameters are loaded and are present in DiagnosticLink®.

# 54-320 New BHM Software for Switch Expansion Module Fault SPN 6918 FMI 7

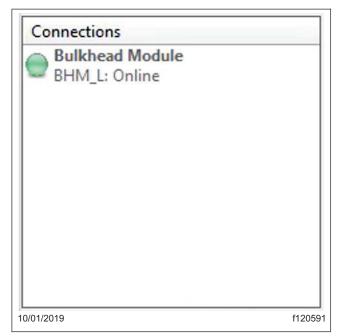
- 1. Park the vehicle on a level surface, apply the parking brakes, and shut down the engine. Chock the tires.
- 2. Connect the vehicle to DiagnosticLink.
- 3. Ensure that the BHM is connected. See Fig. 1.

Fig. 1, Verifying that the BHM is Connected

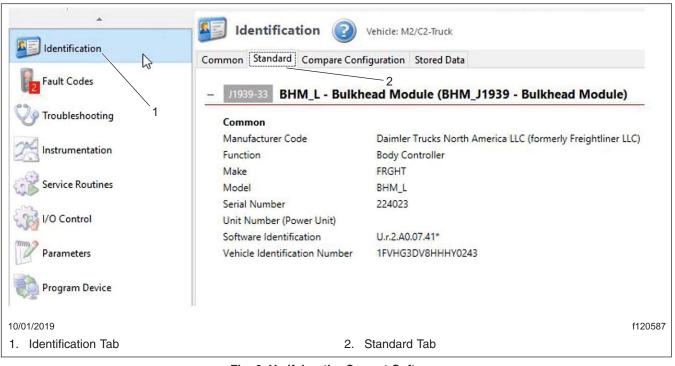
4. Go to the "Identification" tab then click on the "Standard" tab. See Fig. 2.

Fig. 2, Verifying the Correct Software

- 5. Verify that the BHM is currently installed with 7.41 software, then click the "Program Device" tab.
- 6. Click "Remove All" to clear VINs from the program device list.
- 7. Click Add. The "Request Equipment Data Download" form will appear. See Fig. 3.
