Service Bulletin

Bulletin No.: 21-NA-055

Subject: Volume Level Difference When Switching Between FM and Sirius XM Audio Sources

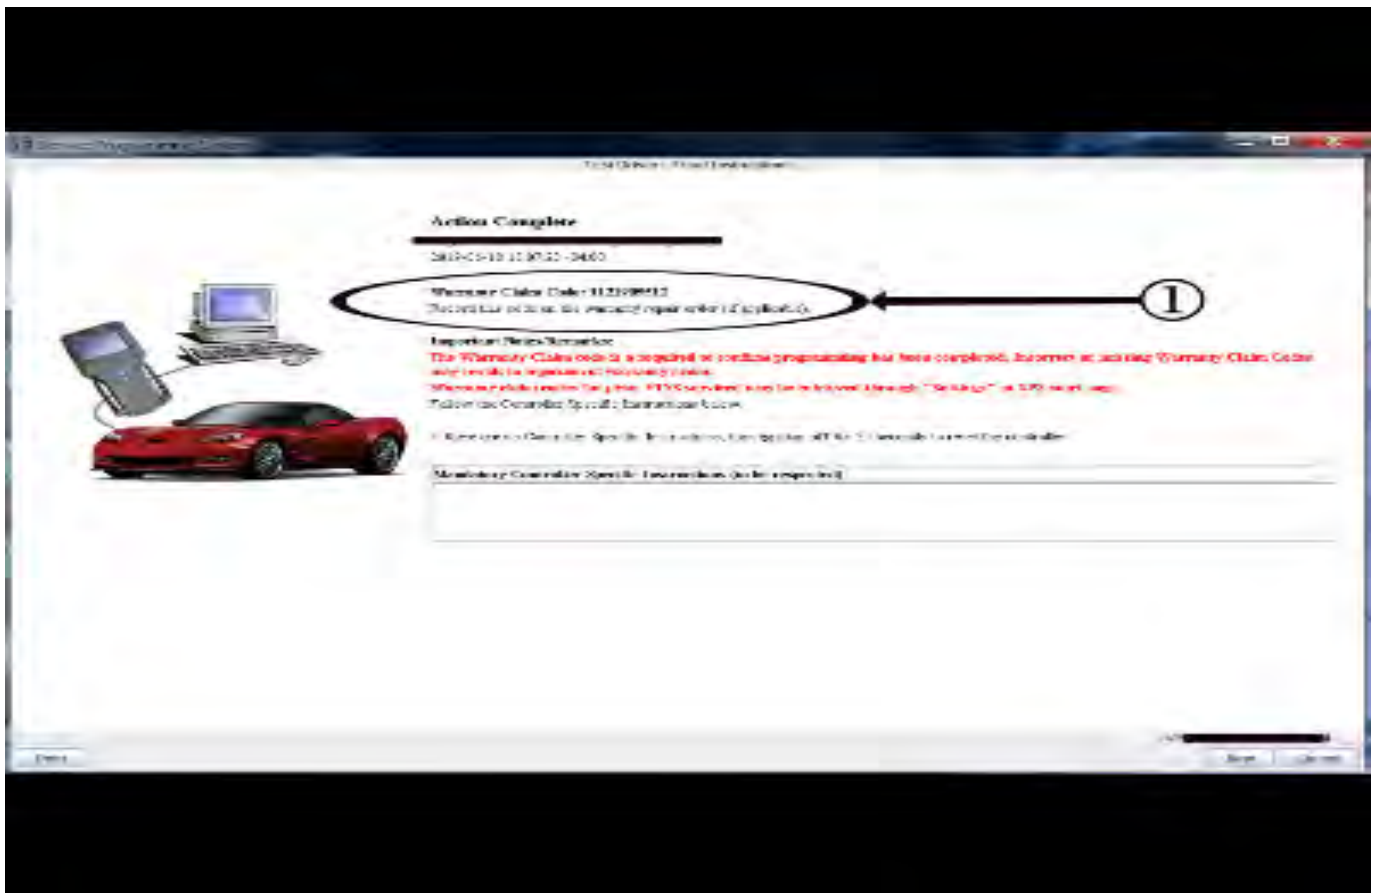
5431209

Note: The screenshots above are an example of module programming and may not be indicative of the specific module that is being programmed. Module selection and VIN information have been blacked out.
