SERVICE BULLETIN

APPLICABILITY: 2016-18MY Legacy/Outback
 2016-18MY Impreza
 2016-18MY Crosstrek
 2016-18MY Forester
 2017-18MY WRX

NUMBER: 15-280-21R

SUBJECT: Gen1 Telematics Reprogramming for 3G Sunset

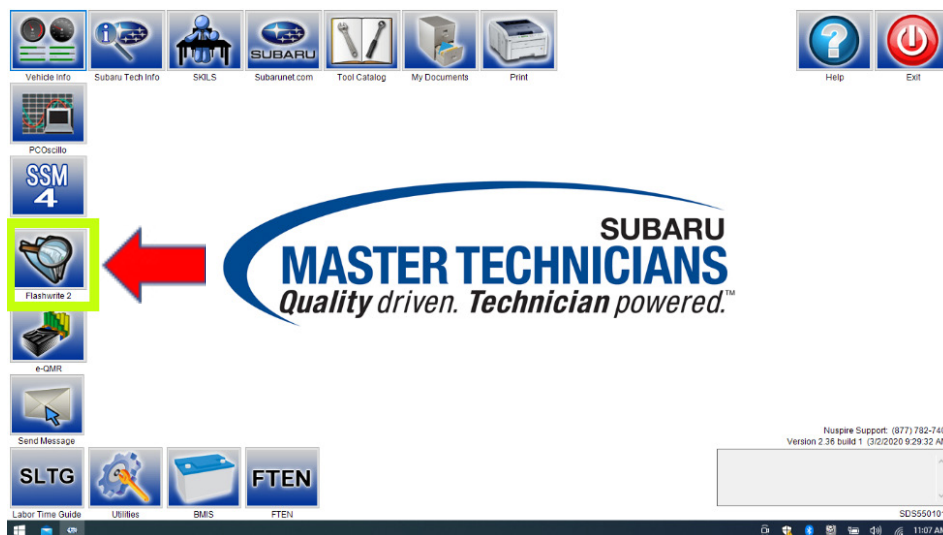
1. Connect the SDS Notebook and DSTi. Select **FlashWrite2** from the SDS Notebook GUI screen.

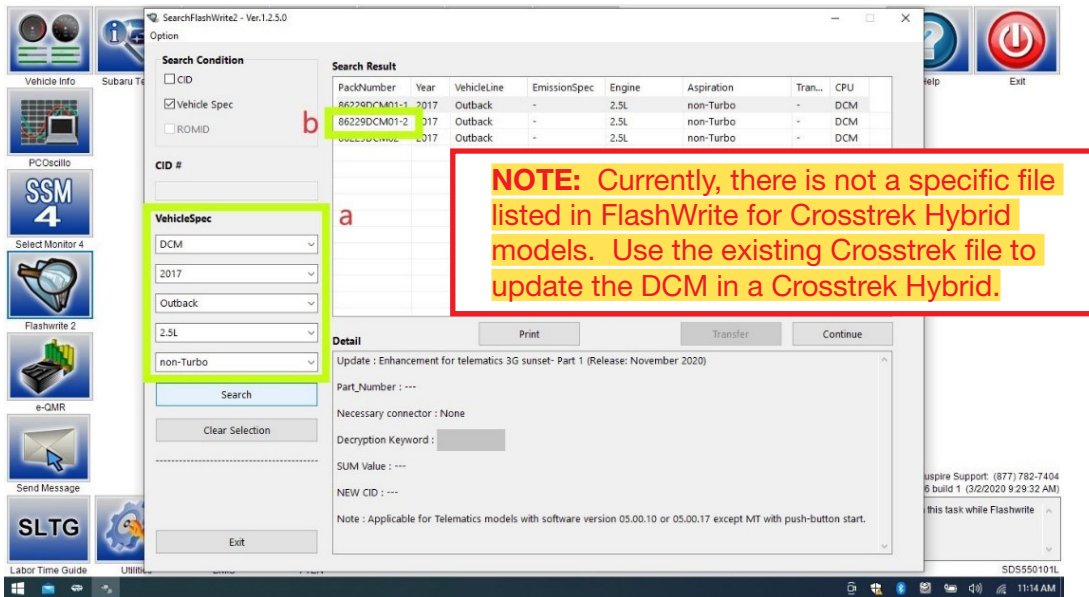
2. Once FlashWrite 2 opens, select DCM from the VehicleSpec drop down.
 - a) Complete entering the Vehicle Spec information.
 - b) Click and select the PK2 file **86229DCM01-2.pk2** intermediate image in FlashWrite.

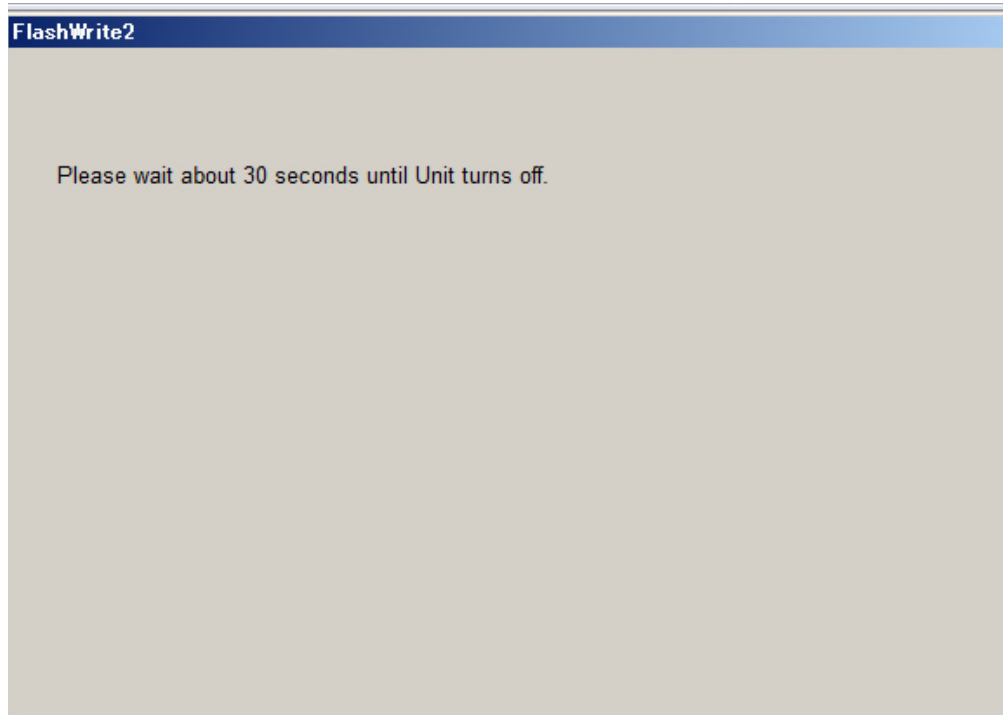
- d) **CRITICAL STEP:** FlashWrite will display the banner message “Please wait about 30 seconds until Unit turns off”. This banner page has a timer built in and will NOT continue until 30 seconds have passed and the DCM has safely shutdown. There is no way to verify the DCM has shutdown except waiting to ensure the full 30 seconds has passed. The next screen, e) shown below will display automatically.

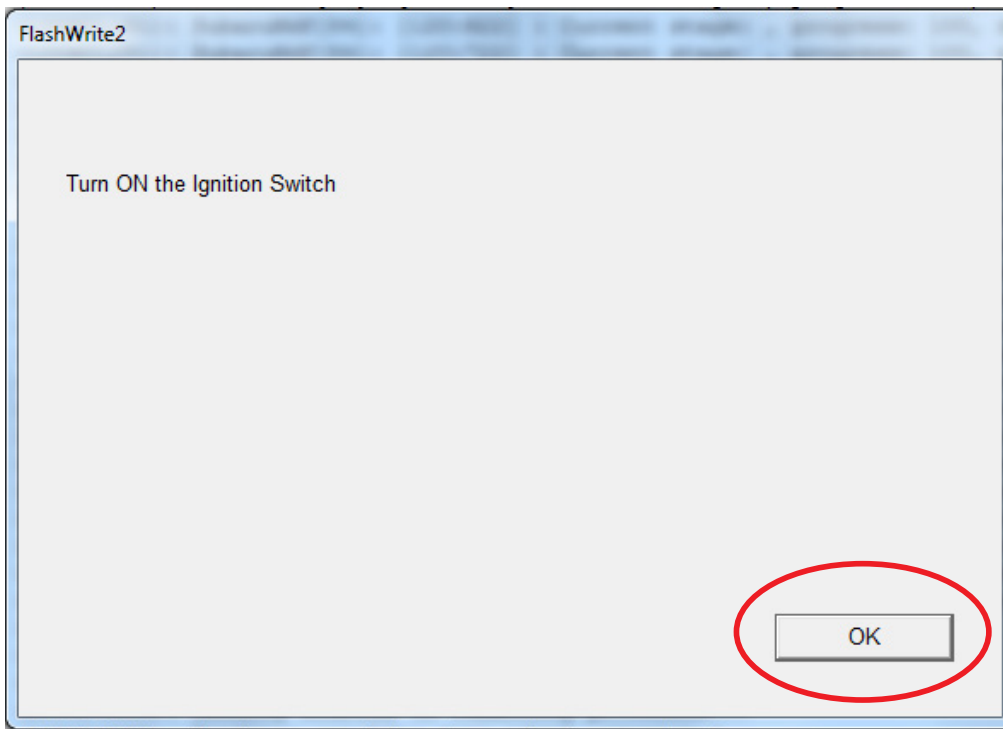
- e) A prompt for toggling ignition to ON will be displayed. Click on ‘OK’

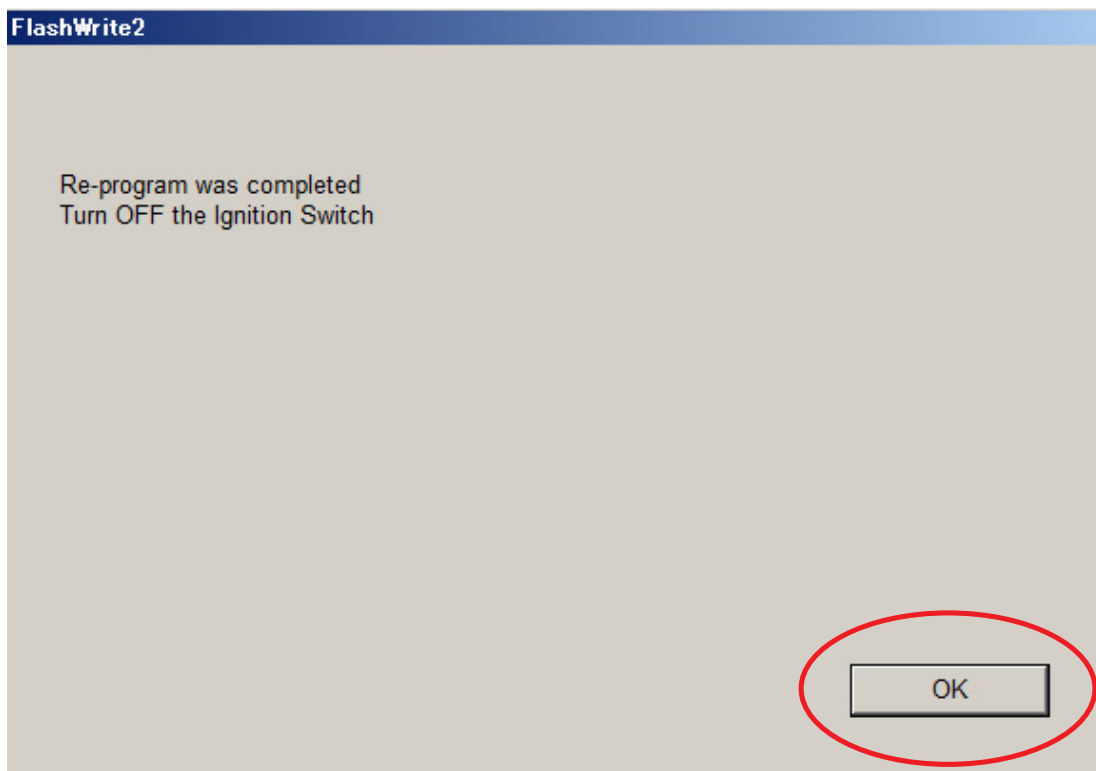
- g) FlashWrite will display the banner message “Re-program was completed. Turn OFF the Ignition Switch.”

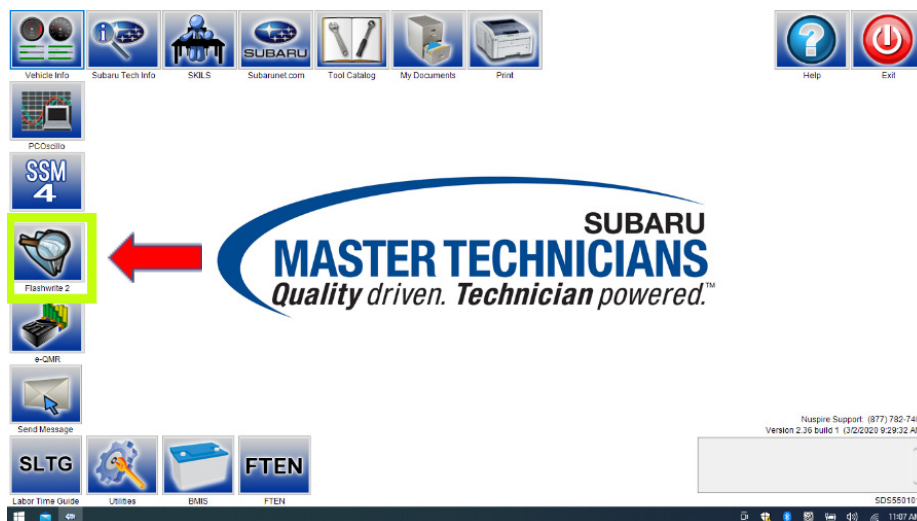
1. Connect the SDS Notebook and DSTi. Select **FlashWrite2** from the SDS Notebook GUI screen.

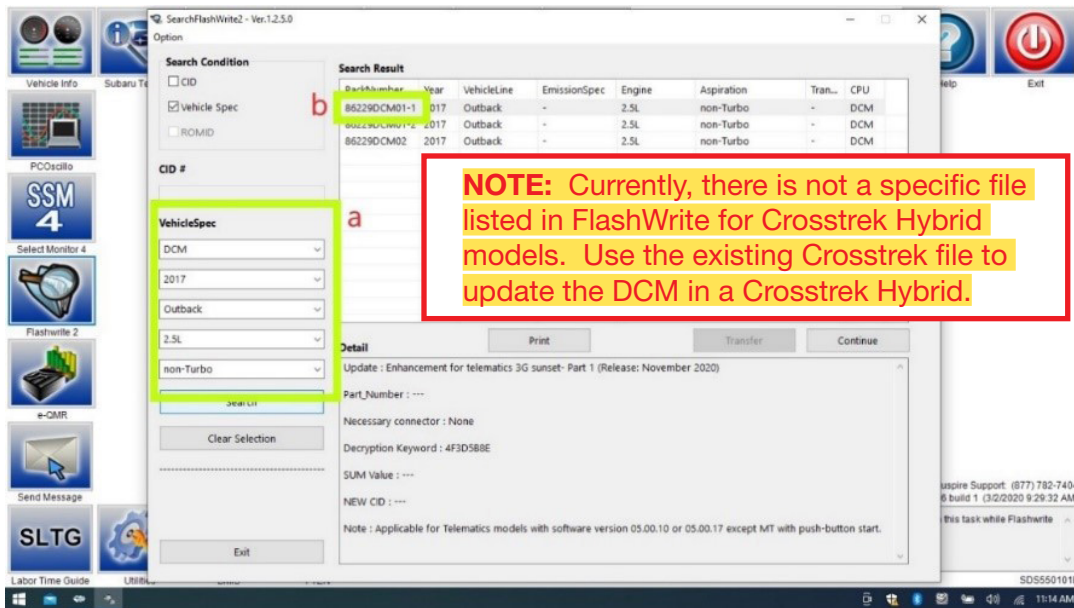
2. Once FlashWrite 2 opens, select DCM from the VehicleSpec drop down.
 - a) Complete entering the Vehicle Spec information.
 - b) Click and select the Pak file **86229DCM01-1.pak** intermediate image in FlashWrite.

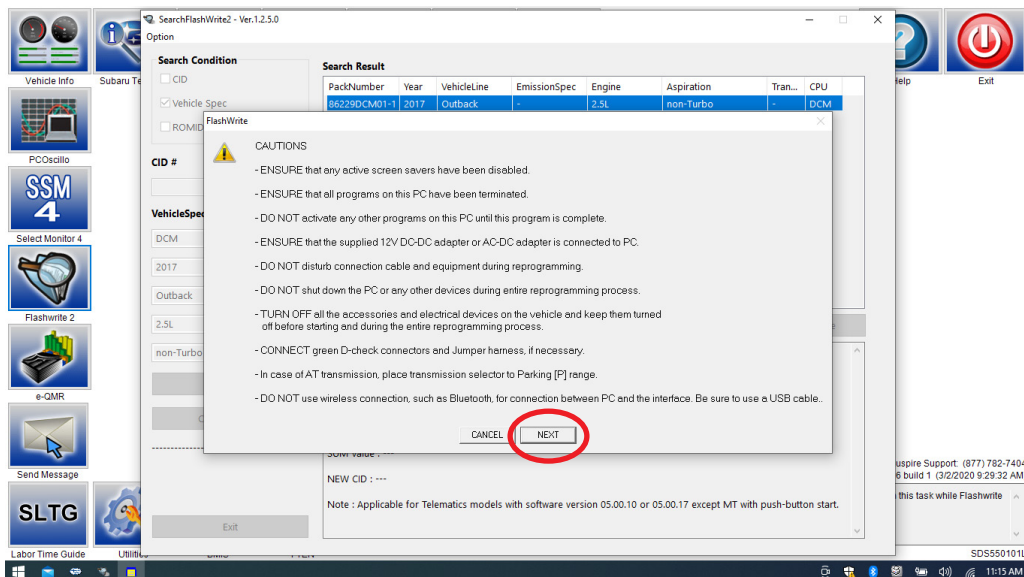
3. **CAUTIONS** will be displayed. Check the notices and click on “NEXT.”

WARNING: In the screenshot above, the on-screen directions indicate to leave the vehicle in PARK, doing this will cause the reflash procedure to FAIL. The vehicle **MUST BE LEFT IN NEUTRAL** for the entire reflash procedure. Reference **Step 1** above for all the vehicle conditions required for reprogramming.

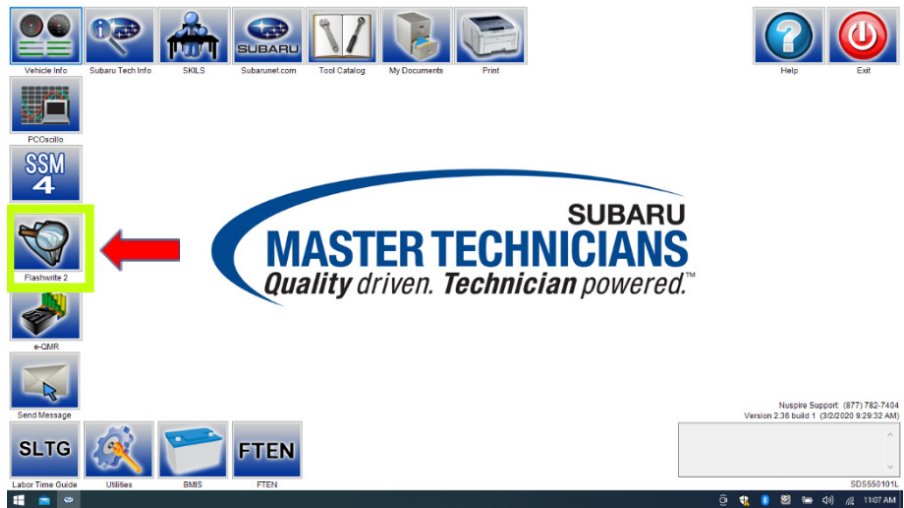
1. Connect SDS Notebook and DSTi. Select **FlashWrite2** from the SDS Notebook GUI screen.

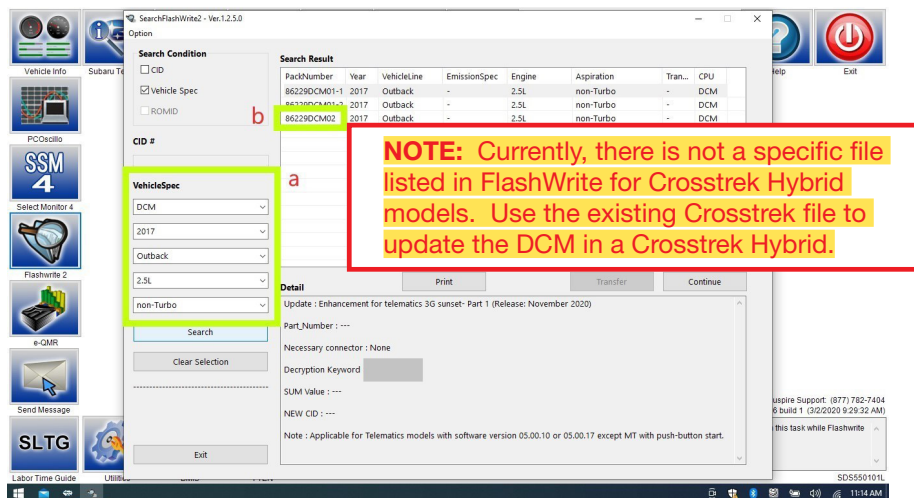
2. Once FlashWrite 2 opens, select DCM from the VehicleSpec drop down.
 - a) Complete entering the Vehicle Spec information.
 - b) Click and select the PK2 file **86229DCM02.pk2** intermediate image in FlashWrite.

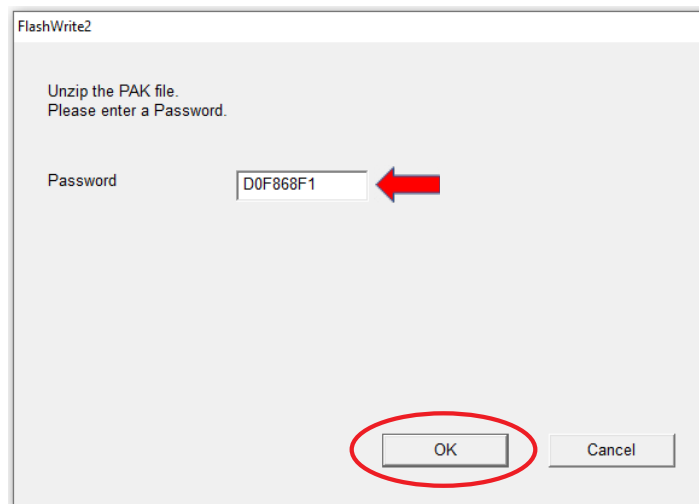
3. Enter the Decryption Keyword from the table above (D0F868F1) and click “OK”.

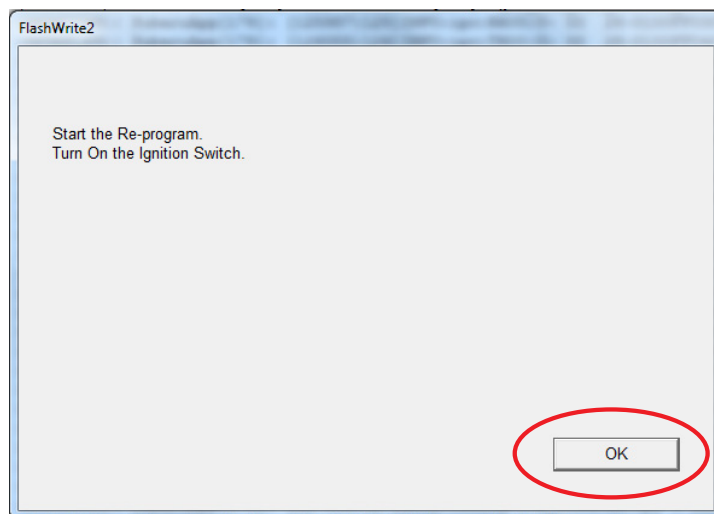
a) Turn the ignition switch ON and Click on ‘OK’ to start the reprogram.

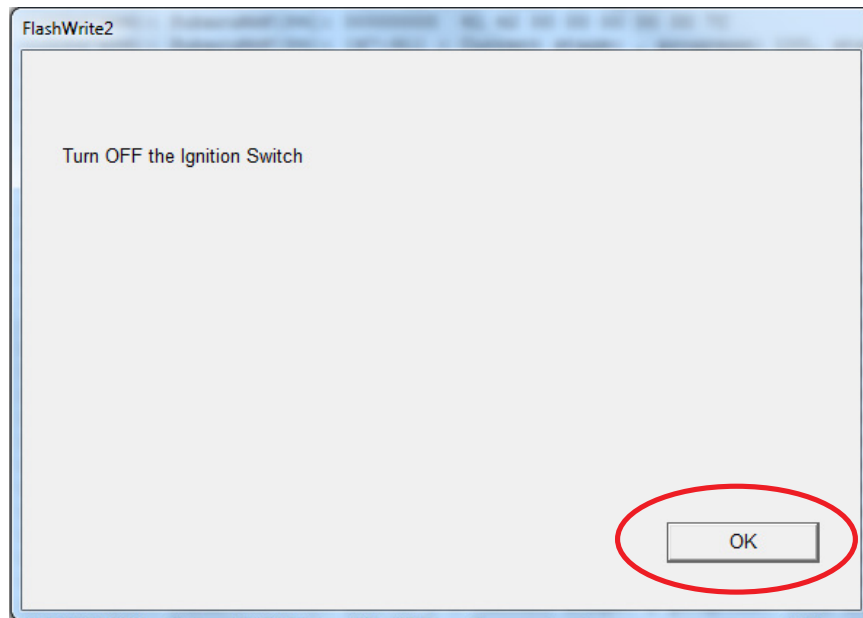
- c) **CRITICAL STEP:** After the reprogramming is finished, always put a CVT equipped vehicle in PARK and ensure the ignition is turned completely OFF. A prompt for toggling the ignition to OFF will be displayed. Click 'OK'.

1. Push the start button (once) switching to Accessory.
2. Move the selector into Park.
3. Push the start button again to switch the vehicle OFF.
4. **WAIT 30 SECONDS** and click OK.

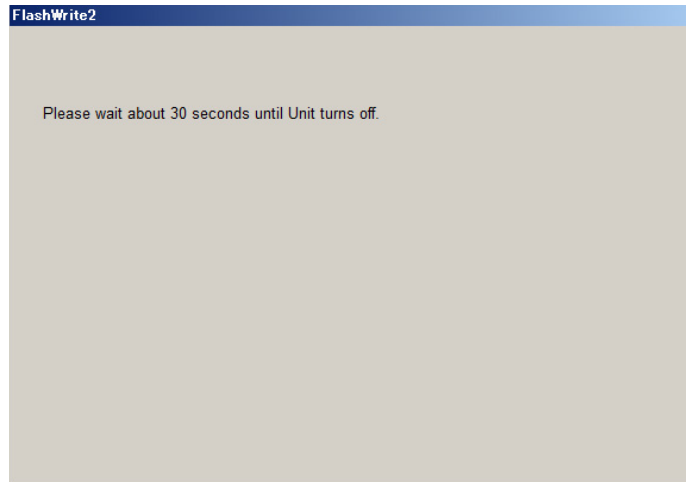
- d) **CRITICAL STEP:** FlashWrite will display the banner message “Please wait about 30 seconds until Unit turns off”. This banner page has a timer built in and will NOT continue until 30 seconds have passed and the DCM has safely shutdown. There is no way to verify the DCM has shutdown except **waiting to ensure the full 30 seconds has passed**. The next screen, e) shown below will display automatically.

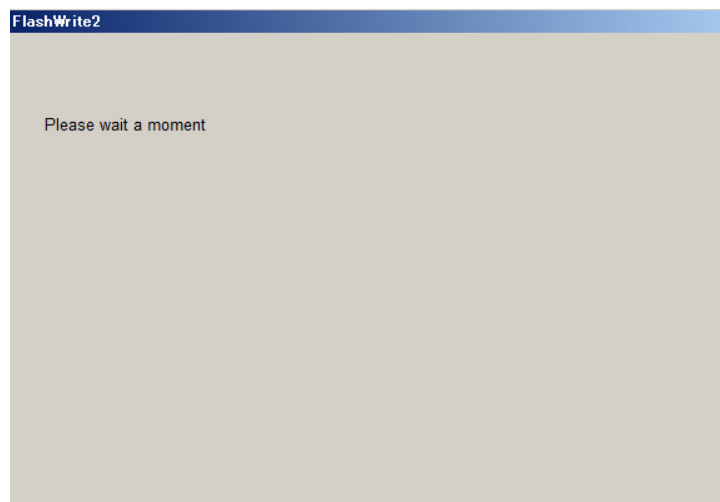
- f) FlashWrite will display the banner message “Please wait a moment.”

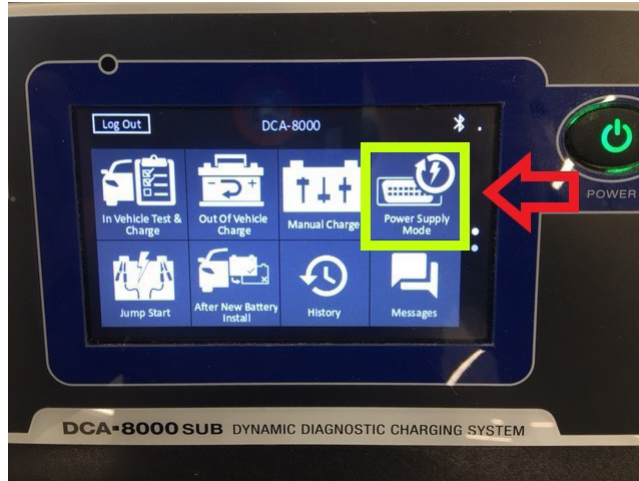
- **NEVER** connect the DST-i until the Power Supply Mode function has completed its battery test mode and the Charging Voltage has dropped to a steady 13.5 Volts on the display.
- Once Power Supply Mode reaches a steady 13.5 volts, connect the DST-i to the OBD connector.
- **If the battery voltage rises above 14V while the reprogramming is in process, the procedure will abort.** Charging voltage above 14V can indicate a need to test or charge the vehicle battery before any further reprogramming attempt is made.

CRITICAL: Power Supply Mode voltage must be stabilized at **13.5** Volts before proceeding.
