WMA6 - Updating Software for Various Control Units ((Workshop Campaign)

Model Year: 2021

Model Line: Taycan(Y1A)

Concerns: Software update (software version VR12.1.1)

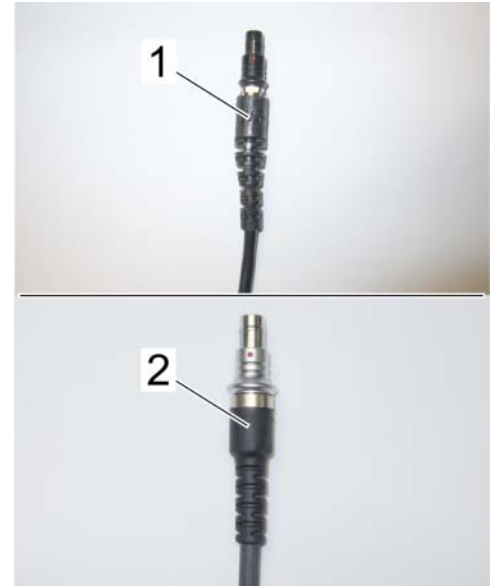
PIWIS Tester data cable

If the connection between the vehicle and PIWIS Tester is interrupted, check the data cable for the PIWIS Tester for signs of damage. If the data cable is damaged, it **must** be **replaced**. To do this, follow the instructions in the PPN for "Returning faulty USB cable caps" (PPN portal > Dr Ing. h.c. Porsche AG > Aftersales > Workshop > PIWIS > Documents).

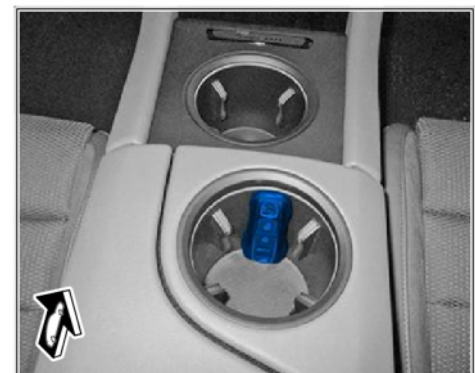
Emergency start tray

2 Position the **driver's key** with the back facing forward upright between the holding struts in the rear cupholder (**emergency start tray**) to guarantee a permanent radio link between the vehicle and remote control ⇒ *Emergency start tray*.
