**WMA5 - Updating Software for Various Control Units (Workshop Campaign)**

Model Line: **Taycan (Y1A)**

Concerns: **Software update (software version VR12.1.1)**

Information: **Software optimizations are available for various control units for the Taycan.**

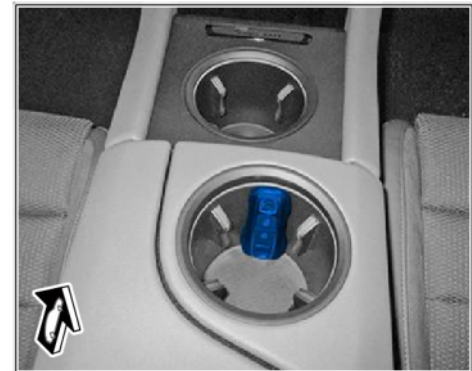
*Emergency start tray*

- 2 Position the **driver's key** with the back facing forward upright between the holding struts in the rear cupholder (**emergency start tray**) to guarantee a permanent radio link between the vehicle and remote control ⇒ *Emergency start tray*.

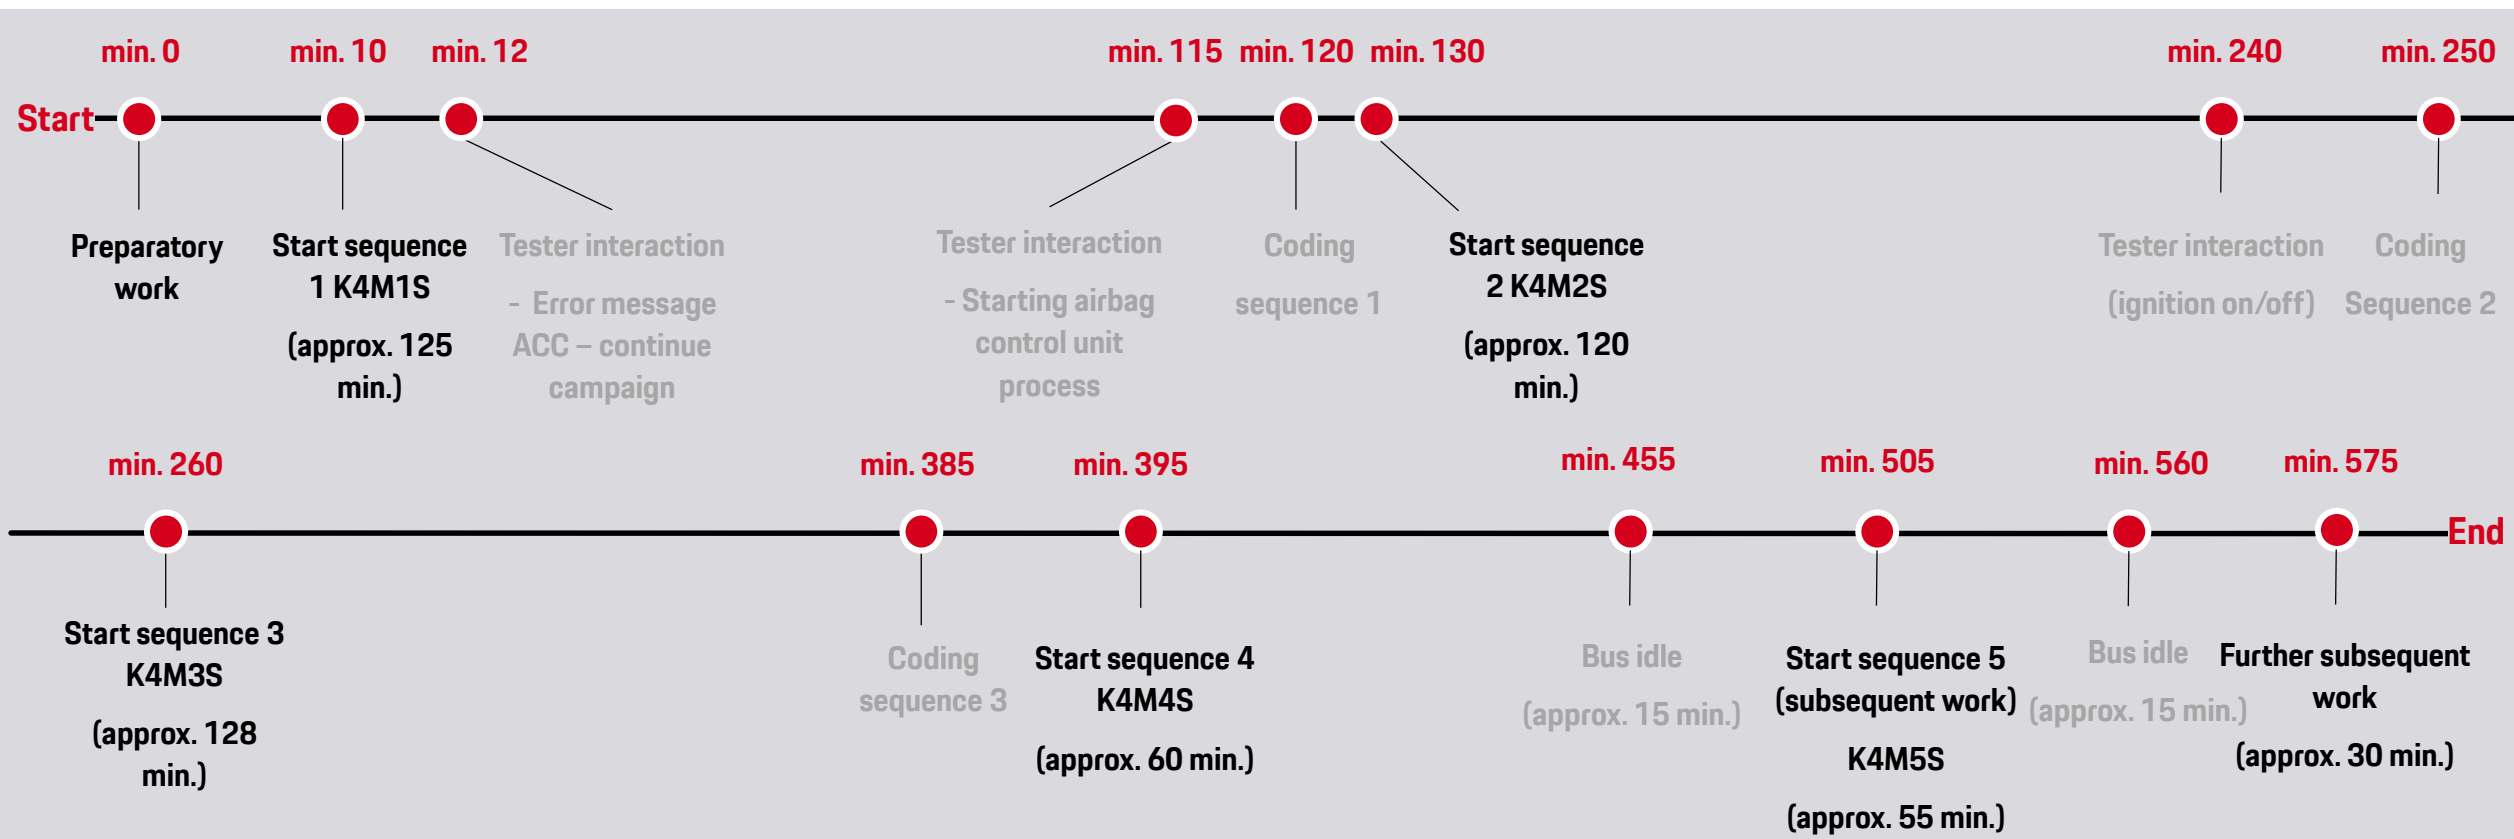
# Rough time schedule supplement for workshop campaign WMA5 – Scope 3

Please note that this chart only represents a supplement to Technical Information WMA5 (TI 15/21). The listed times are for orientation purposes only and may vary depending on vehicle equipment.
