WMA5 - Updating Software for Various Control Units (Workshop Campaign)

Model Line: **Taycan (Y1A)**

Concerns: **Software update (software version VR12.1.1)**

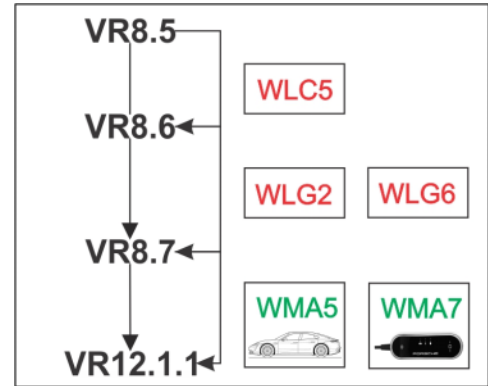
Evolution Taycan Software Versions

Overview of control units for software version VR12.1.1			
Control unit	Programming time	Action required	
		program	code
<p>Sequence 1: Combined software update for various control units (Update via PIWIS Tester)</p> <p>Includes:</p> <ul style="list-style-type: none"> Distance measuring sensor control unit (ACC) Front-end electronics control unit (BCM1) Rear-end electronics control unit (BCM 2) Radar sensor for front corner radar Lane Change Assist control unit, left and right Central control unit for assistance systems (zFAS) Airbag control unit Reversing camera Interior surveillance sensor Seat occupancy detection Weather sensor 	approx. 125 minutes		
		■	■
		■	■
		■	■
		■	■
		■	■
		■	■
		■	■
		■	■
		■	■
		■	■
		■	■
		■	■
		■	■
