WMA6 - Updating Software for Various Control Units ((Workshop Campaign)

Model Line: Taycan (Y1A)

Concerns: Software update (software version VR12.1.1)

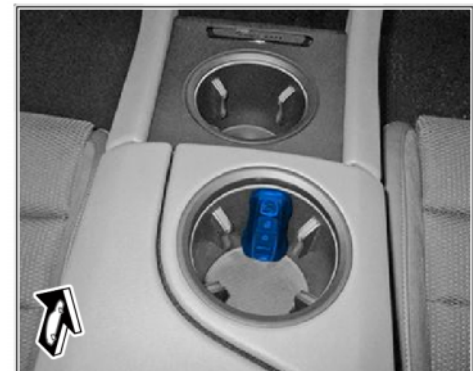
2 Position the **driver's key** with the back facing forward upright between the holding struts in the rear cupholder (**emergency start tray**) to guarantee a permanent radio link between the vehicle and remote control ⇒ *Emergency start tray*.

Emergency start tray

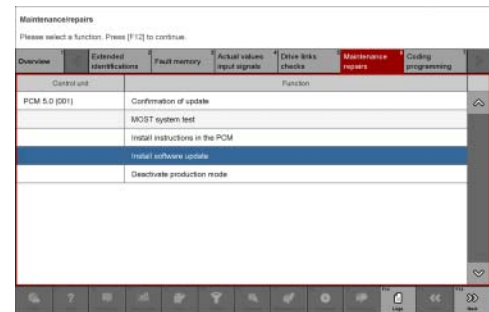
Installing PCM 6.0 software update

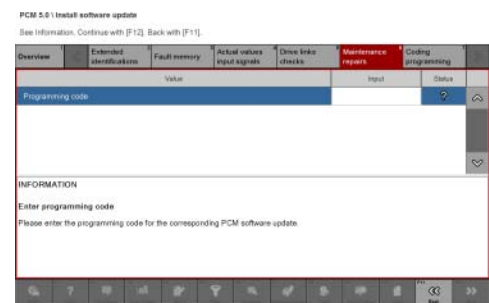
Entering PCM 6.0 programming code

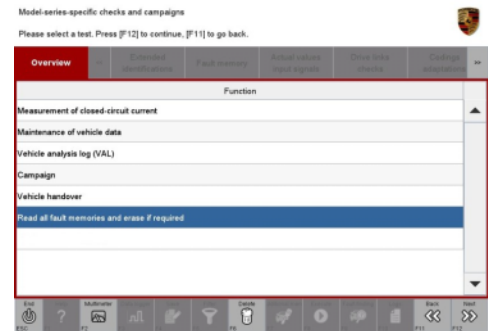
Erasing fault memories

- 3.4 Press **•F8** to delete fault memory entries.
- 3.5 Press **•F12** ('Yes') in response to the question as to whether you really want to delete all fault memory entries.
