Technical product information

Topic	New Continental GT and GTC- Repeat window drop glass concerns
Market area	Russische Föderation (5RU),Australia E04 Bentley rest Asia and Australia (6E04),China 796 VW Import Comp. Ltd (Vico), Beijing (6796),Germany E02 Bentley rest Europe (6E02),Japan E03 Bentley Japan (6E03),Korea, (South) E08 Bentley South Korea (6E08),United Arab Emirates E06 Bentley Middle East and Africa (6E06),United Kingdom E01 Bentley UK (6E01),United States E05 Bentley USA and rest America (6E05)
Brand	Bentley
Transaction No.	2062035/4
Level	EH
Status	Approval
Release date

New Continental GT and GTC

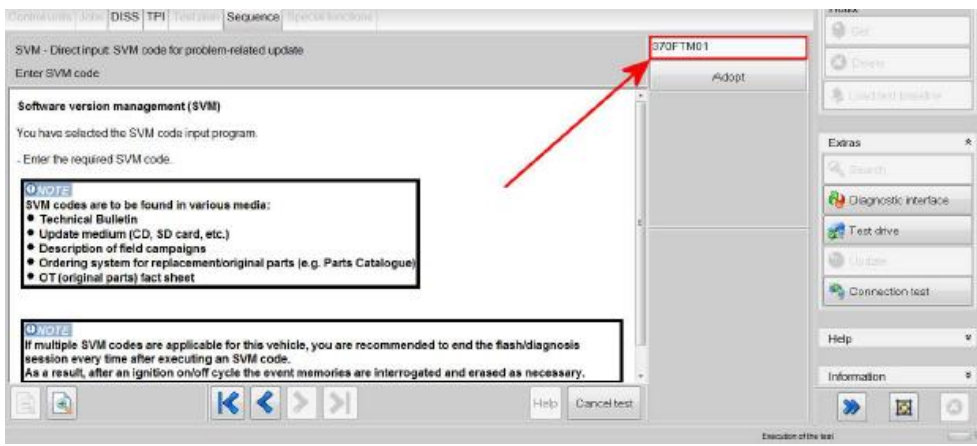
2) Referring to Figure 2 – Enter the SVM code 370FTM01

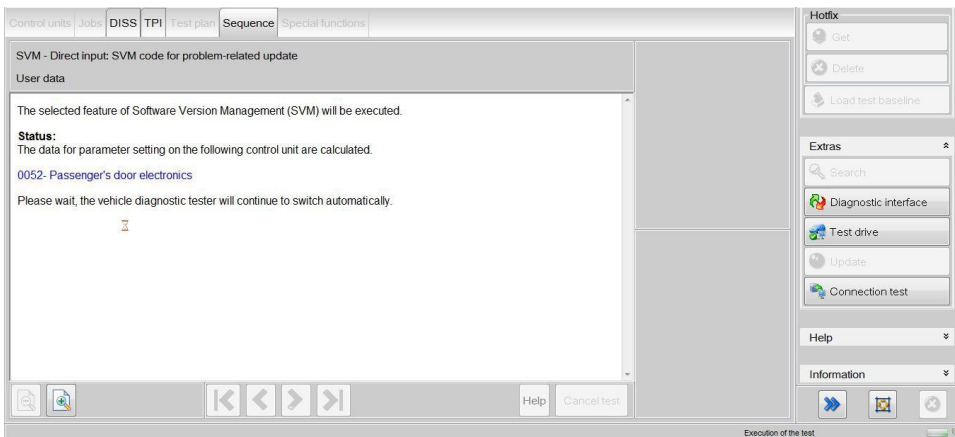
- When prompted enter your global user ID and password
 - Follow all on screen prompts to continue through the procedure, the identification data will be transferred
- 3) The Required control units will be automatically updated in the order shown in Figures 3 through to 6
