## SERVICE ACTION

Reference number:	SA-63-1466	Issued: 12 April, 2021
Subject:	DCDC Convertor Software Update	
Model(s):	DBX	
VIN Range:	Refer to the separately published list of affected Vehicle Identification Numbers (VINs)	
Applicable to:	All Dealers	
Distribute to:	After Sales Manager Executive Manager Service Manager Sales Manager	Warranty Staff Technician(s) Parts Staff

There is a new software update available for the DCDC convertor which makes improvements to the 48V battery system. To update the DCDC Convertor software to the latest version do the workshop procedures that follow:

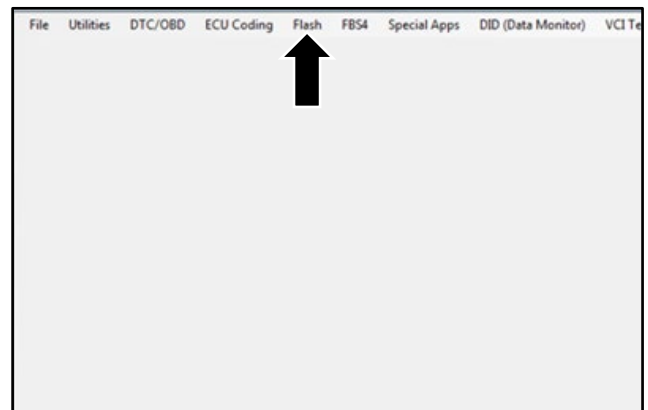
Figure 1

1. Set the ignition to on, but do not start the engine.
2. Connect the Vehicle Communication Interface (VCI) to the vehicle by using the Diagnostic Link Cable (DLC).
3. Start the AMDS 2.0 software and make sure it is connected to the internet. If necessary, update to the latest version.
4. Select "Flash" (refer to Figure 1).

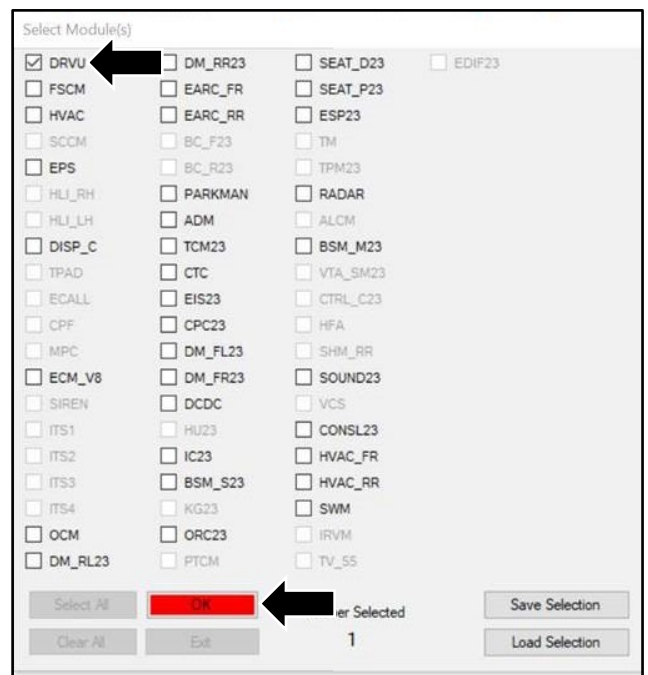
Figure 2

5. Select "DRVU" then click "OK" (refer to Figure 2).

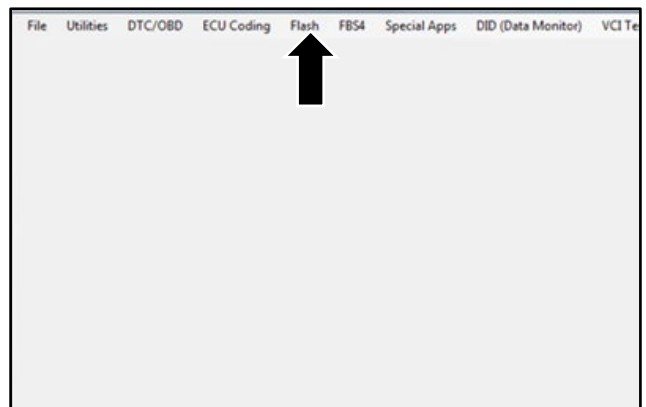
Figure 5

9. Set the ignition to “Off” for 30 seconds.
10. Set the ignition to “On” but do not start the engine.
11. Make sure there are no diagnostic trouble codes (DTCs) stored for the DRVU module.
12. Select “Flash” (refer to Figure 5).

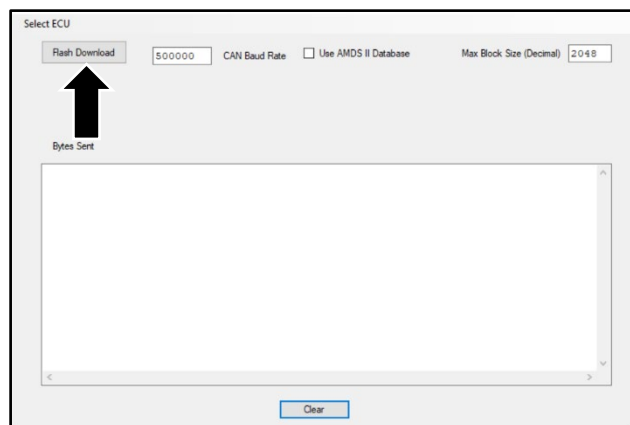
Figure 7

14. Select "Flash Download" (refer to Figure 7).

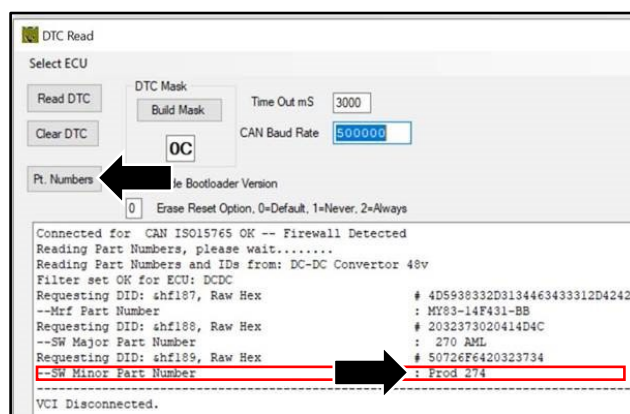
Figure 8

16. In the "DTC Read" window select the DCDC module then select "Pt. Numbers".

Do a check and make sure the software part number is: **Prod 274** (refer to Figure 8).
