## Telematics Reprogram Dealer Inventory

Reference: PM979

# PM979 2021 KICKS TELEMATICS (AUDIO CONTROL UNIT) REPROGRAM

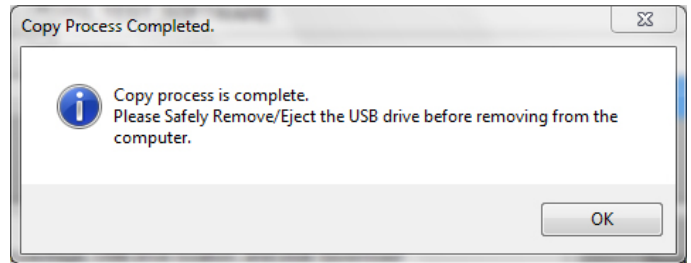
4. When the data download/transfer is completed, the message in Figure 4 will display.

- Select **OK**

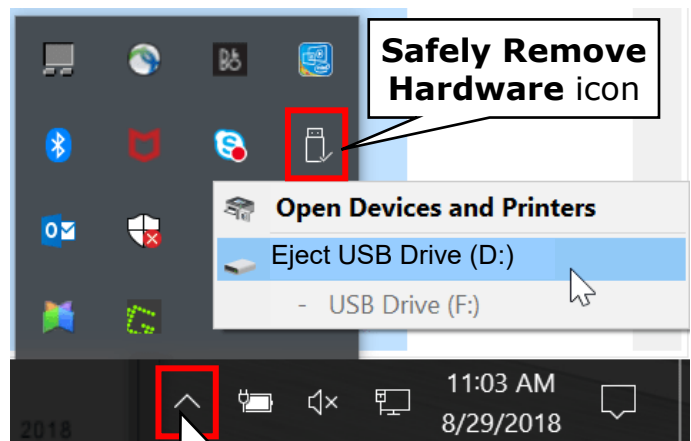
Figure 5

5. Once the transfer is complete, safely remove the USB drive from the ASIST Station. (Figure 5)

- From the PC toolbar, select the Safely Remove Hardware icon
- Select the USB drive to be removed
- Wait for message to appear that states, It is safe to remove hardware
- Remove the USB drive from the ASIST station

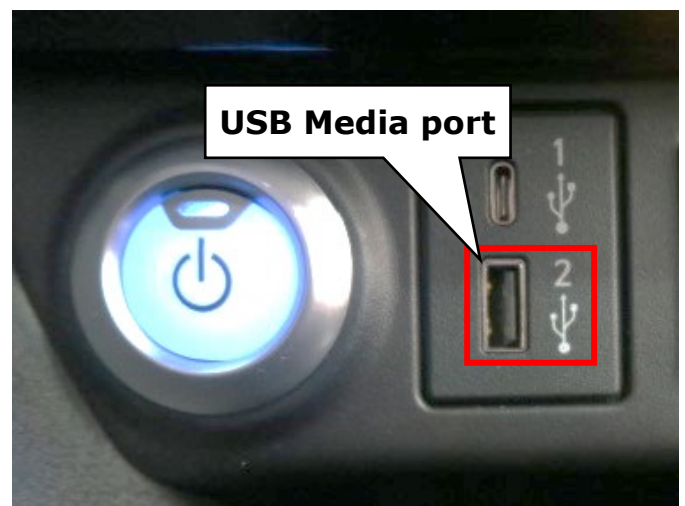
Figure 6

7. Insert the USB drive with infotainment software update into the vehicle's USB media port. (Figure 6)

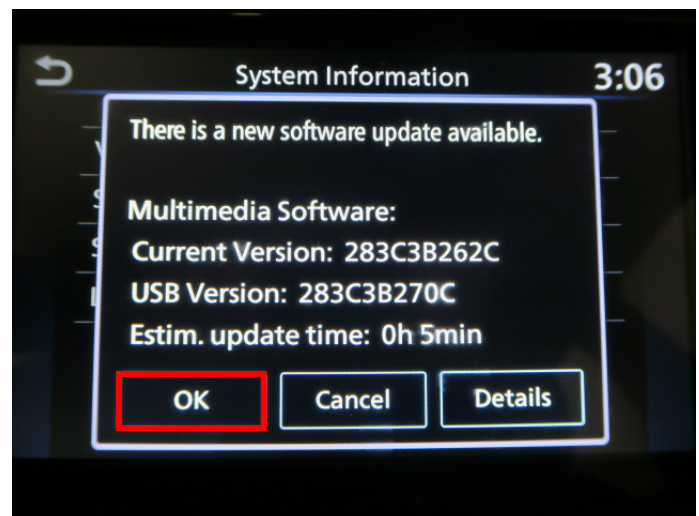
8. Wait approximately 10-30 seconds for the screen in Figure 7 to appear.
  - Select "OK"

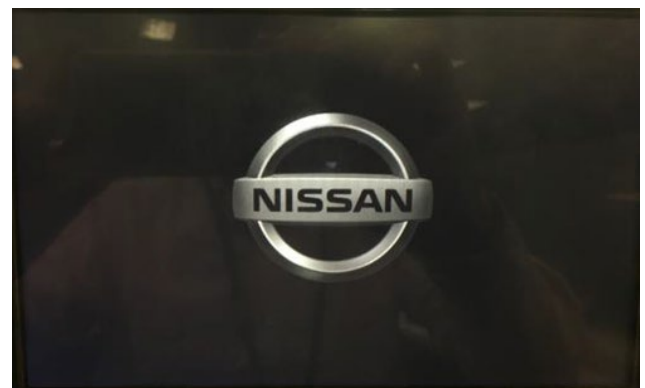
Figure 10

11. Allow the system to boot up completely (approximately 30 seconds).

- The Nissan logo will be displayed during the reboot (Figure 10)

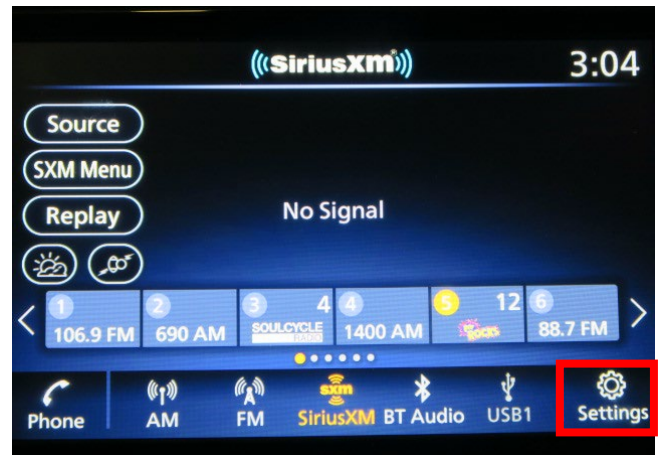
Figure 11

12. Select "Settings" located in the lower RH corner of the AV unit display. (Figure 11)

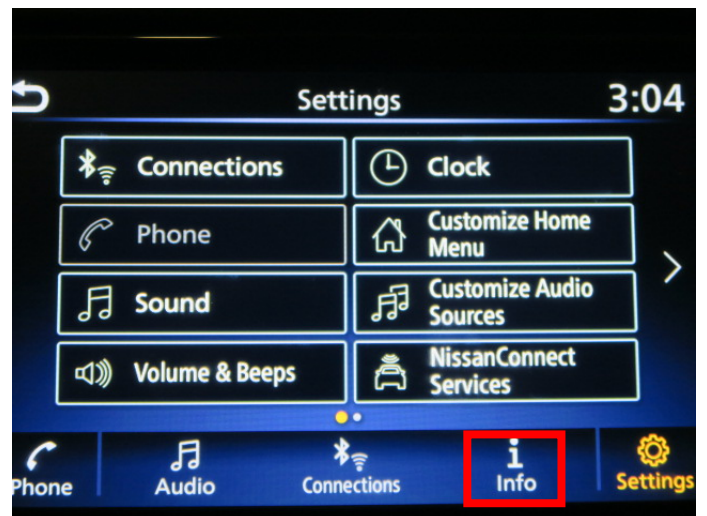
Figure 12

13. Select "Info" located at the lower part of the AV unit display. (Figure 12)

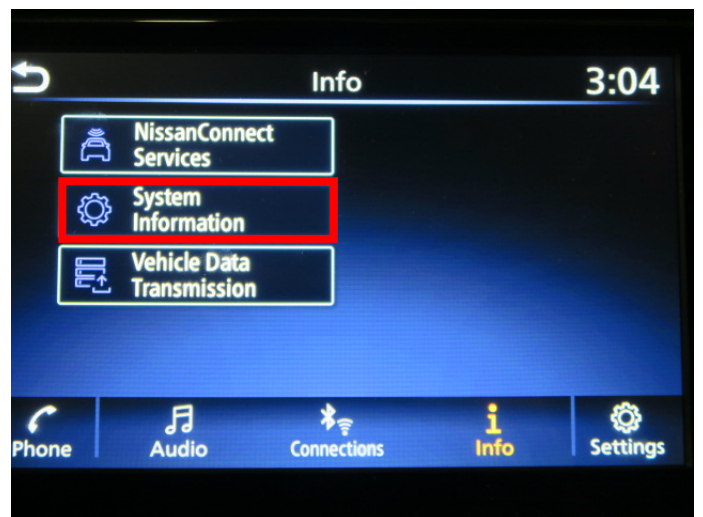
Figure 13

14. Select "System Information". (Figure 13)

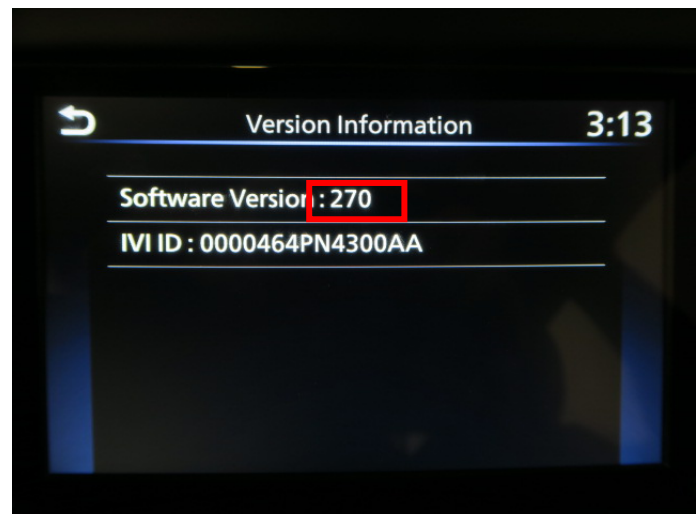
Figure 15

16. Verify Software Version is **270**.

- If software version is correct, procedure is complete, proceed to claims information
- If the software version is **NOT 270**, start this procedure over and verify the correct software shown in Step 3 is downloaded
